HISTORIC AMERICAN BUILDINGS SURVEY

INDEX TO PHOTOGRAPHS

Auditorium Building (Roosevelt University)
430 South Michigan Avenue
Chicago
Cook County
Illinois

HABS No. IL-1007

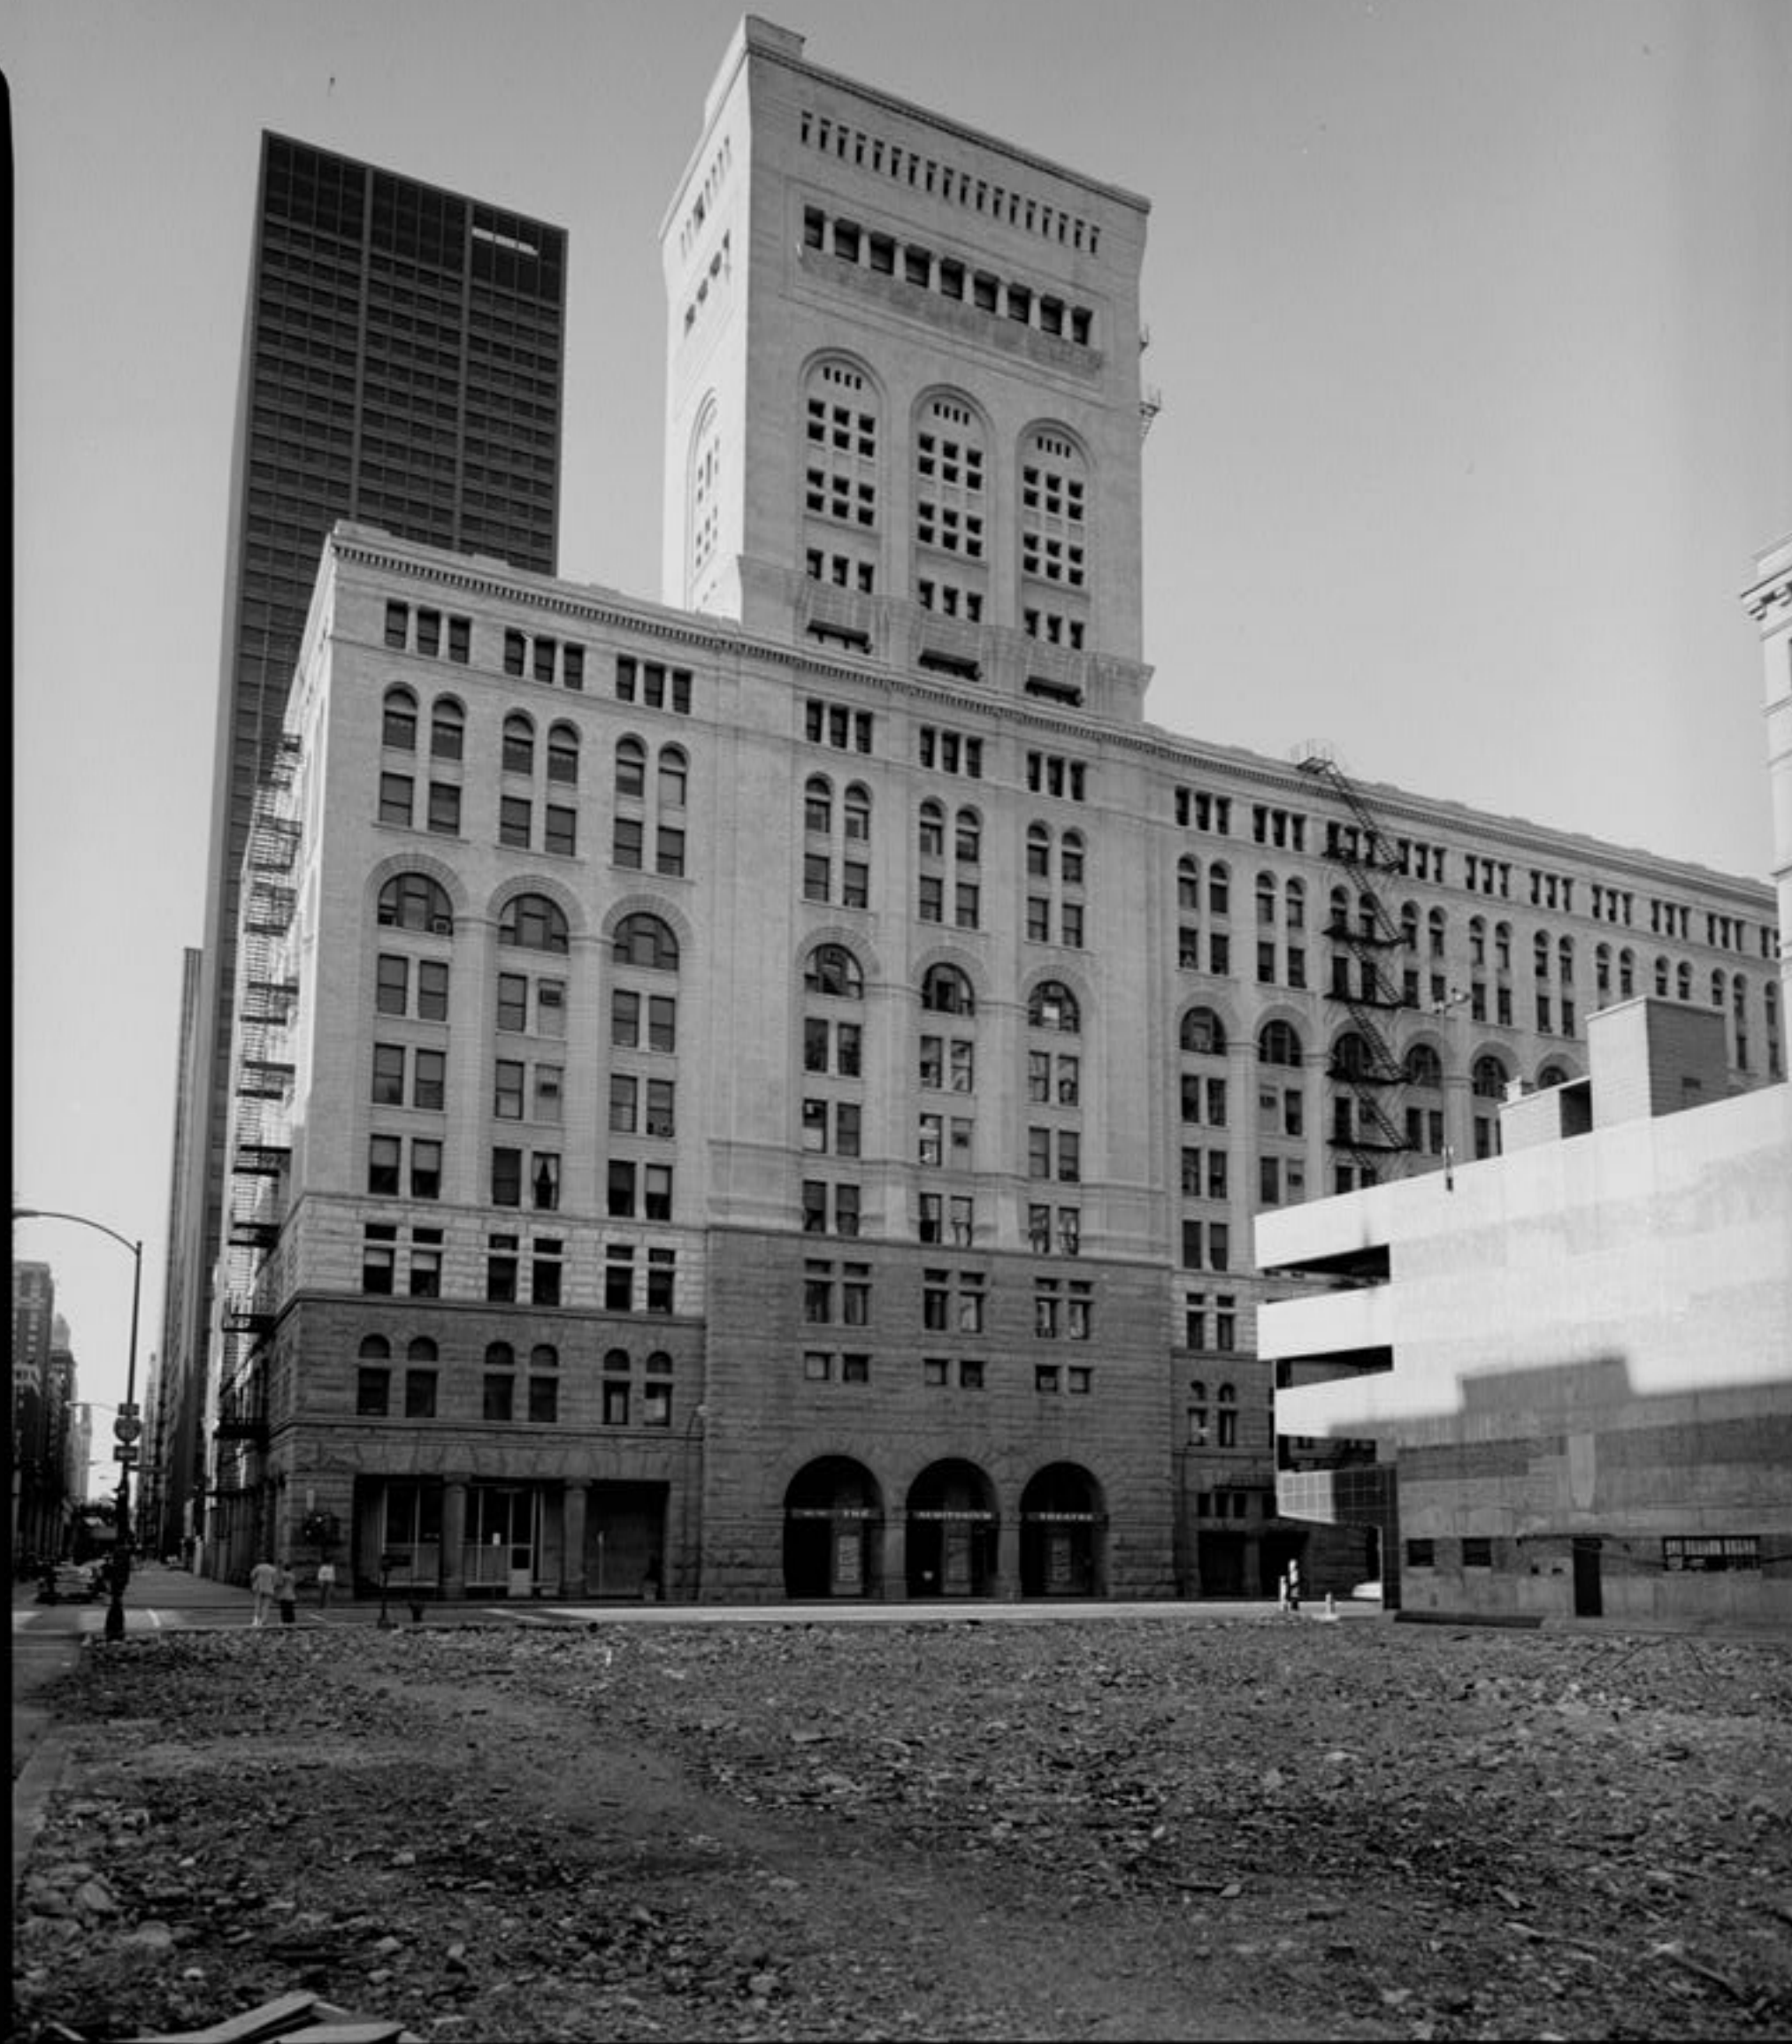
HABS NO. IL-1007-7

- IL-1007-7 WESTERN HALF OF SOUTH (CONGRESS STREET) ELEVATION.
- IL-1007-8 STEPPED FOUNDATION UNDER TOWER.
- IL-1007-9 COLUMN IN NORTHEAST CORNER OF BASEMENT WITH LATER REINFORCING.

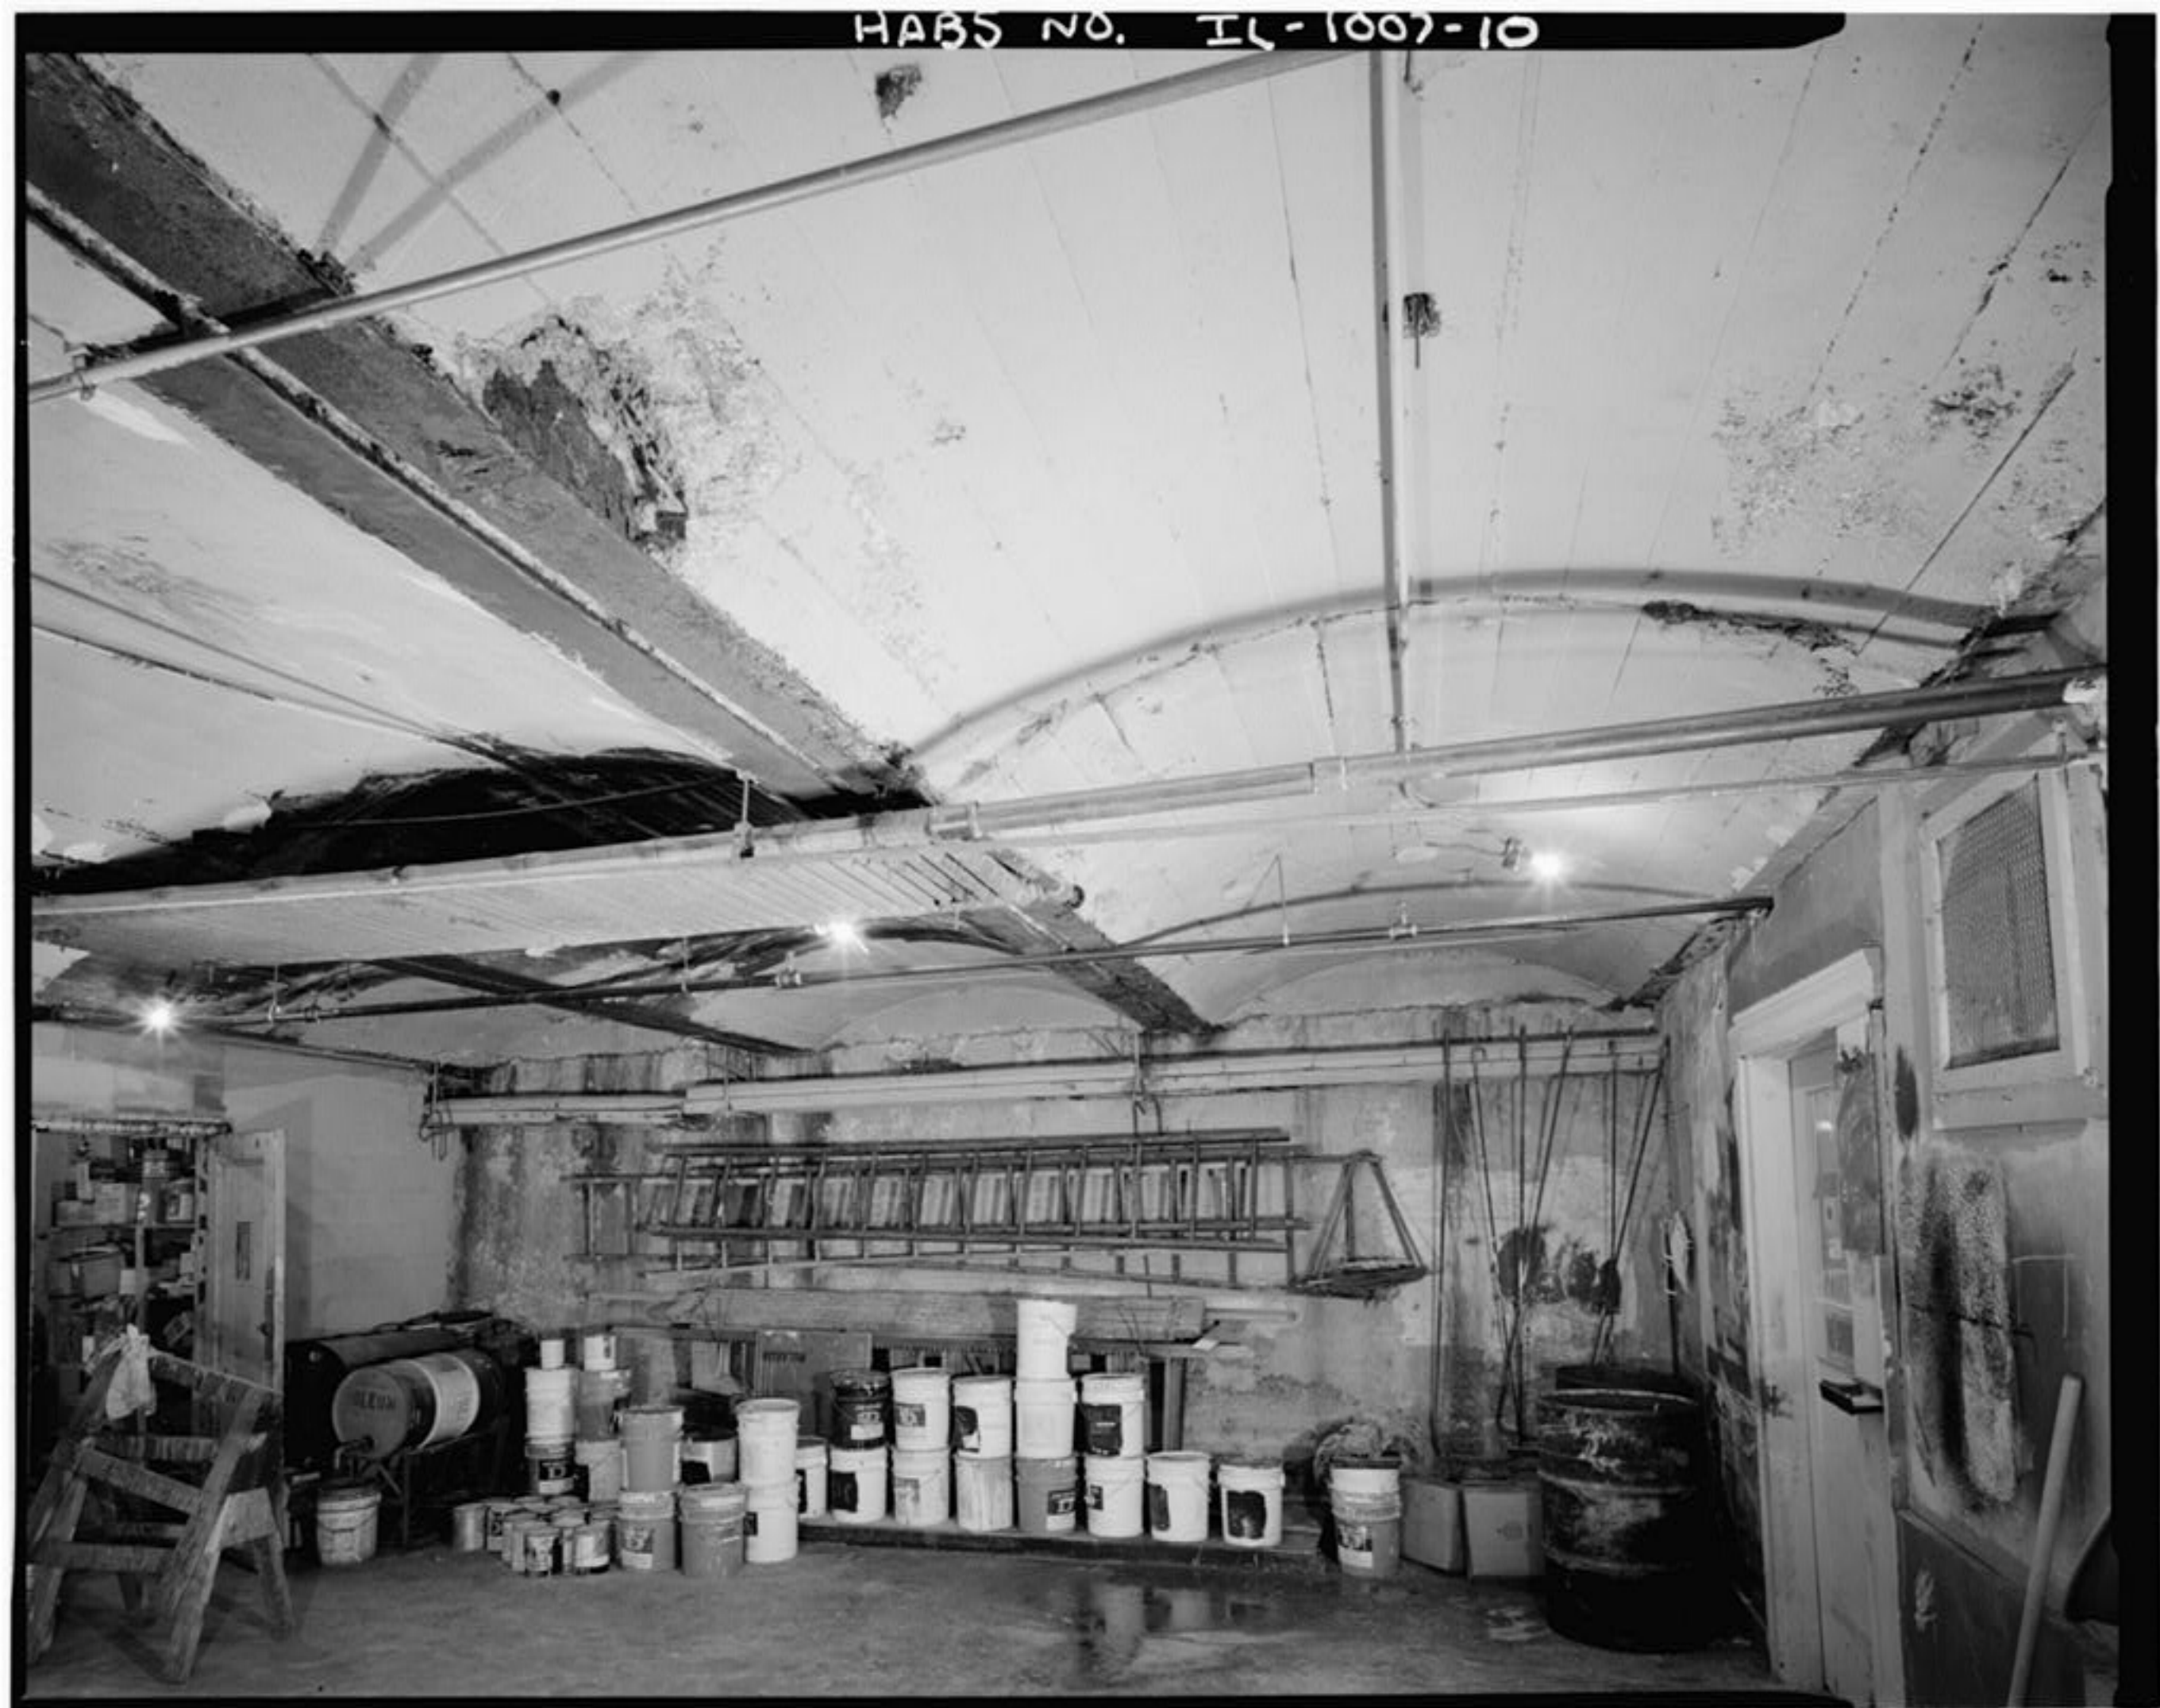
HABS NO. IL-1007-10

- IL-1007-10 VAULTS UNDER MICHIGAN AVENUE SIDEWALK, ORIGINALLY THE BARBER SHOP.
- IL-1007-11 ORIGINAL STAIRWAY TO HOTEL LOBBY FROM TUNNEL TO AUDITORIUM ANNEX.

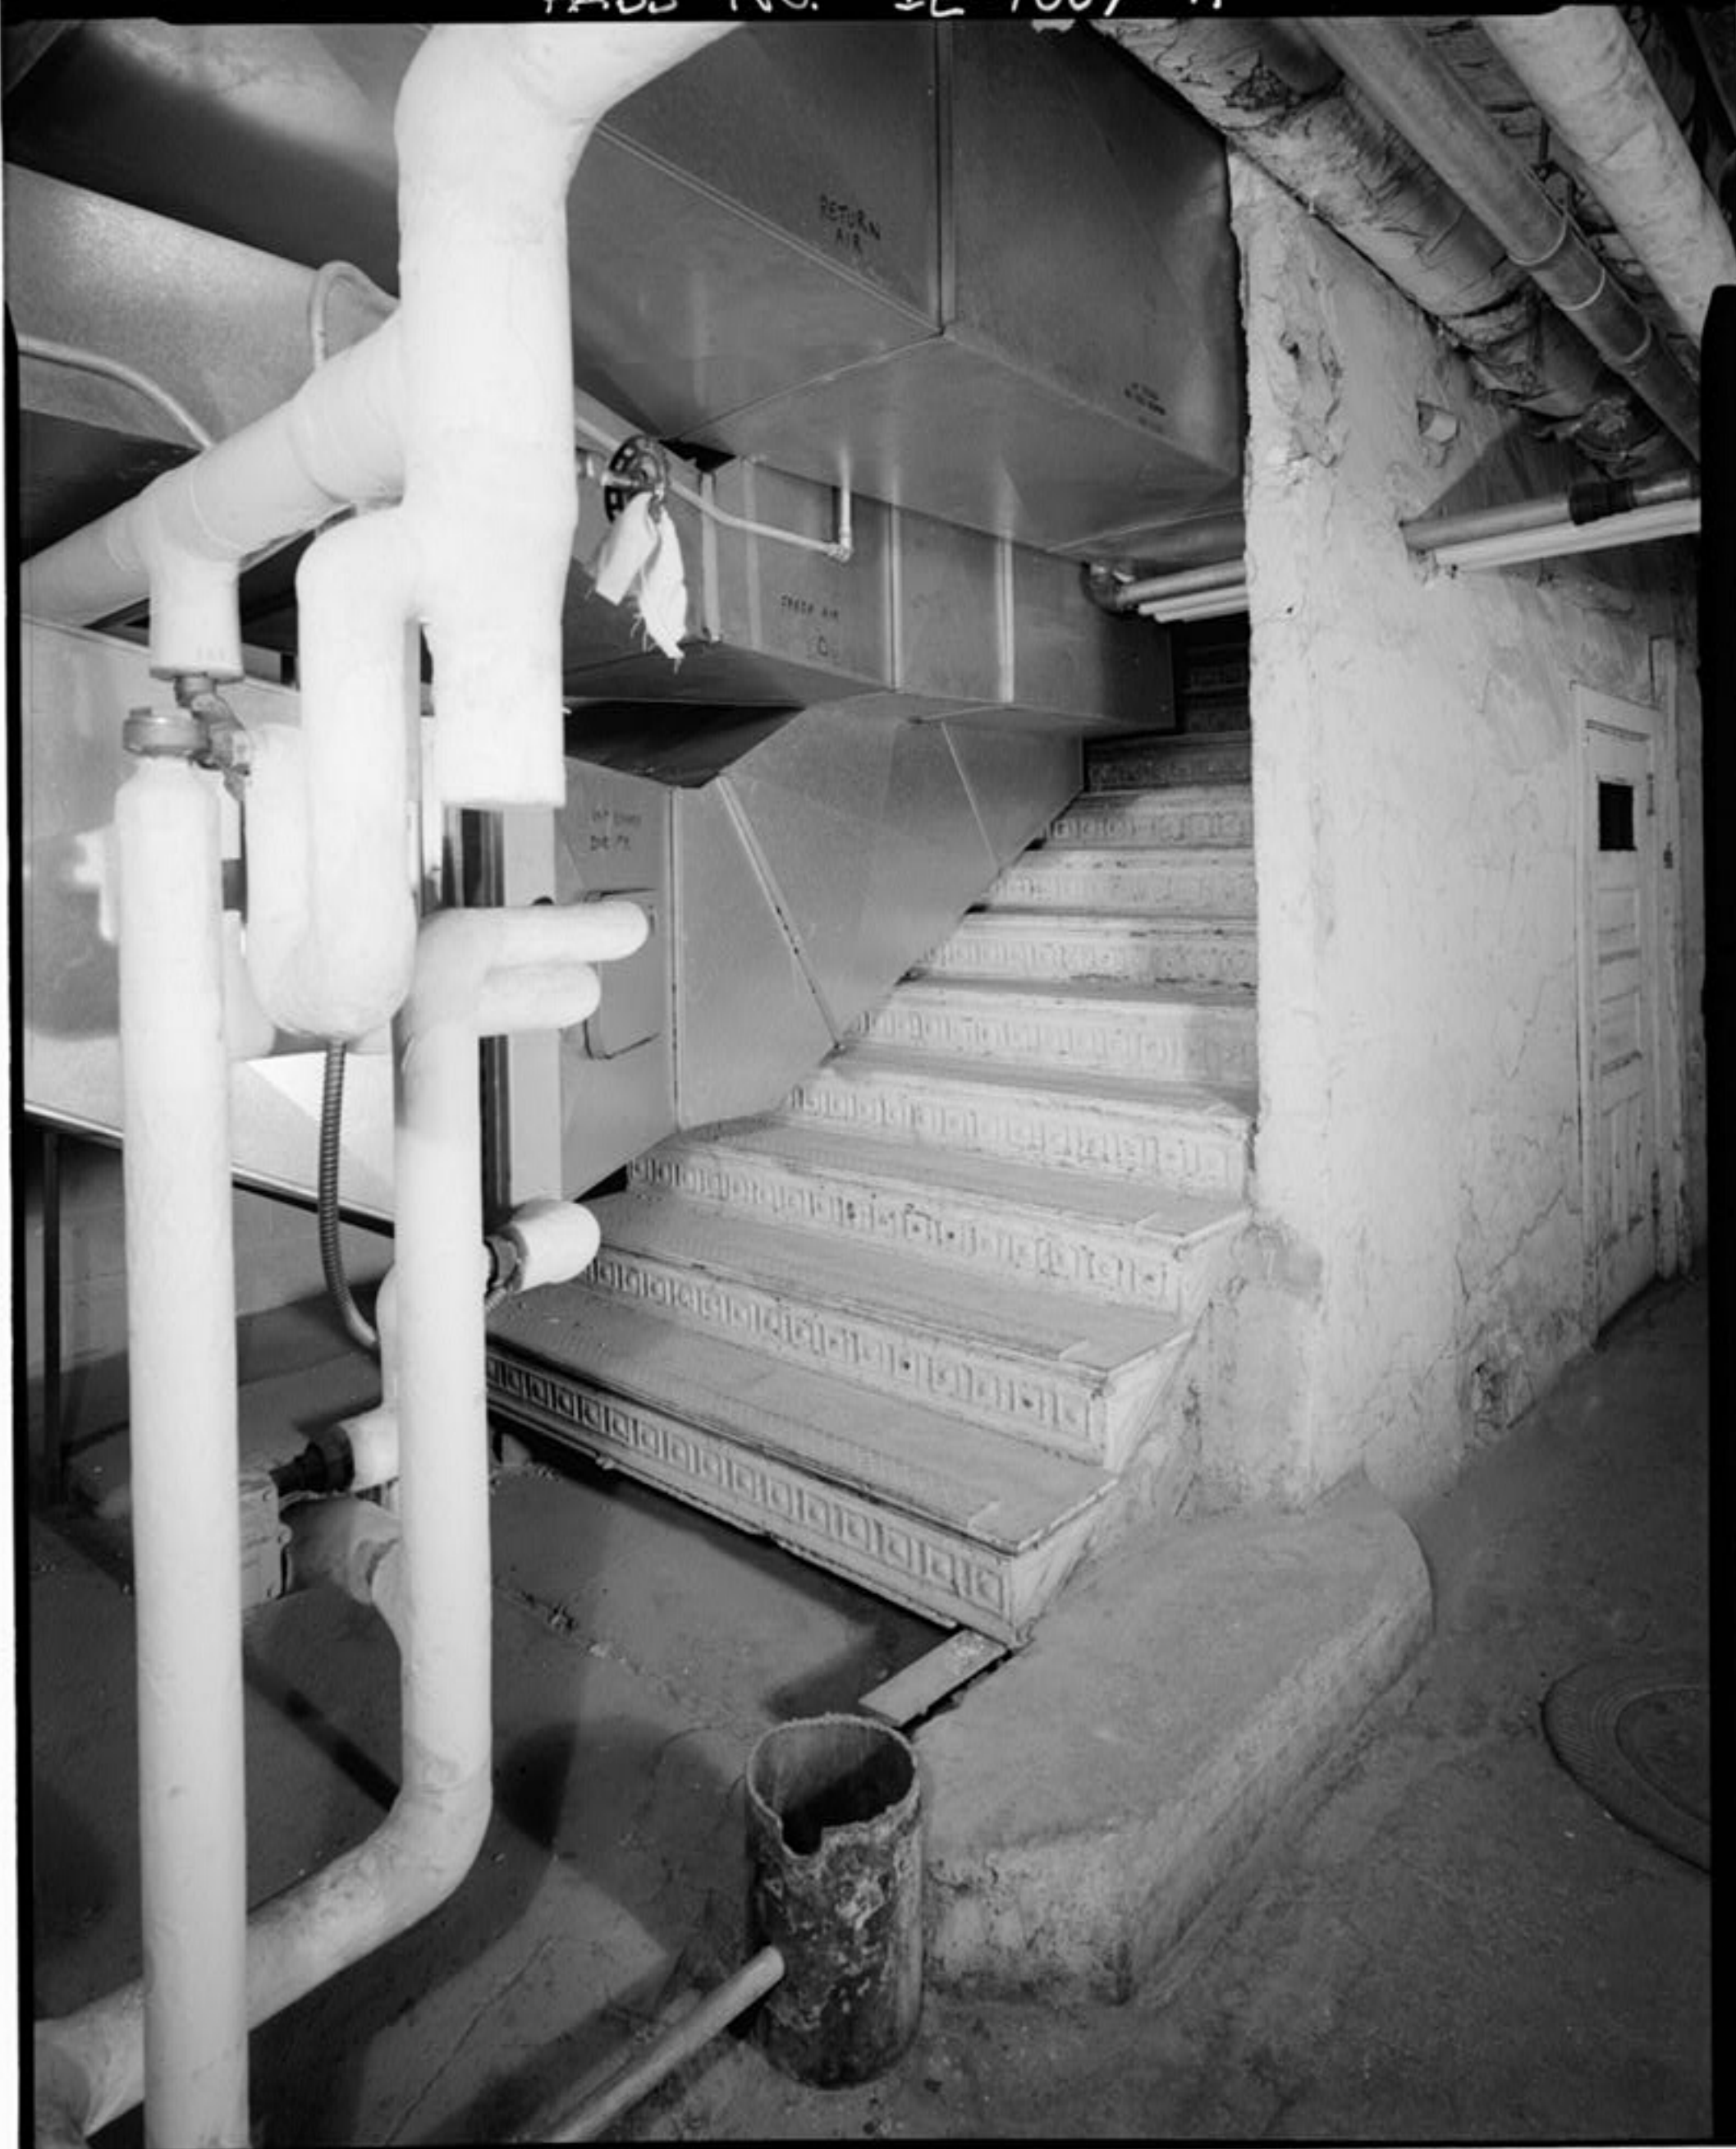
HABS NO. IL-1007-11

- IL-1007-12 LOCATION OF MAIN SUPPLY FAN FOR THEATER HVAC SYSTEM, LOOKING WEST.
- IL-1007-13 FOUNDATION OF STEAM ENGINE WHICH DROVE MAIN SUPPLY FAN FOR THEATER, LOOKING WEST.

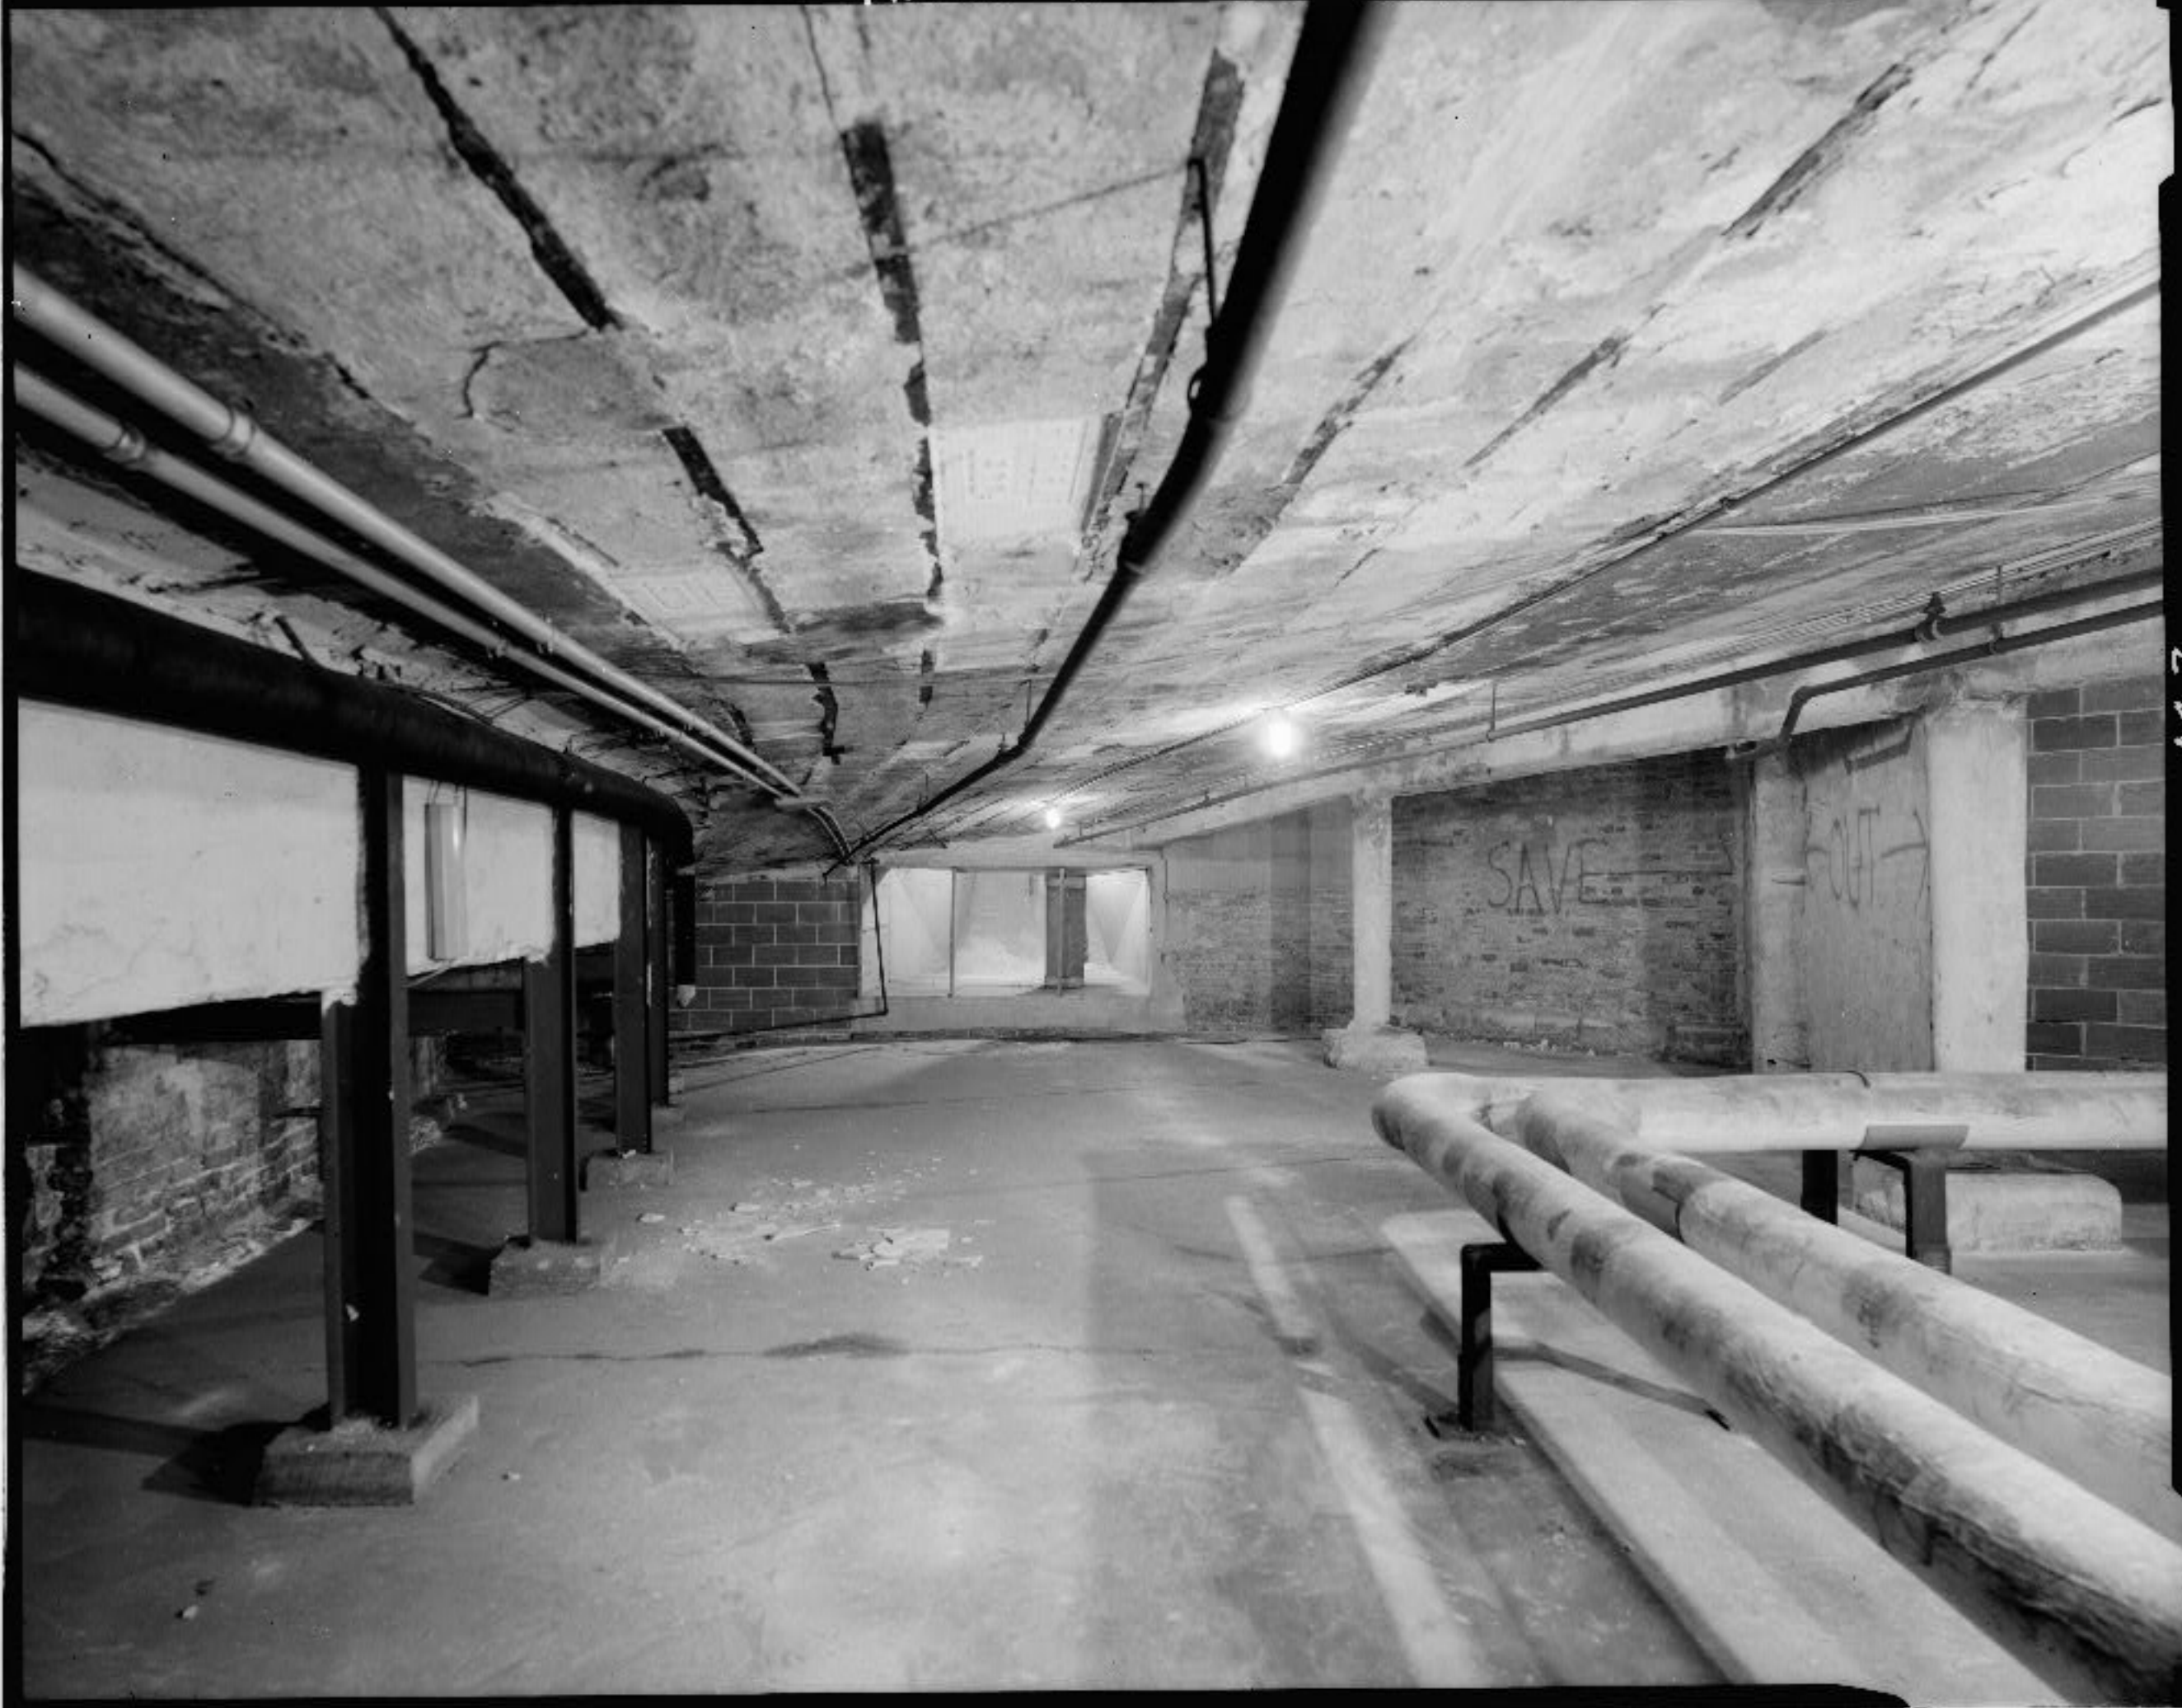
HABS NO. IL-1007-14

- IL-1007-14 MAIN SUPPLY PLENUM UNDER THEATER, ORCHESTRA PIT ON LEFT AND VERTICAL SUPPLY DUCT FOR SOUTH HALF OF THEATER IN CENTER.
- IL-1007-15 ORIGINAL SHONE'S HYDRO-PNEUMATIC SEWAGE EJECTORS IN STAGE BASEMENT.

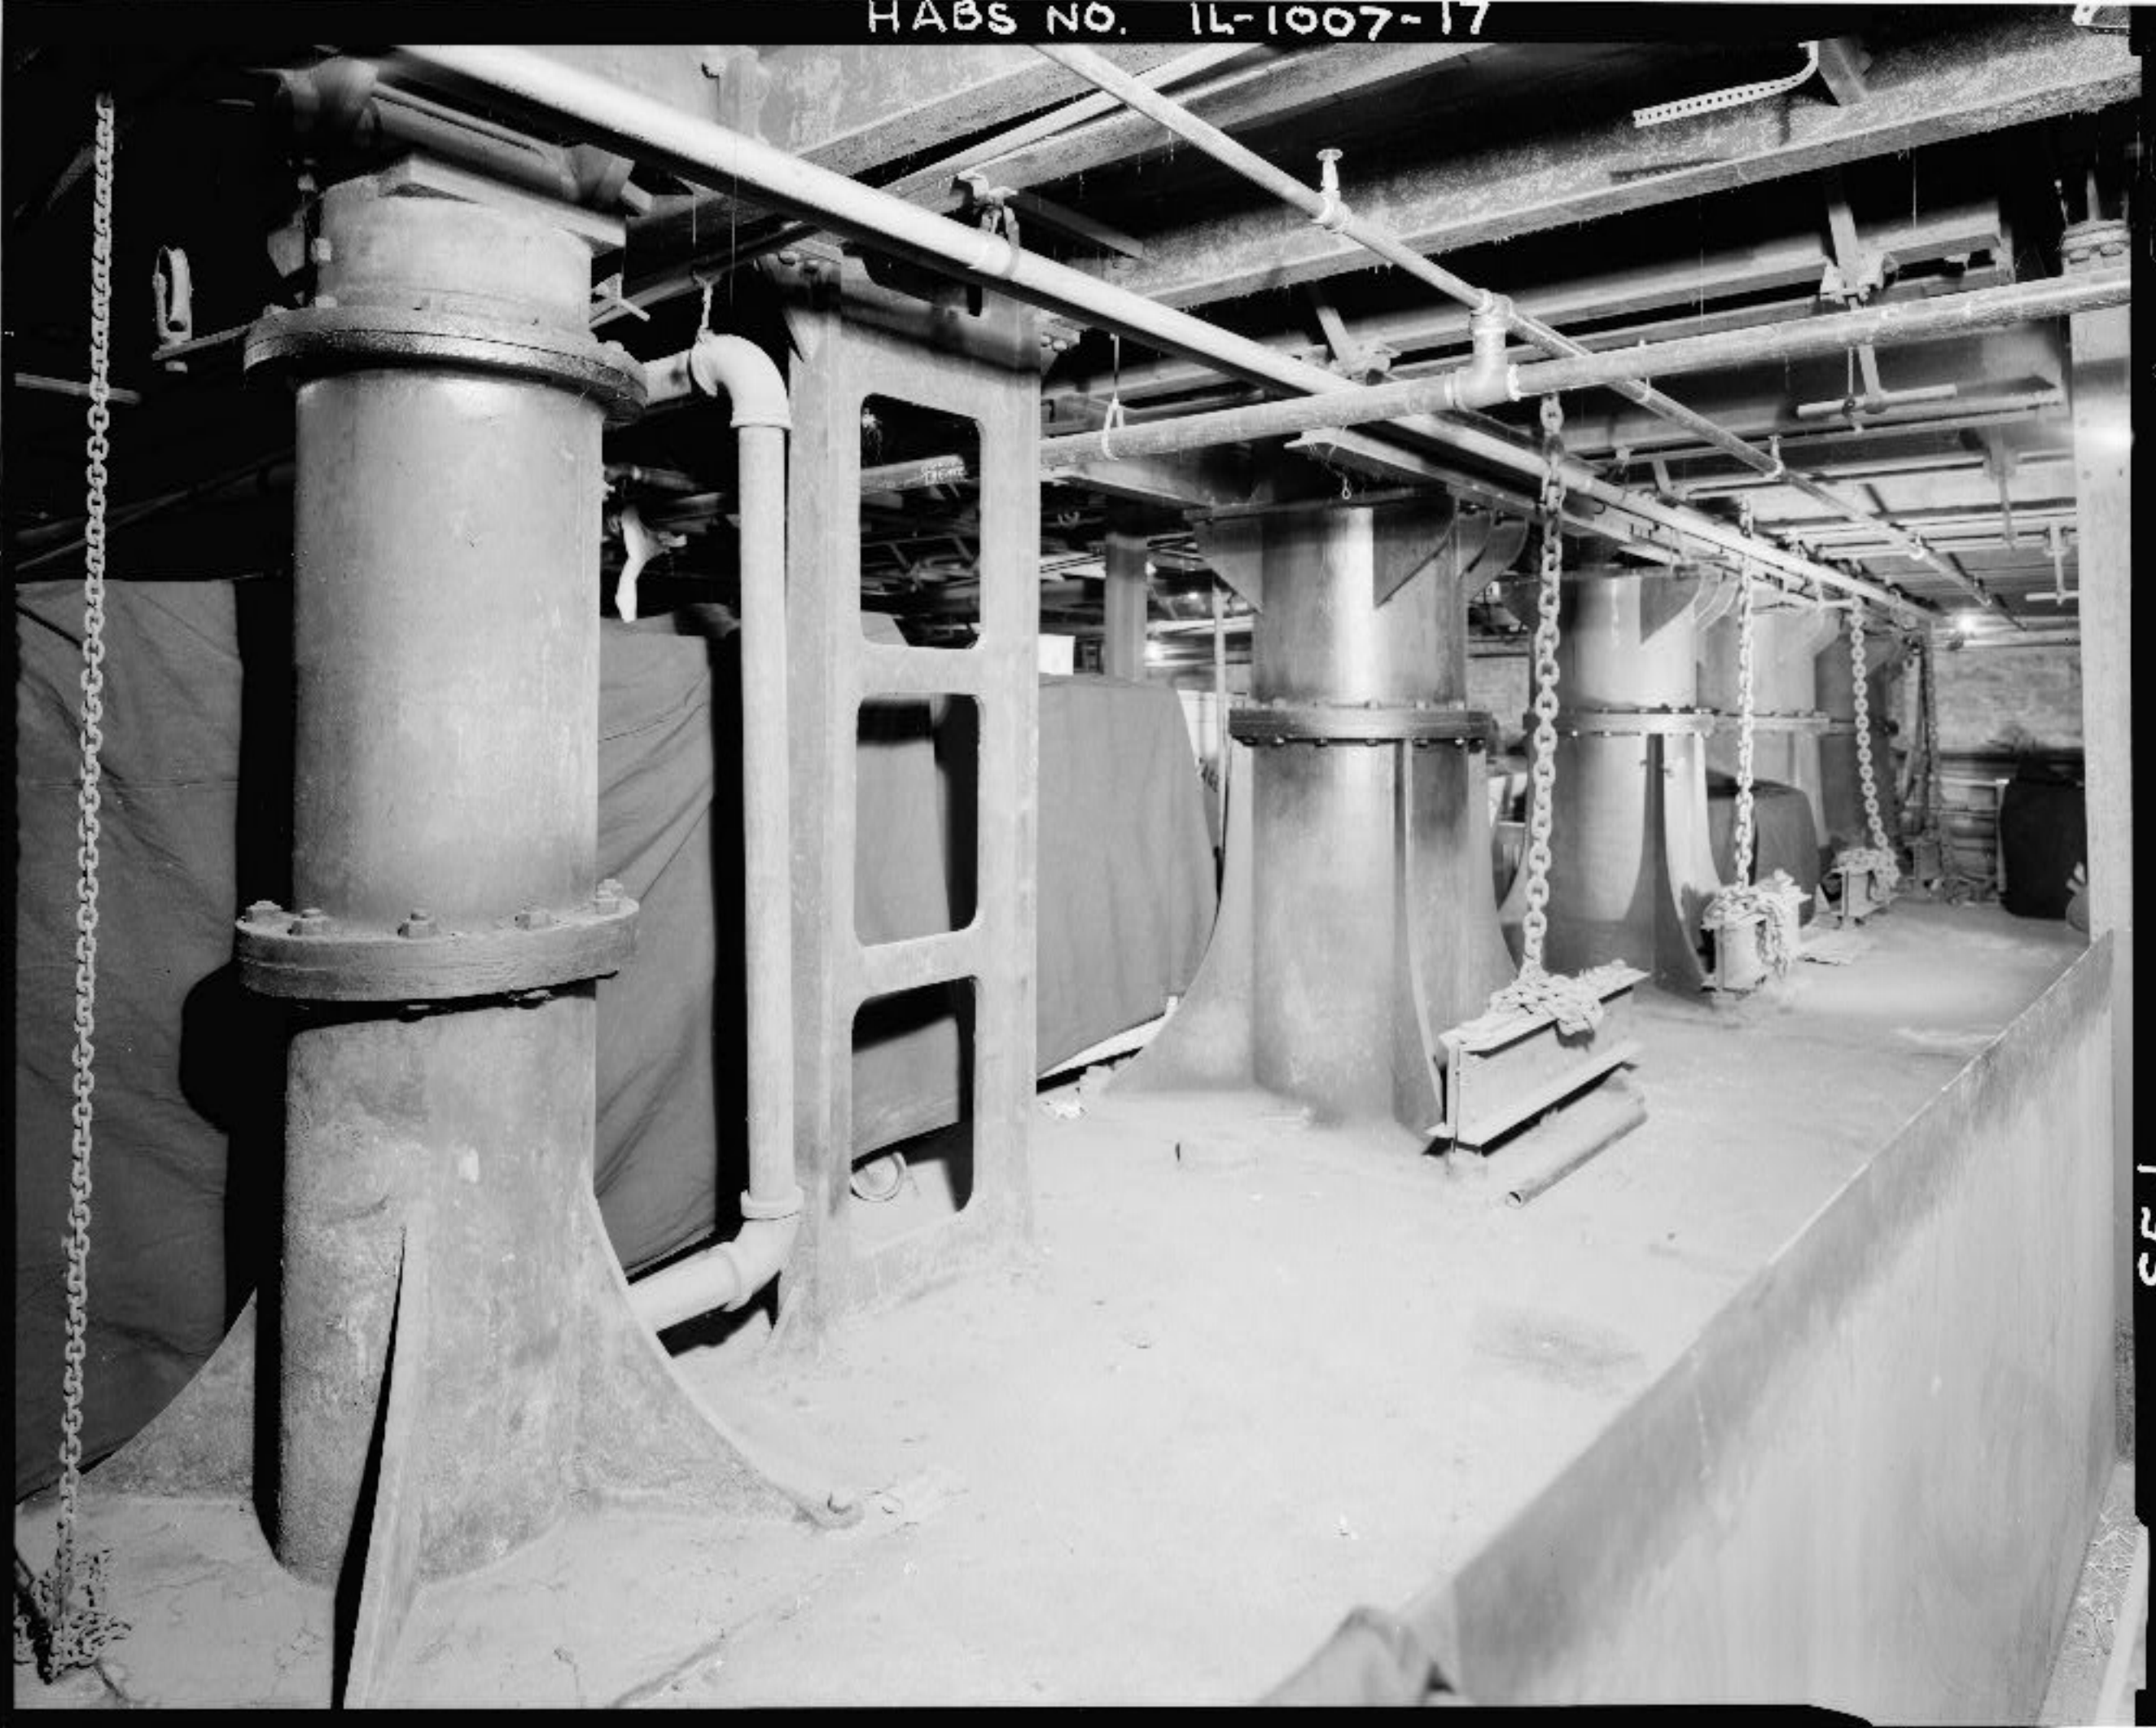
HABS NO. 1L-1007-17

- IL-1007-16 UNUSED WATER TANK IN BASEMENT.
- IL-1007-17 SOUTH SIDE OF SOUTH BANK OF HYDRAULIC RAMS, LOWER LEVEL OF STAGE, LOOKING NORTHEAST.
- IL-1007-18 NORTH BANK OF HYDRAULIC RAMS WITH CONTROL VALVES BEYOND, LOWER LEVEL OF STAGE, LOOKING NORTH.

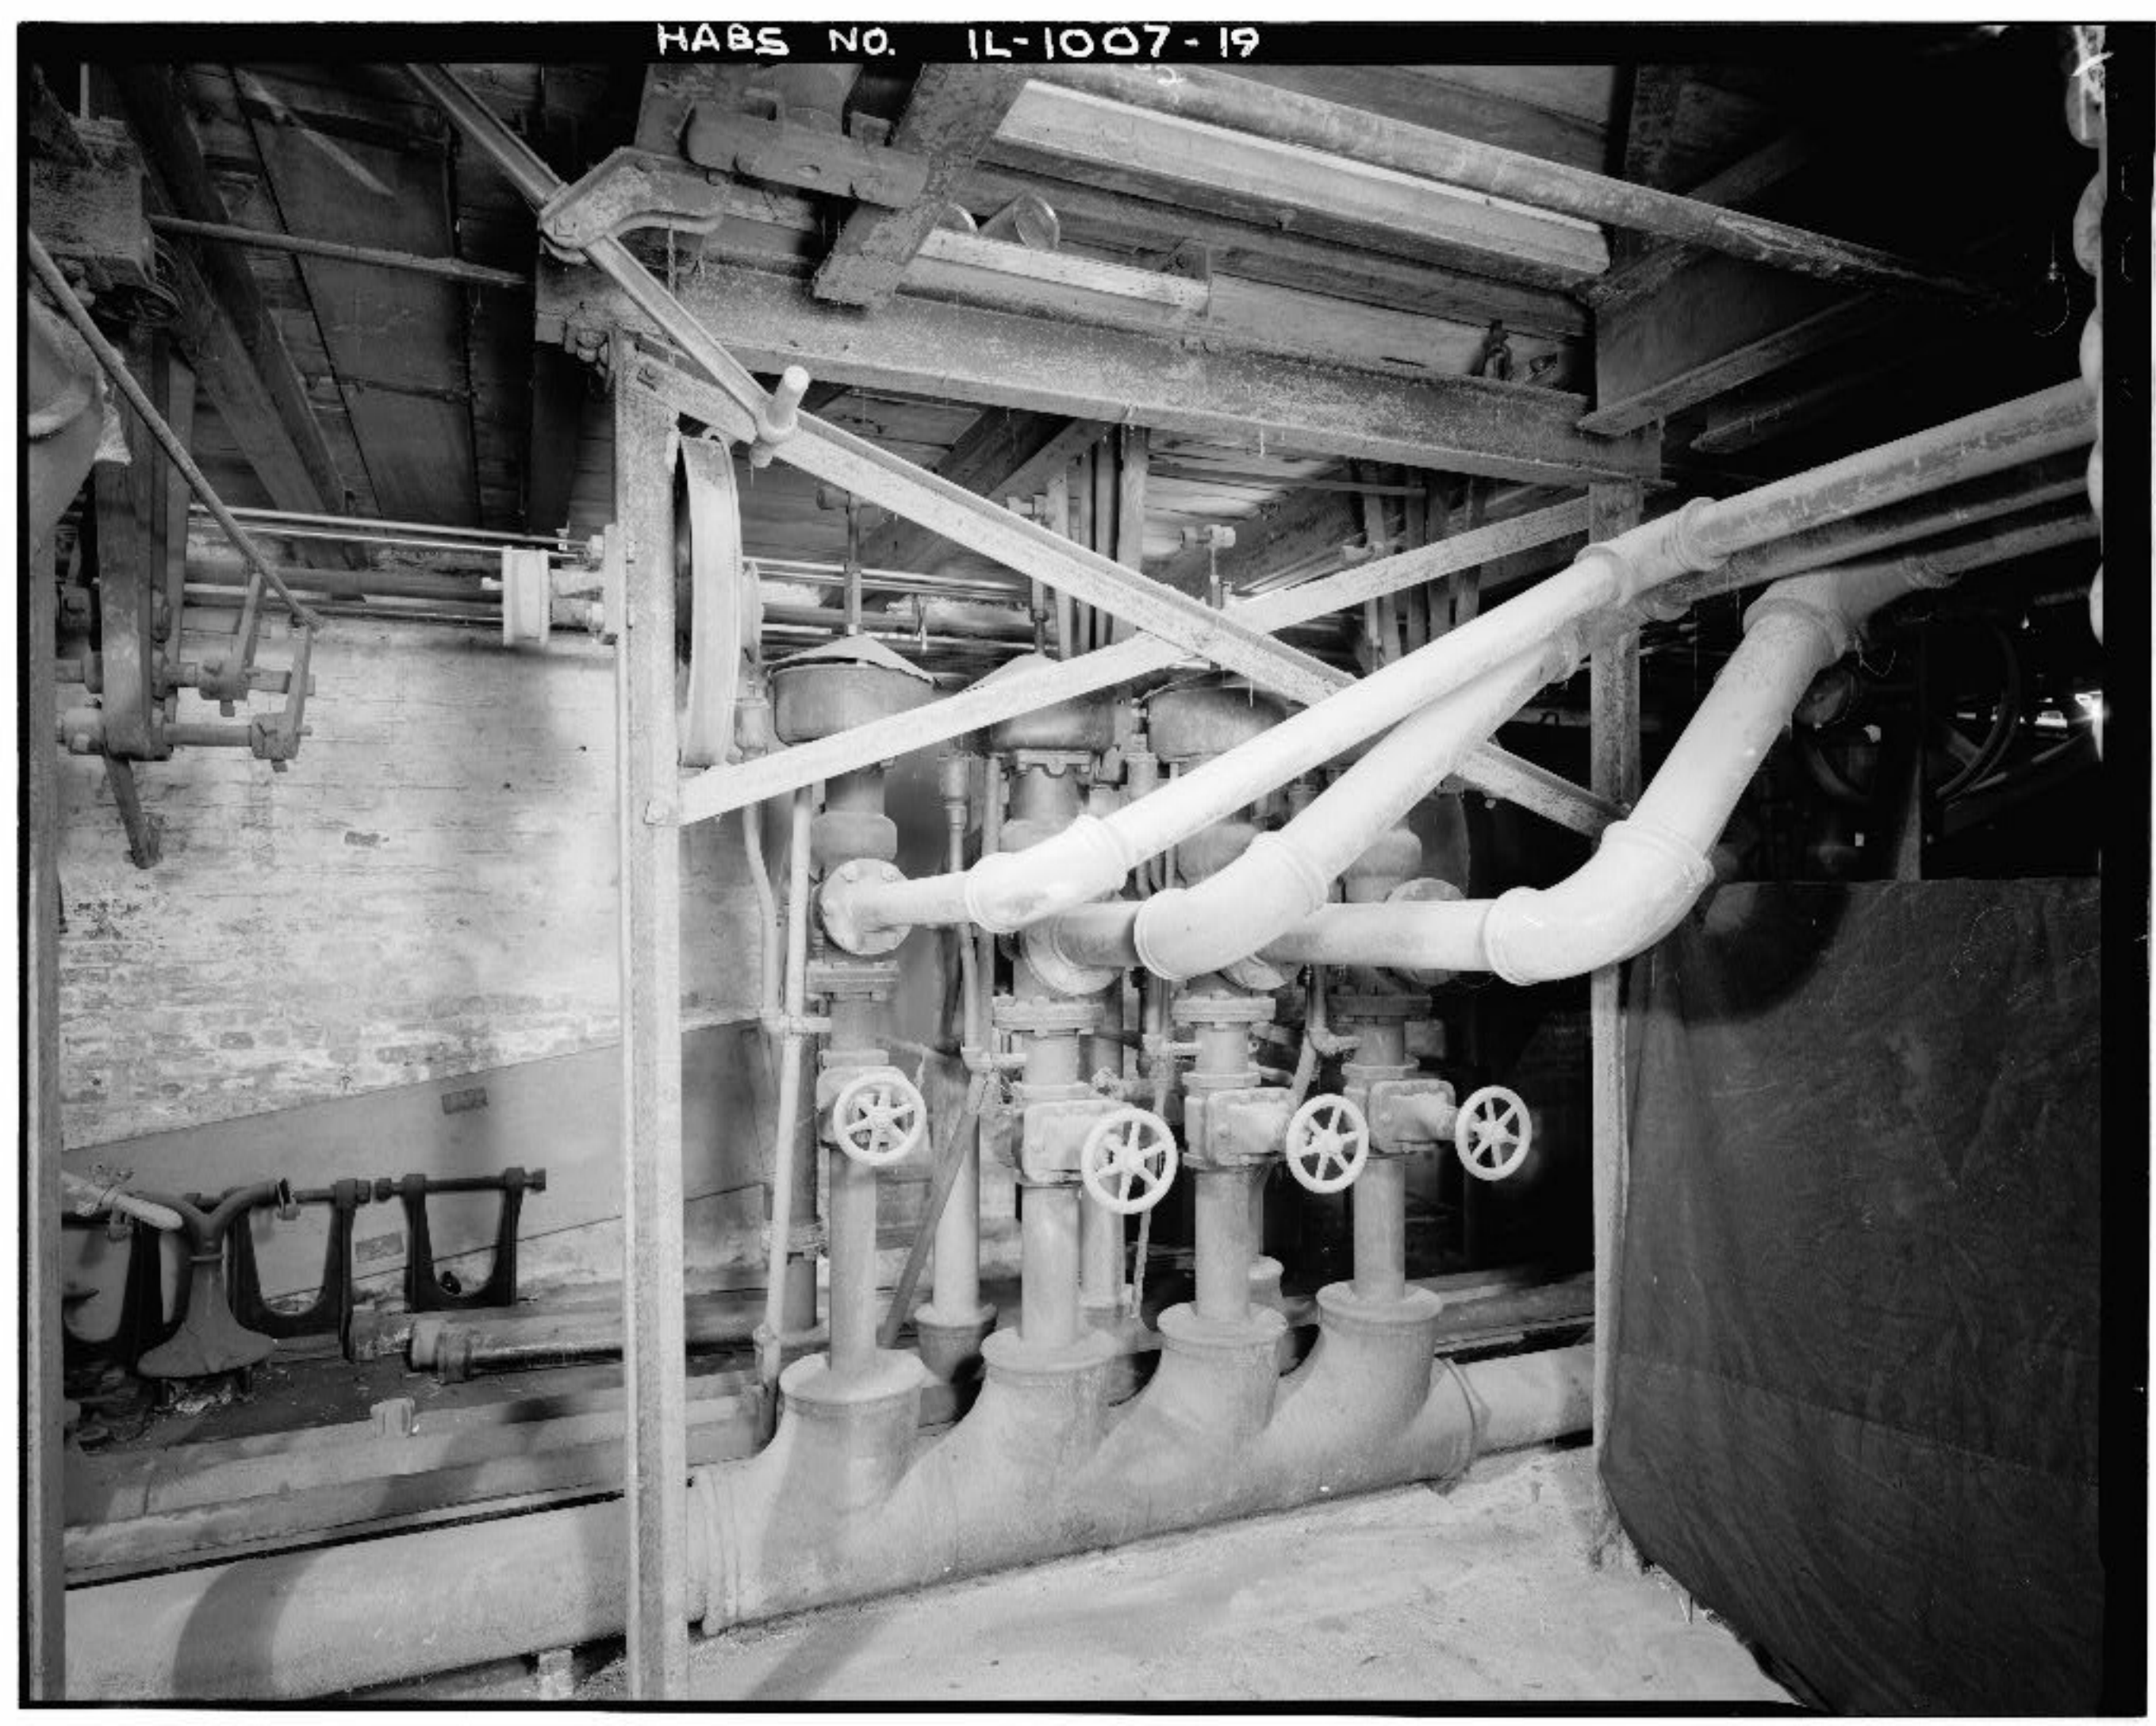
HABS NO. IL-1007-19

- IL-1007-19 DETAIL OF CONTROL VALVES, LOWER LEVEL OF STAGE, LOOKING NORTH.
- IL-1007-20 NORTH BANK OF HYDRAULIC RAMS AND CONTROL VALVES, LOWER LEVEL OF STAGE, LOOKING EAST.
