HISTORIC AMERICAN BUILDINGS SURVEY

INDEX TO PHOTOGRAPHS

Auditorium Building (Roosevelt University)
430 South Michigan Avenue
Chicago
Cook County
Illinois

HABS No. IL-1007

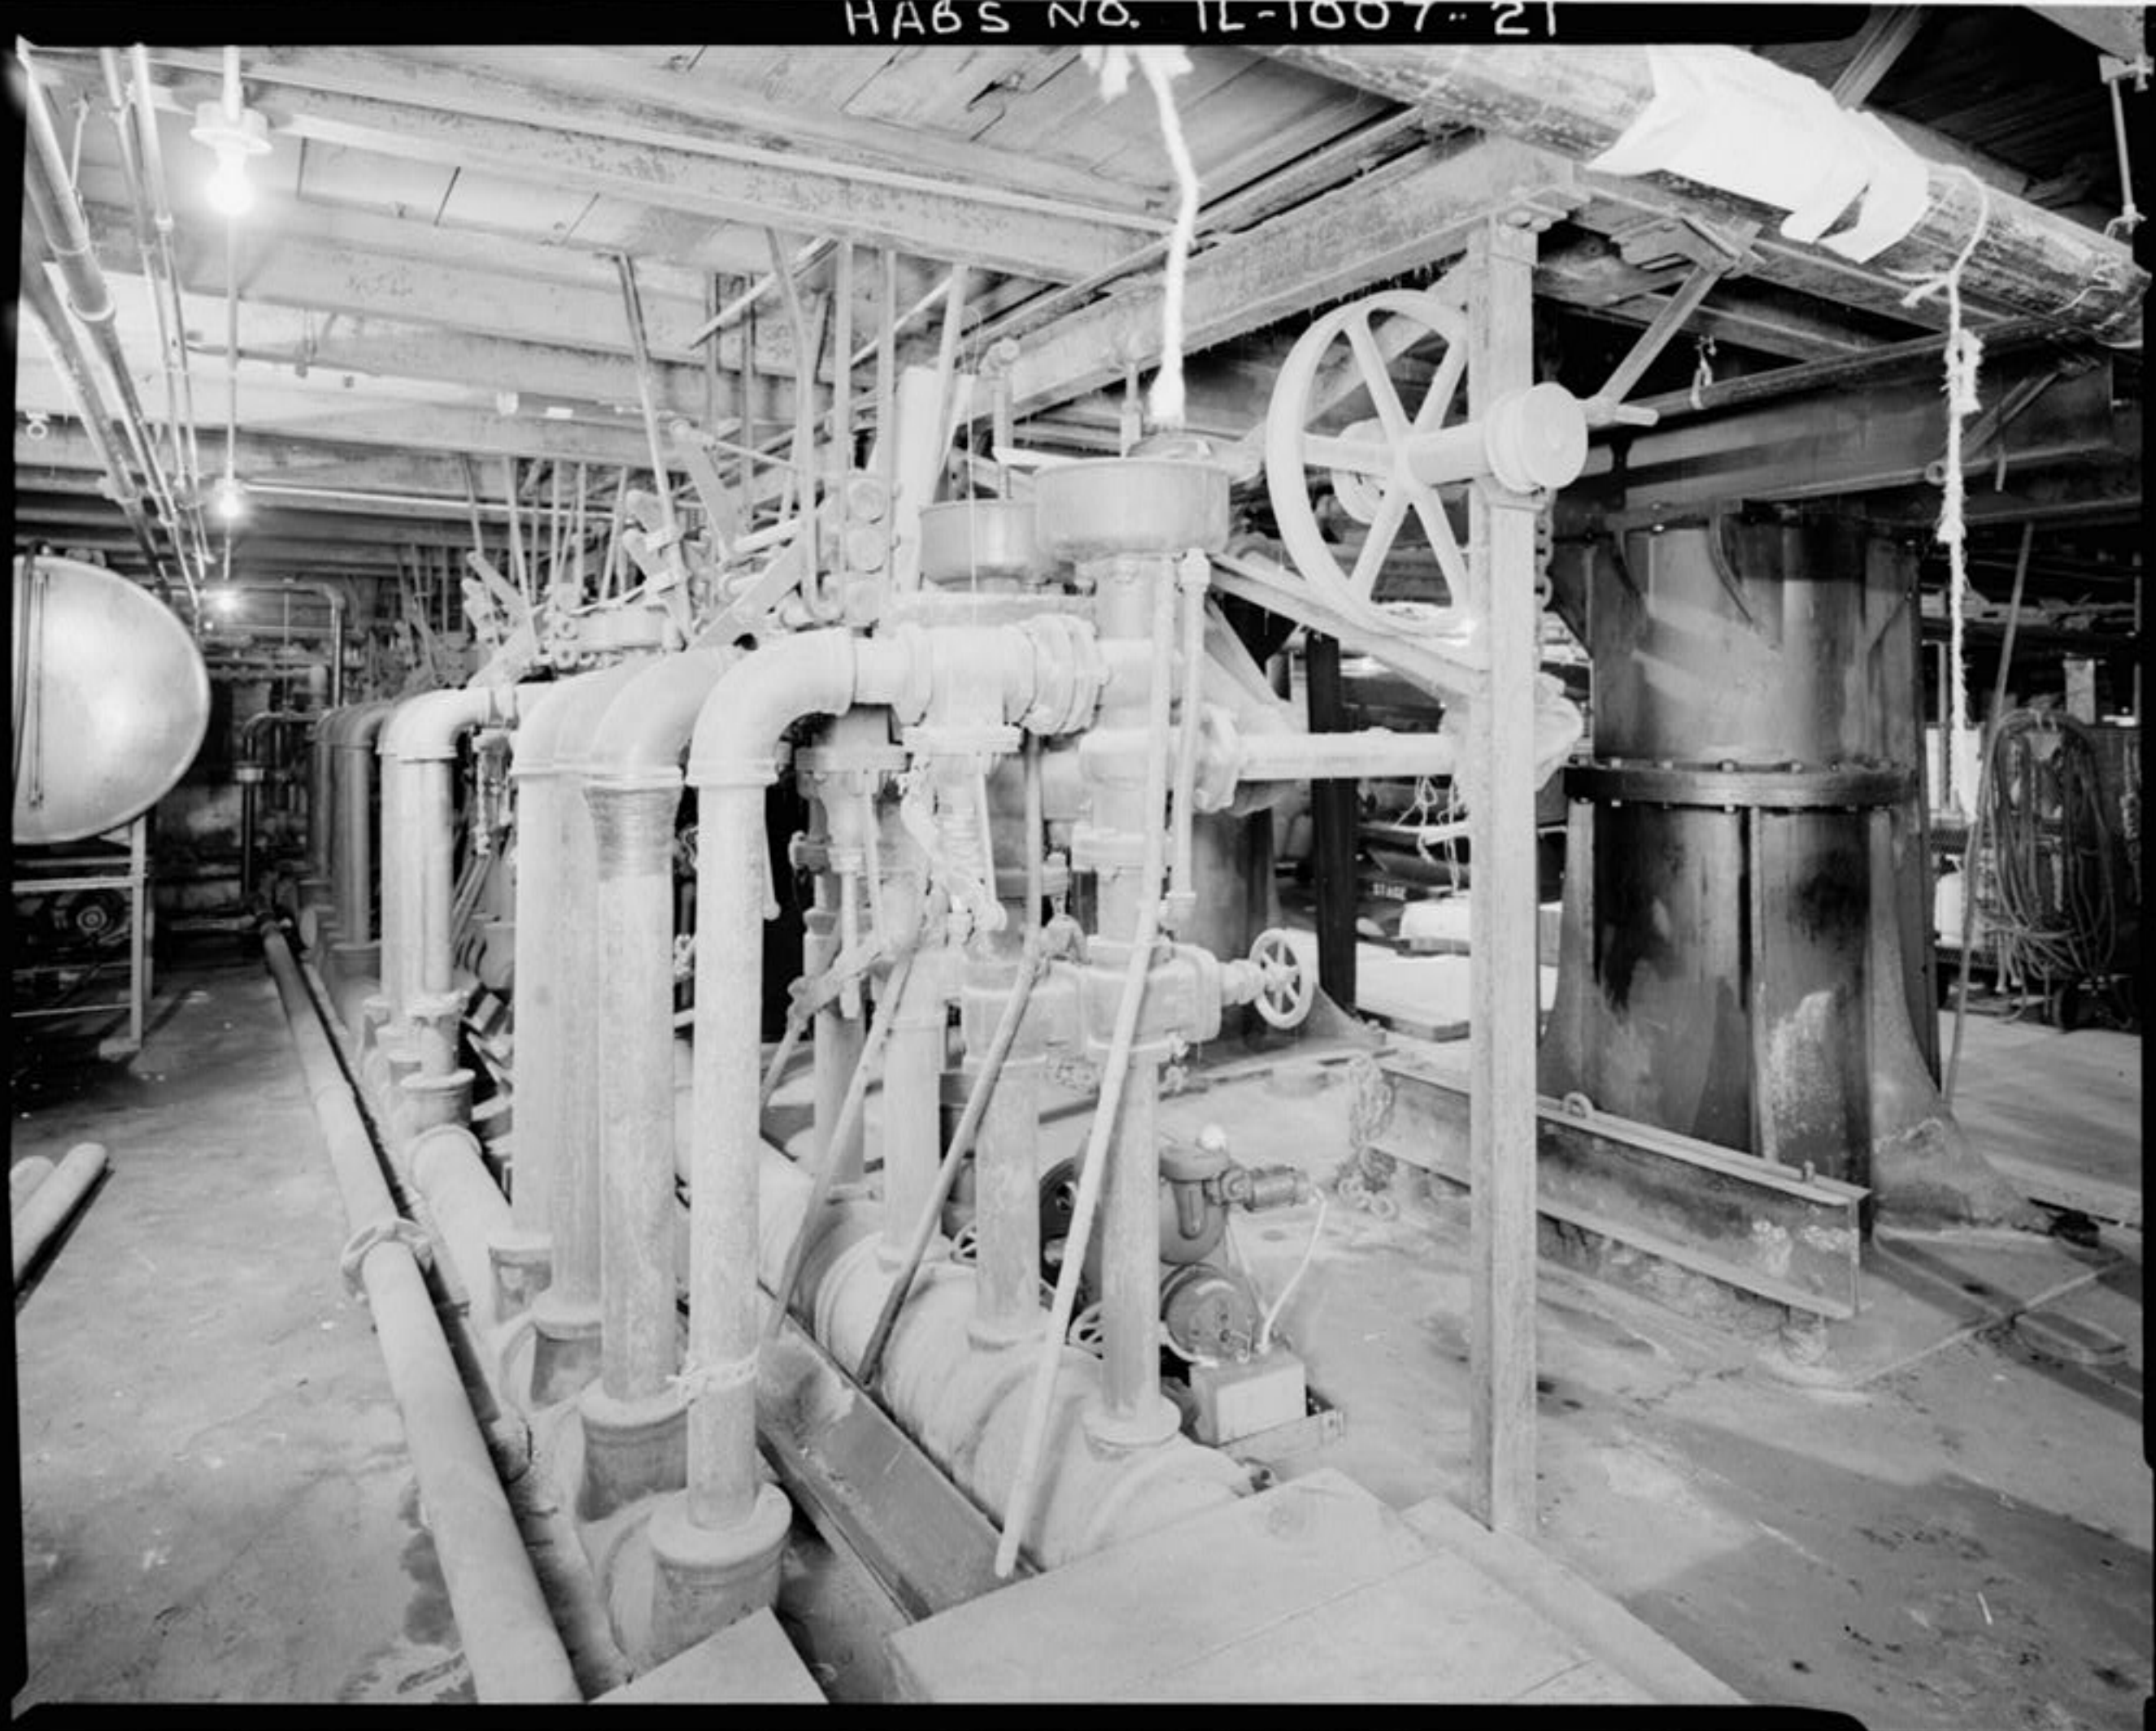
HABS NO. 1L-1007-21

- IL-1007-21 DETAIL OF PIPING FOR CONTROL VALVES AND REGULATORS, LOWER LEVEL OF STAGE, LOOKING SOUTHEAST.
- IL-1007-22 DETAIL OF CONTROL VALVES AND REGULATORS, LOWER LEVEL OF STAGE, LOOKING SOUTH.

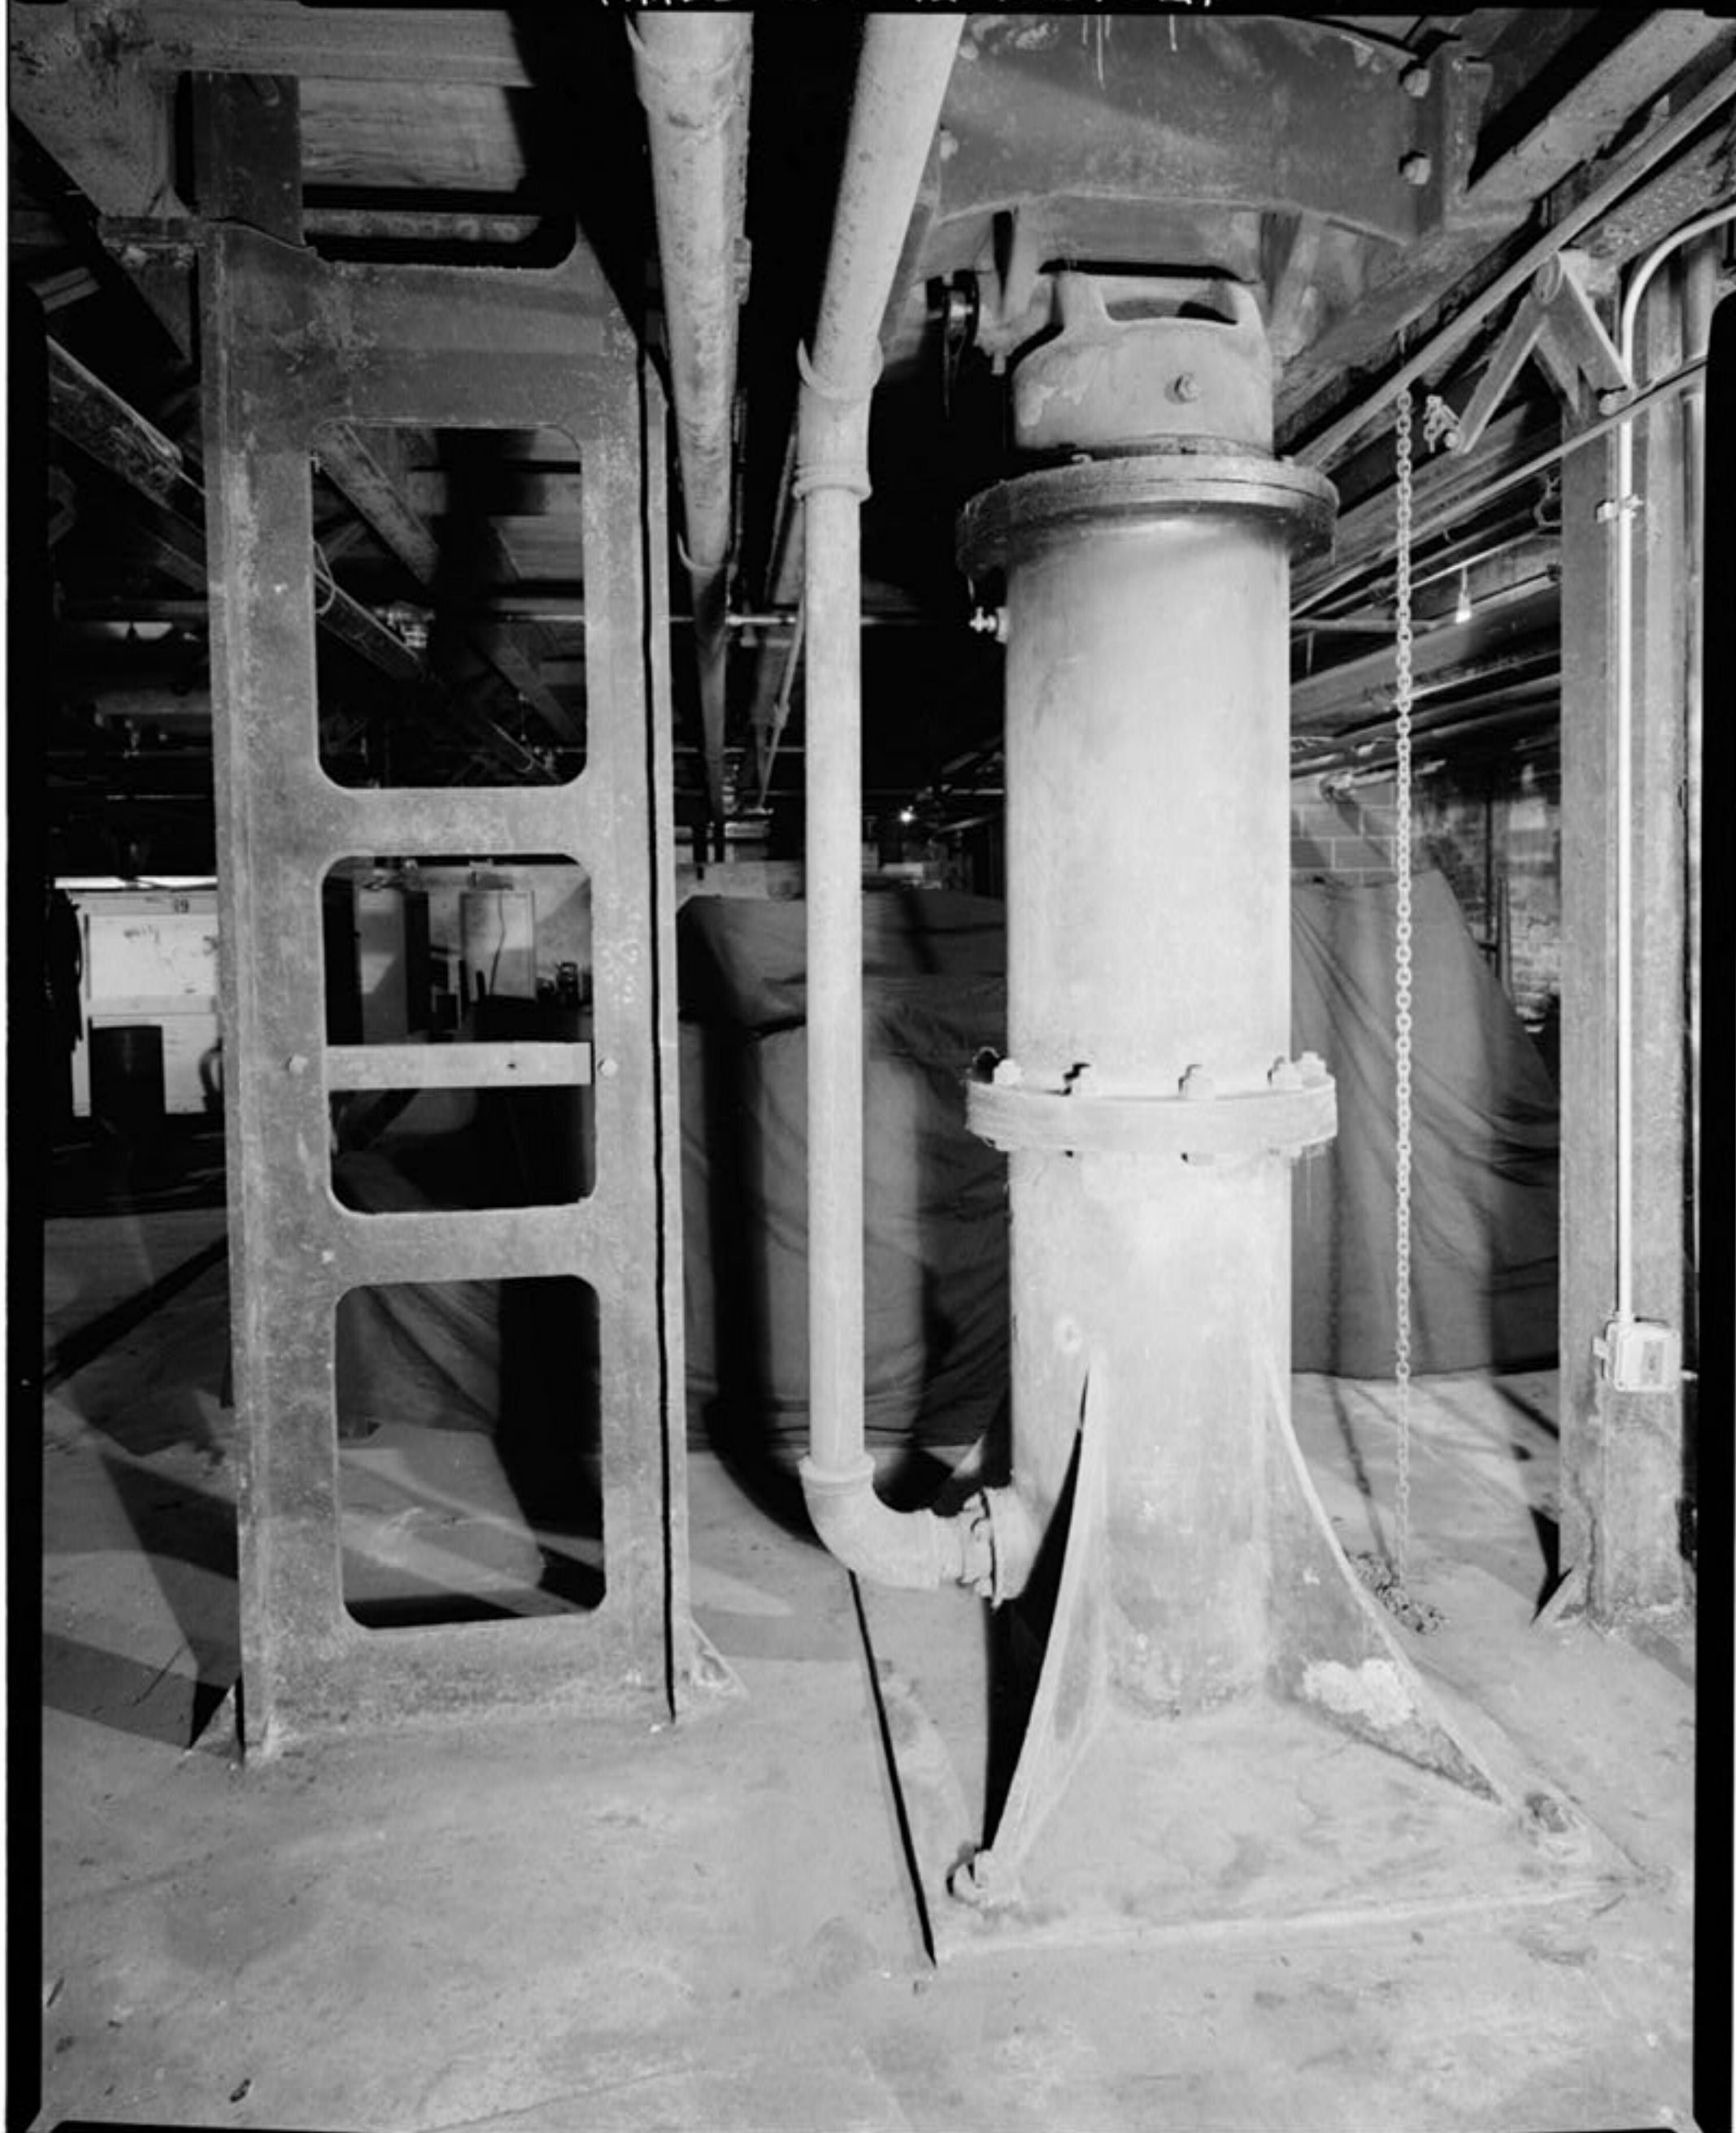
HABS NO. IL-1007-24

- IL-1007-23 CONTROL LEVERS FOR HYDRAULIC RAMS, MIDDLE LEVEL OF STAGE, LOOKING EAST.
- IL-1007-24 WESTERNMOST HYDRAULIC RAM IN NORTH BANK, LOWER LEVEL OF STAGE, LOOKING SOUTH. NOTE PIN CONNECTION BETWEEN STAGE FLOOR AND RAM.

- IL-1007-25 DETAIL OF TIE ROD REINFORCING BELOW WESTERNMOST MOVABLE STAGE SECTION, LOWER LEVEL OF STAGE, LOOKING SOUTH. TAKEN FROM A POINT JUST SOUTH OF RAM IN IL-1007-24.

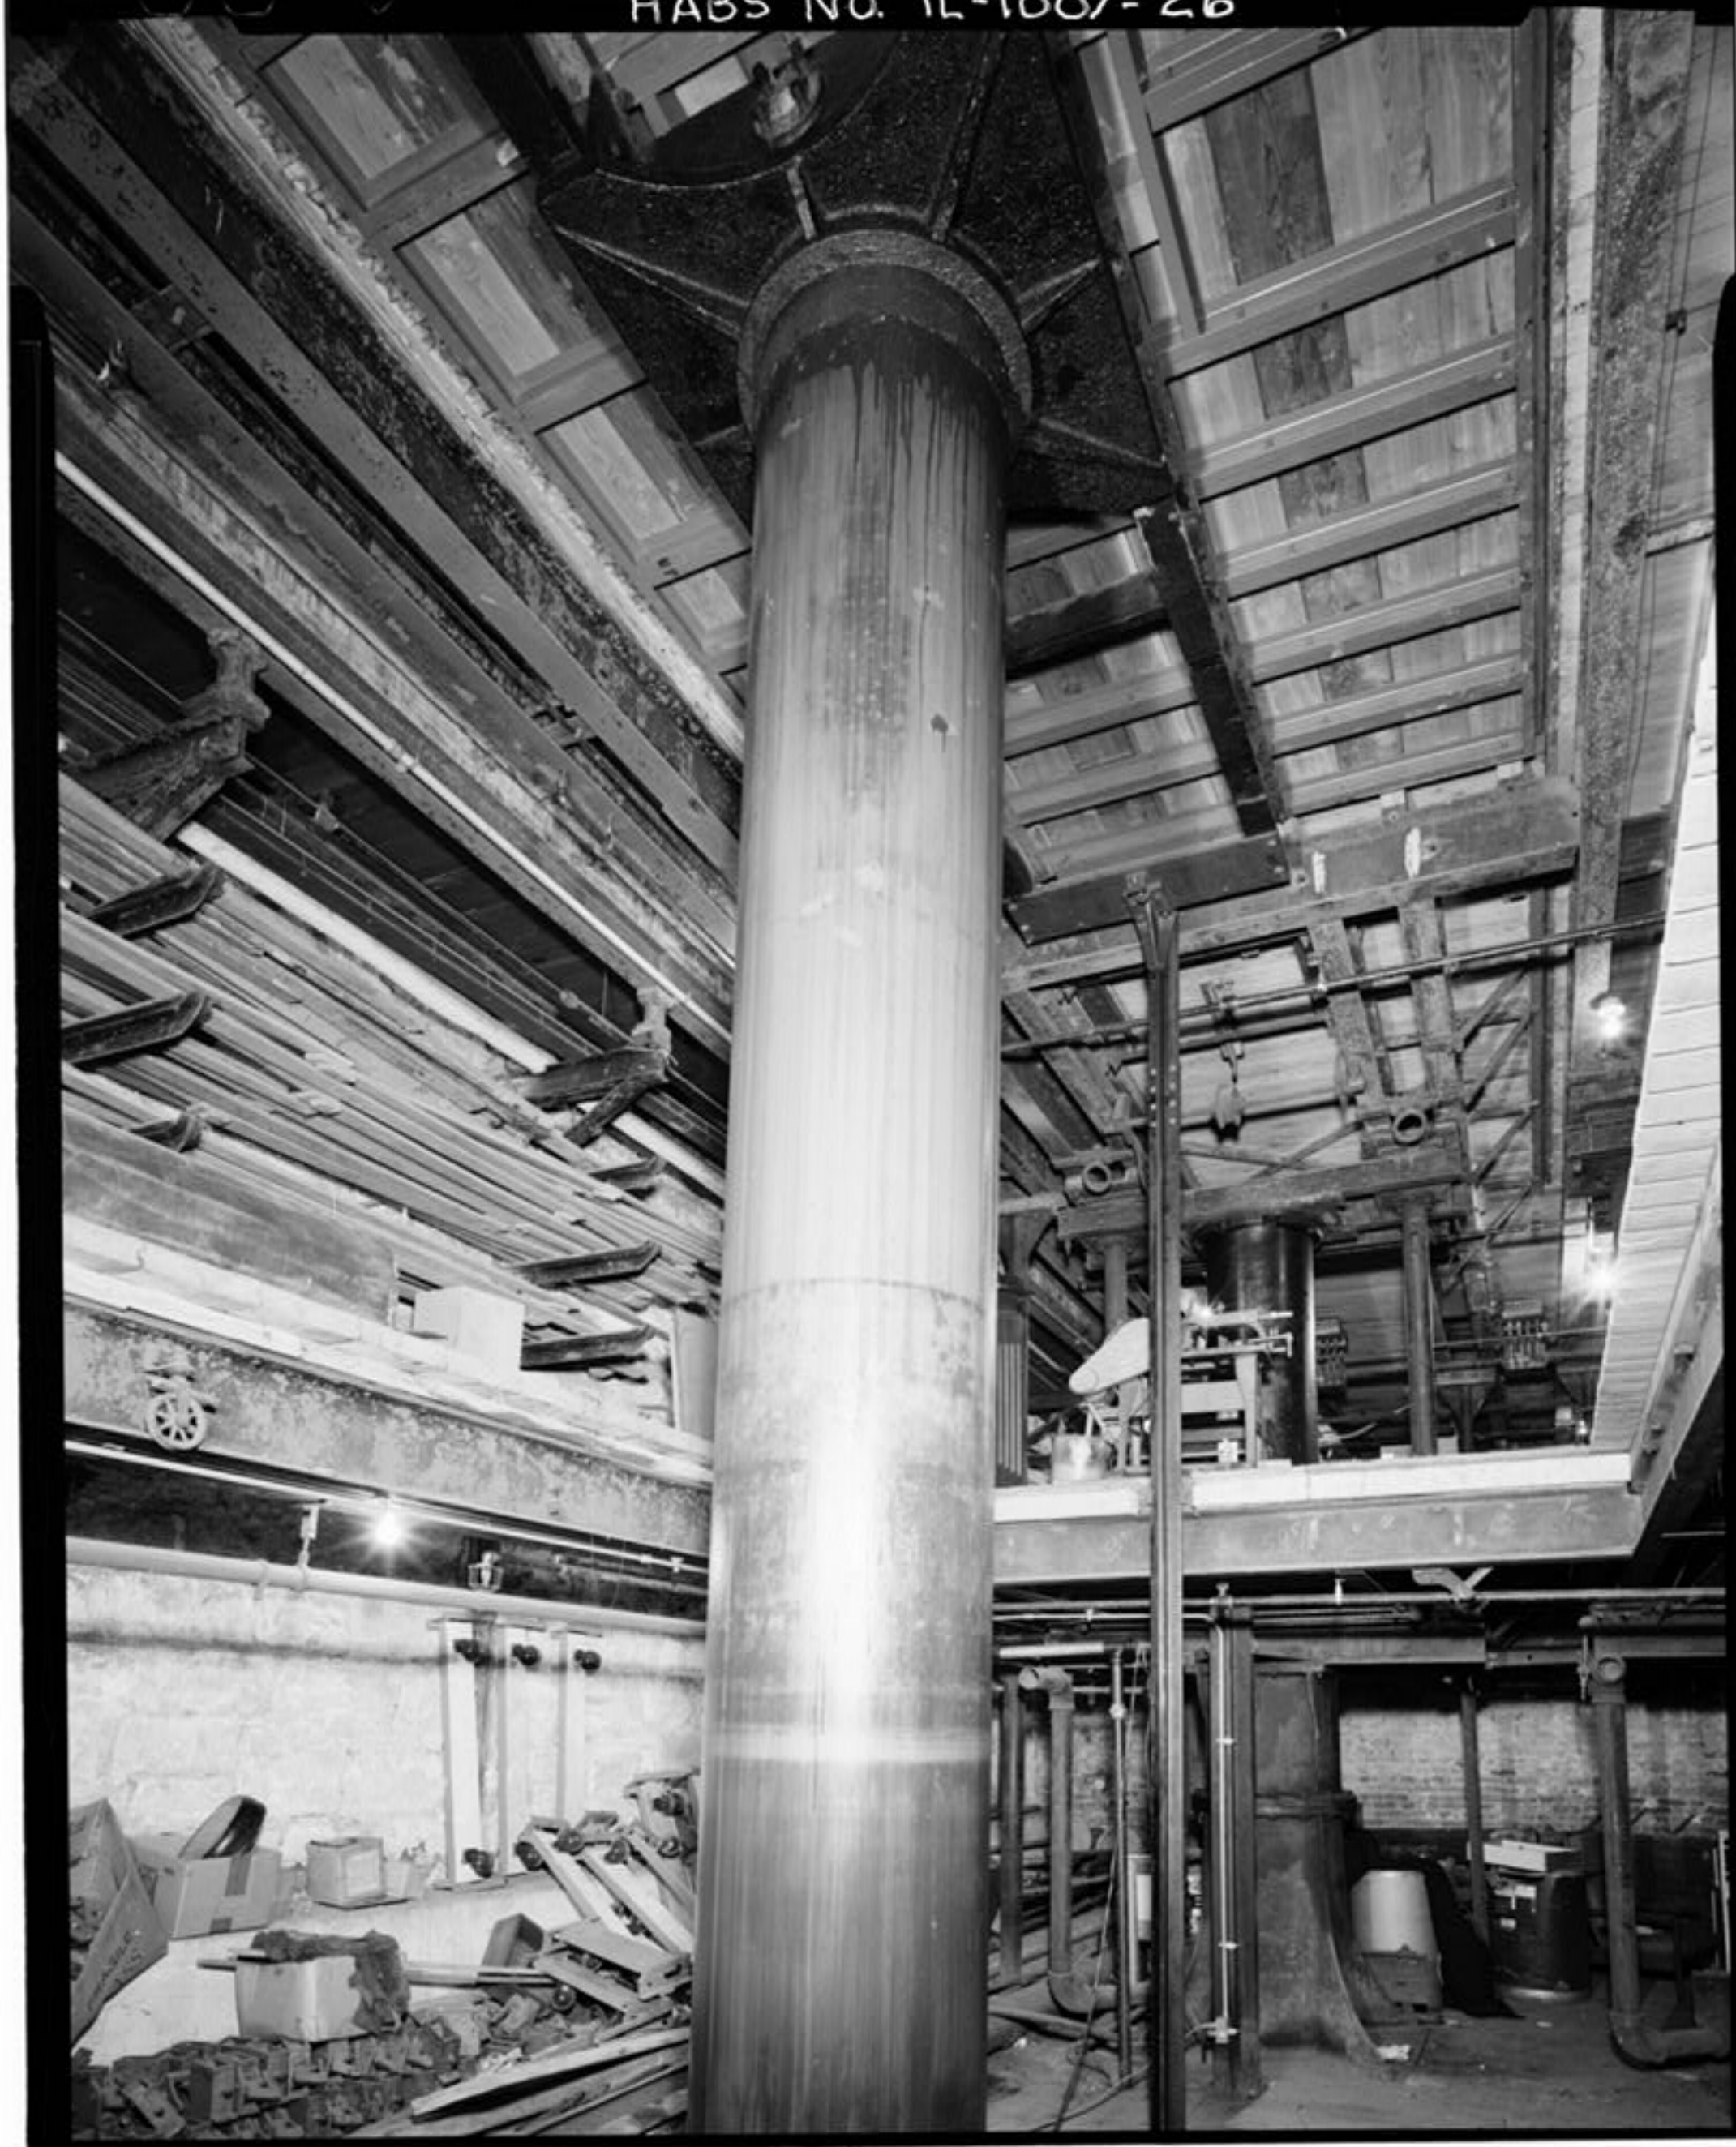
HABS NO. IL-1007-26

- IL-1007-26 EASTERNMOST HYDRAULIC RAM IN CENTER BANK (STILL OPERABLE), LOWER LEVEL OF STAGE, LOOKING SOUTH. THE CENTER BANK OF RAMS MOVED SMALL SECTIONS OF STAGE IN THE CENTER OF EACH LARGE MOVABLE SECTION. THE WEST EDGE OF THIS SECTION HAS BEEN EXTENDED TO THE WEST EDGE OF THE LARGE SECTION WHICH ORIGINALLY SURROUNDED IT. THE SOUTH RAM FOR THE LARGE SECTION IS VISIBLE IN THE BACKGROUND. THE SMALL MOVABLE SECTIONS COULD NOT TILT BUT COULD BE LOWERED TO THE LOWER LEVEL OF THE STAGE WITH HINGED PANELS UNDER EACH LARGE SECTION FILLING THE VOID.

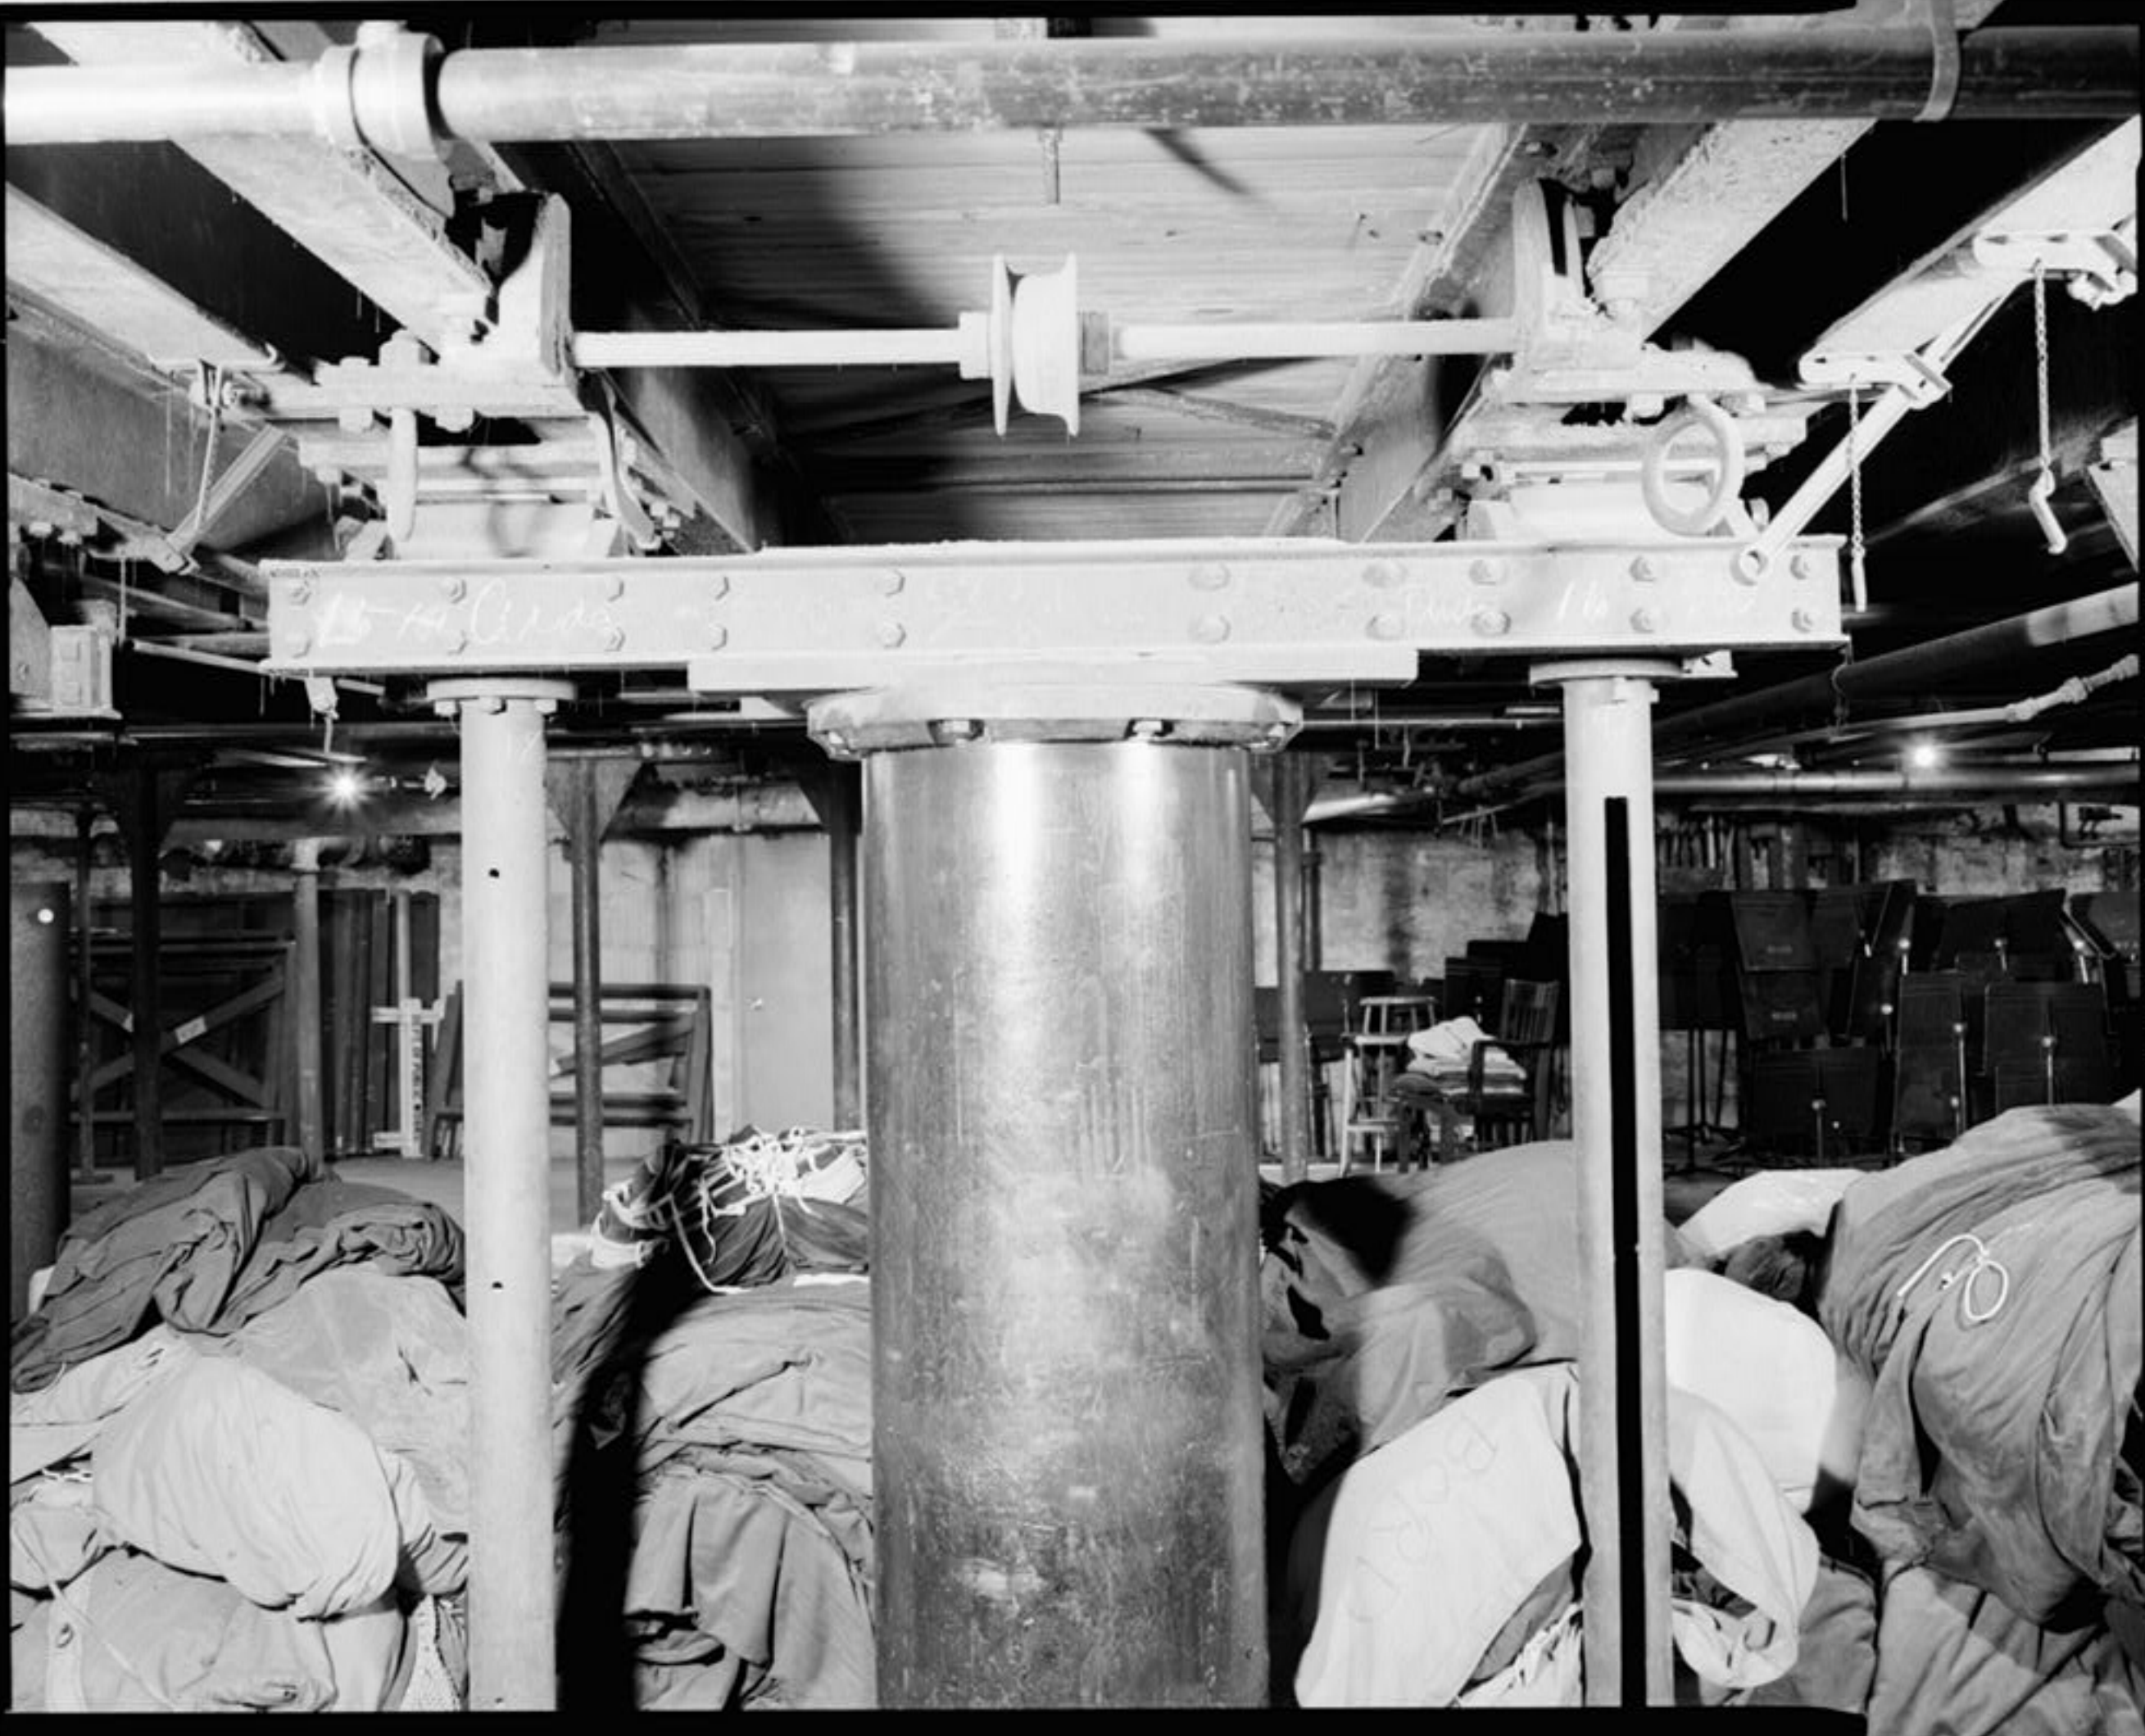
HABS NO. 1L-1007-29

- IL-1007-29 NORTH SIDE OF SOUTH BANK OF HYDRAULIC RAMS, MIDDLE LEVEL OF STAGE, LOOKING SOUTHEAST. RAMS HAVE BEEN FIXED IN POSITION AT STAGE LEVEL AND NEW MIDDLE LEVEL FLOOR CONSTRUCTED BELOW.

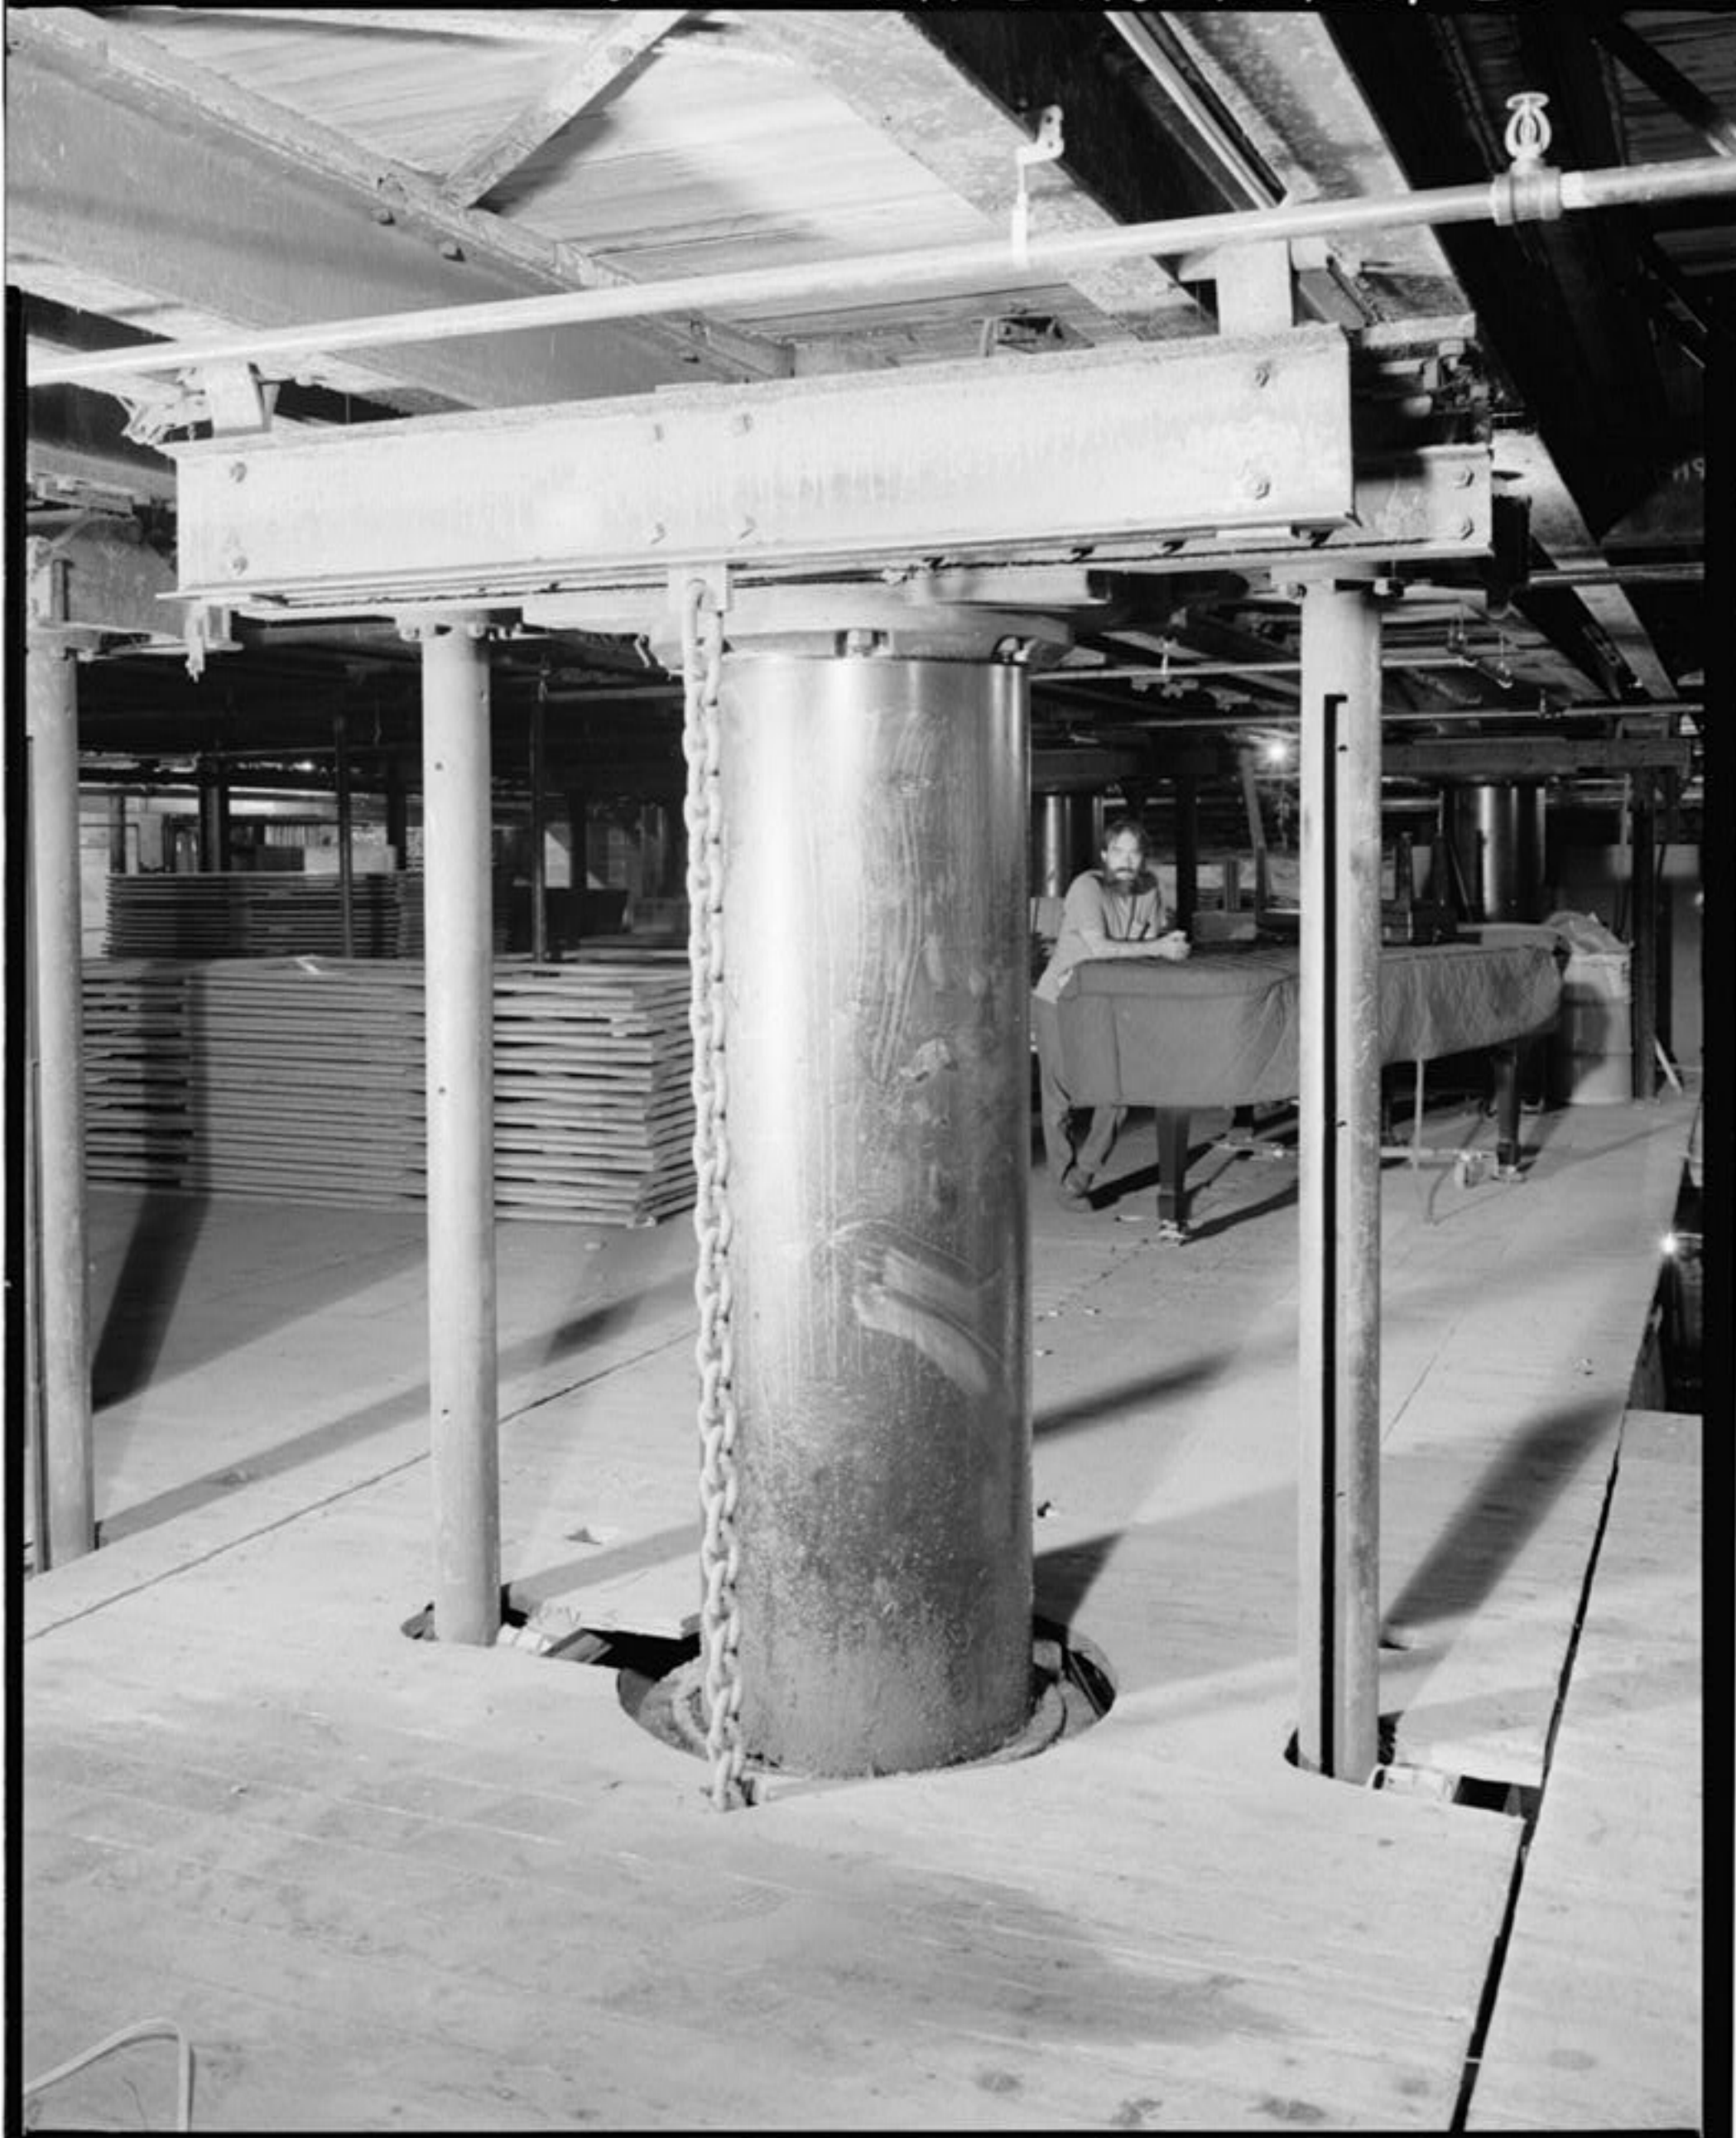
HABS NO. 1L-1007-33

- IL-1007-33 DETAIL OF TOP OF TYPICAL HYDRAULIC RAM SHOWING CHAIN WHICH
 LIMITS UPWARD MOVEMENT.
- IL-1007-34 CONTROL LEVER AND PLATFORM FOR STAR LIFT WITH FIRE DOOR LEADING
 TO ORCHESTRA PIT, MIDDLE LEVEL OF STAGE.

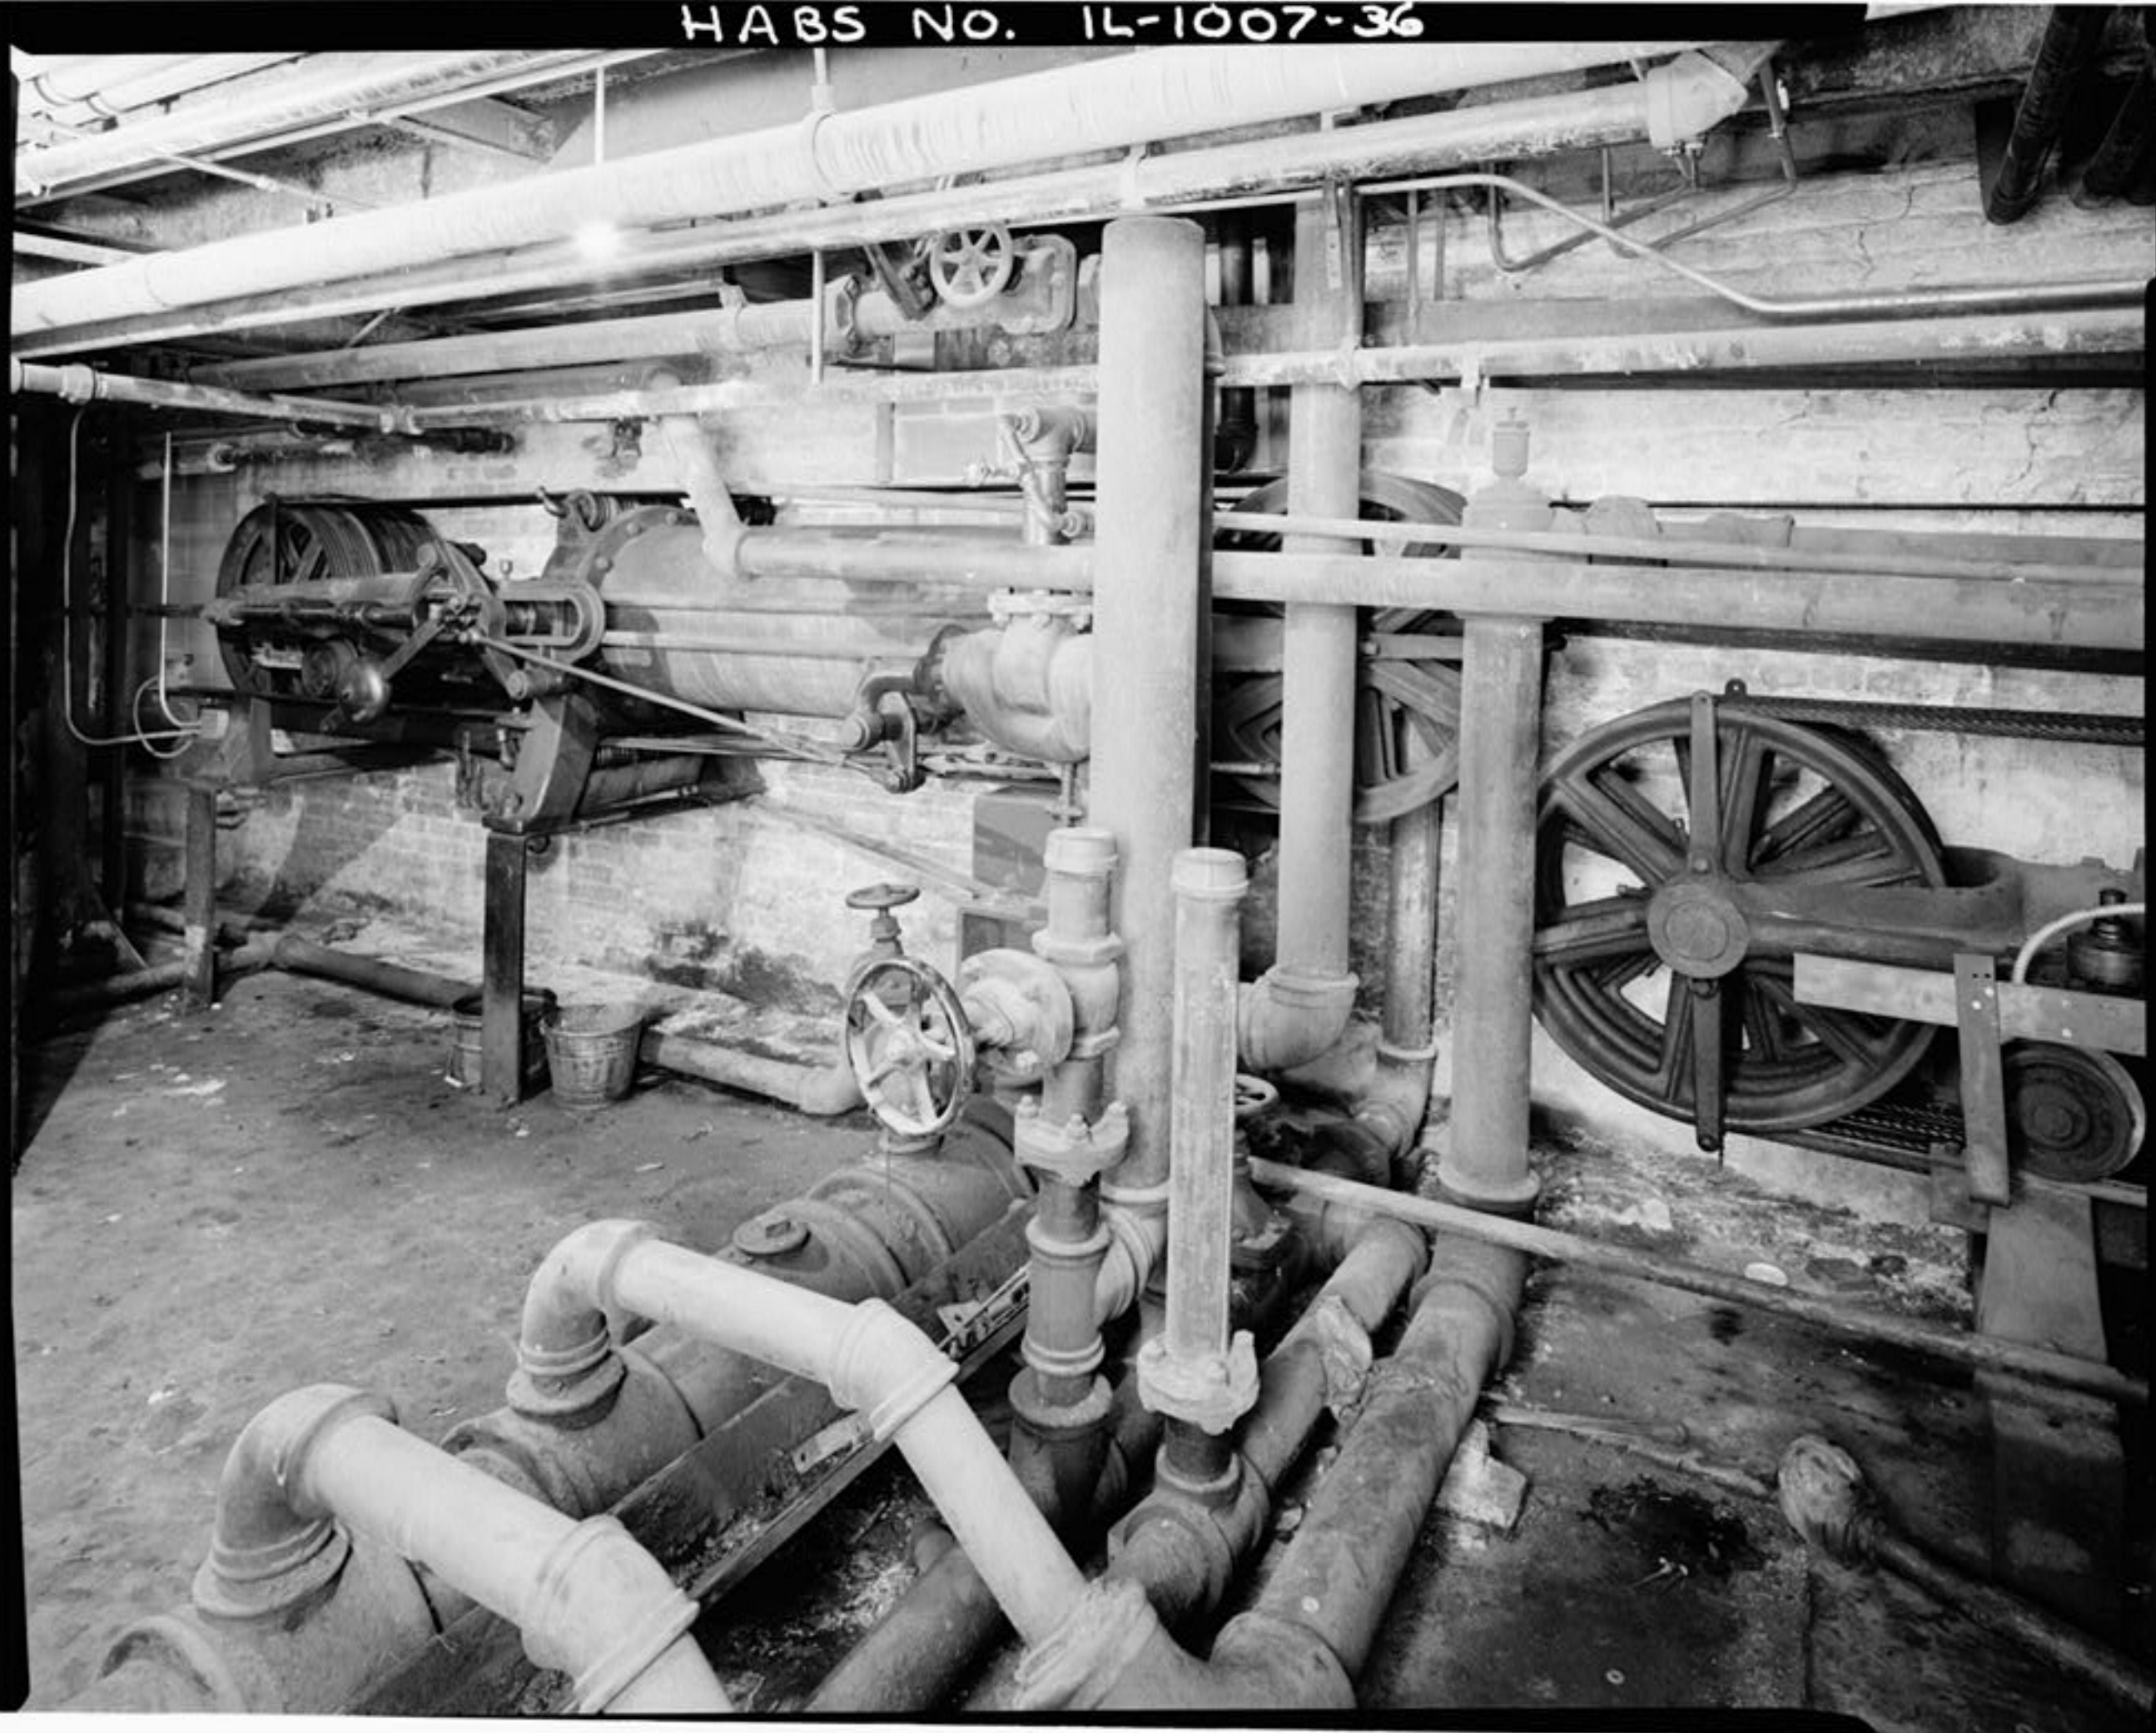
HABS NO. 1L-1007-36

- IL-1007-35 HYDRAULIC RAM AND CONTROL VALVES FOR STAR LIFT, LOWER LEVEL OF
 STAGE.
- IL-1007-36 HYDRAULIC RAM AND SHEAVES FOR OPERATING STAGE CURTAIN, LOWER
 LEVEL OF STAGE.
