HISTORIC AMERICAN BUILDINGS SURVEY

INDEX TO PHOTOGRAPHS

Auditorium Building (Roosevelt University)
430 South Michigan Avenue
Chicago
Cook County
Illinois

HABS No. IL-1007

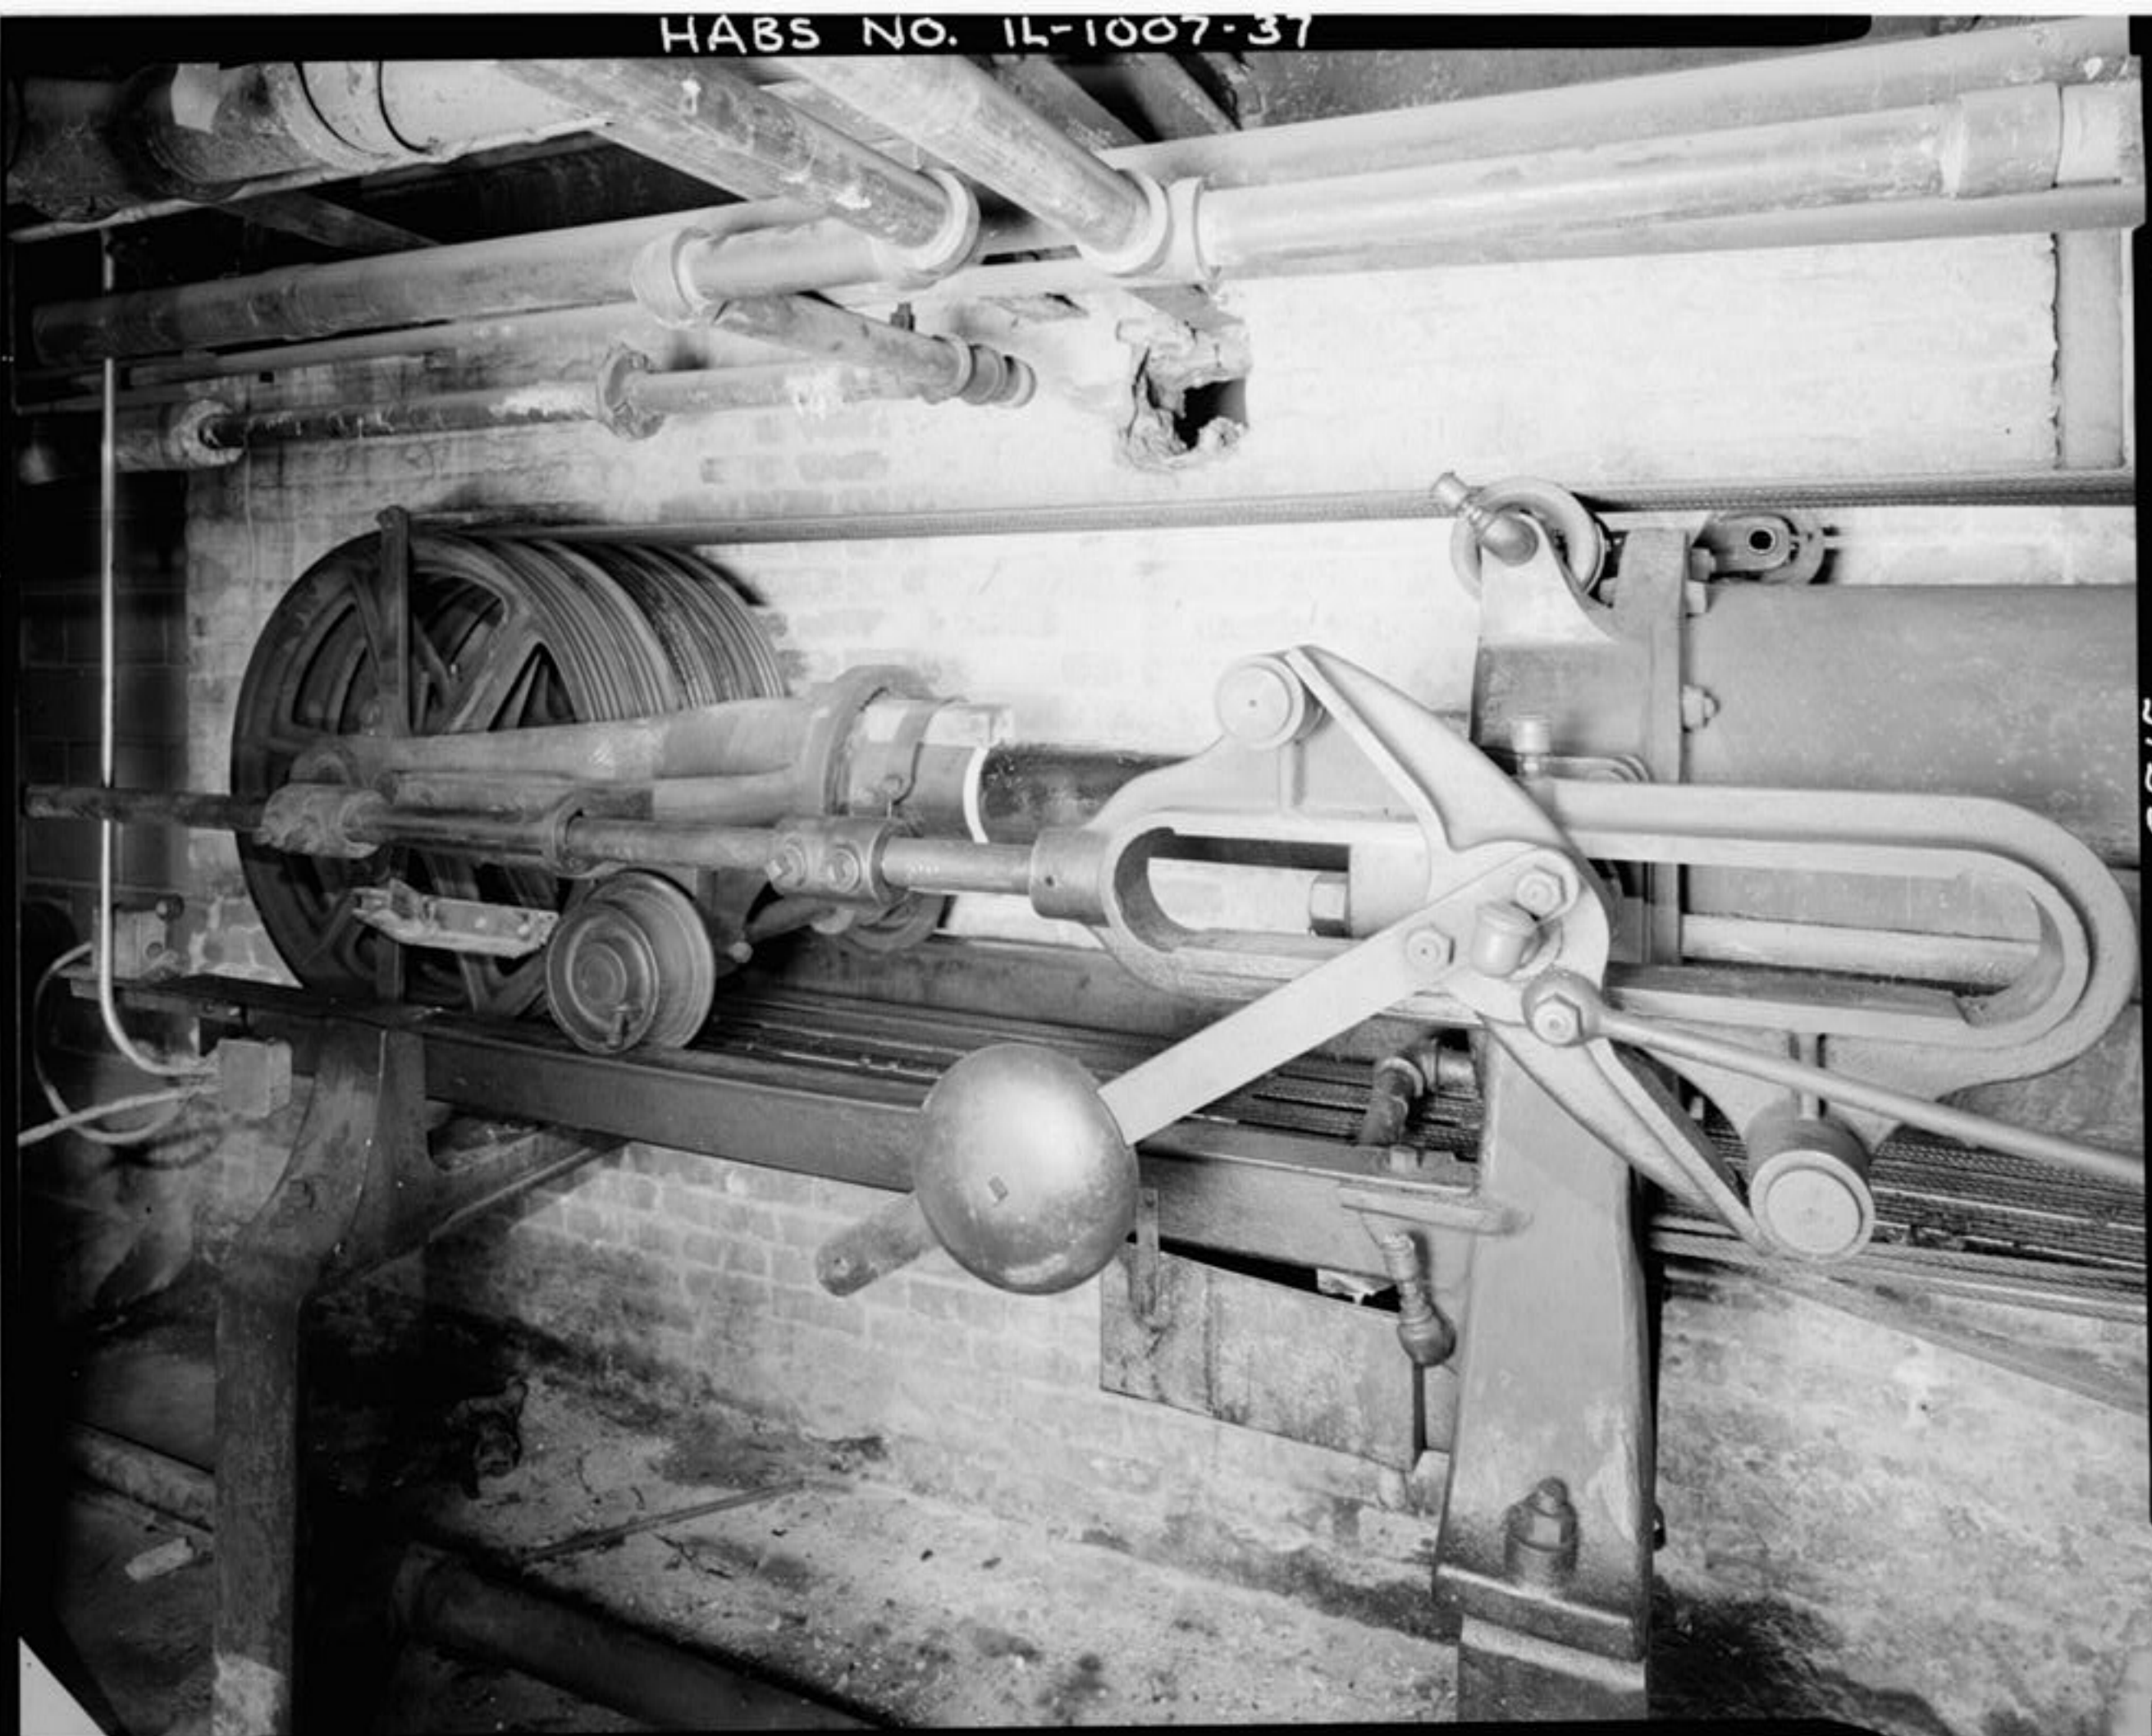
HABS NO. IL-1007-37

- IL-1007-37 DETAIL OF RAM MECHANISM FOR STAGE CURTAIN, LOWER LEVEL OF STAGE.
- IL-1007-38 BASEMENT WALL SHOWING TRANSITION FROM STONE FOUNDATION TO BRICK
 BEARING WALL.

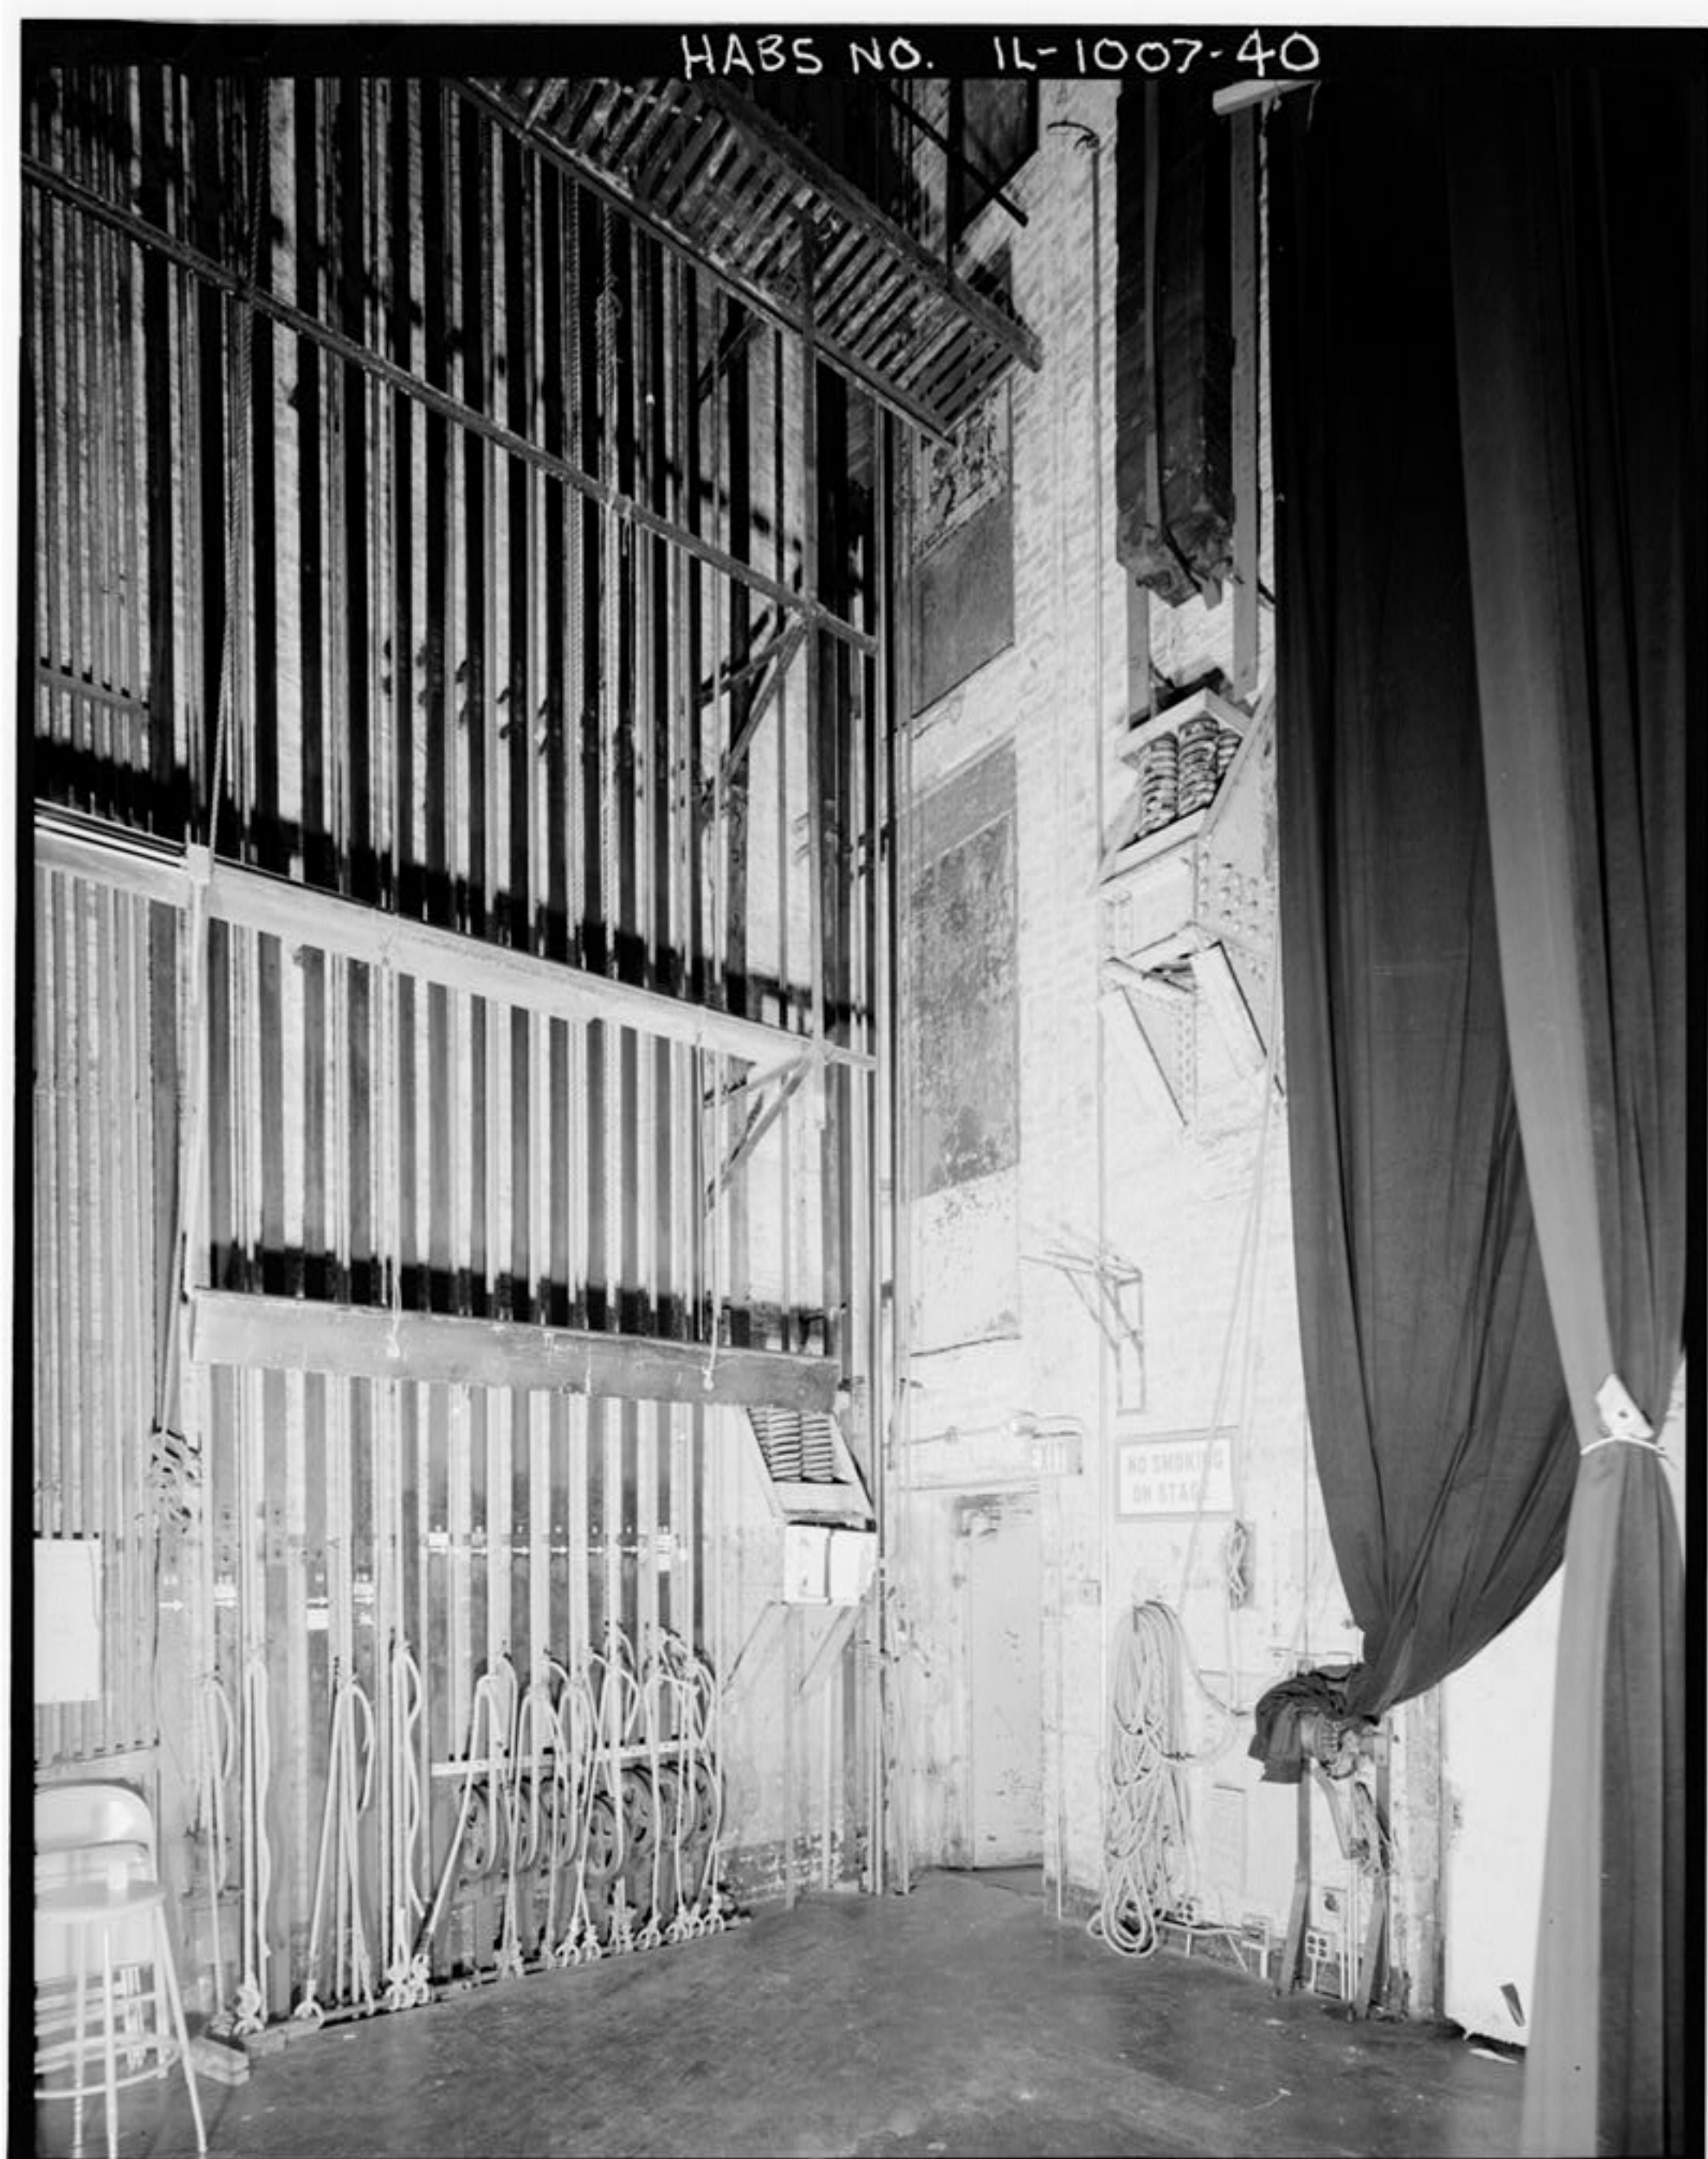
HABS NO. 1L-1007-40

- IL-1007-39 SOUTH WALL OF STAGE HOUSE.
- IL-1007-40 SOUTHWEST CORNER OF STAGE SHOWING RIGGING FOR FLYING SETS,
 LOCATION OF ORIGINAL DOORS IN PROSCENIUM WALL, AND
 COUNTERWEIGHTS FOR STAGE CURTAIN.

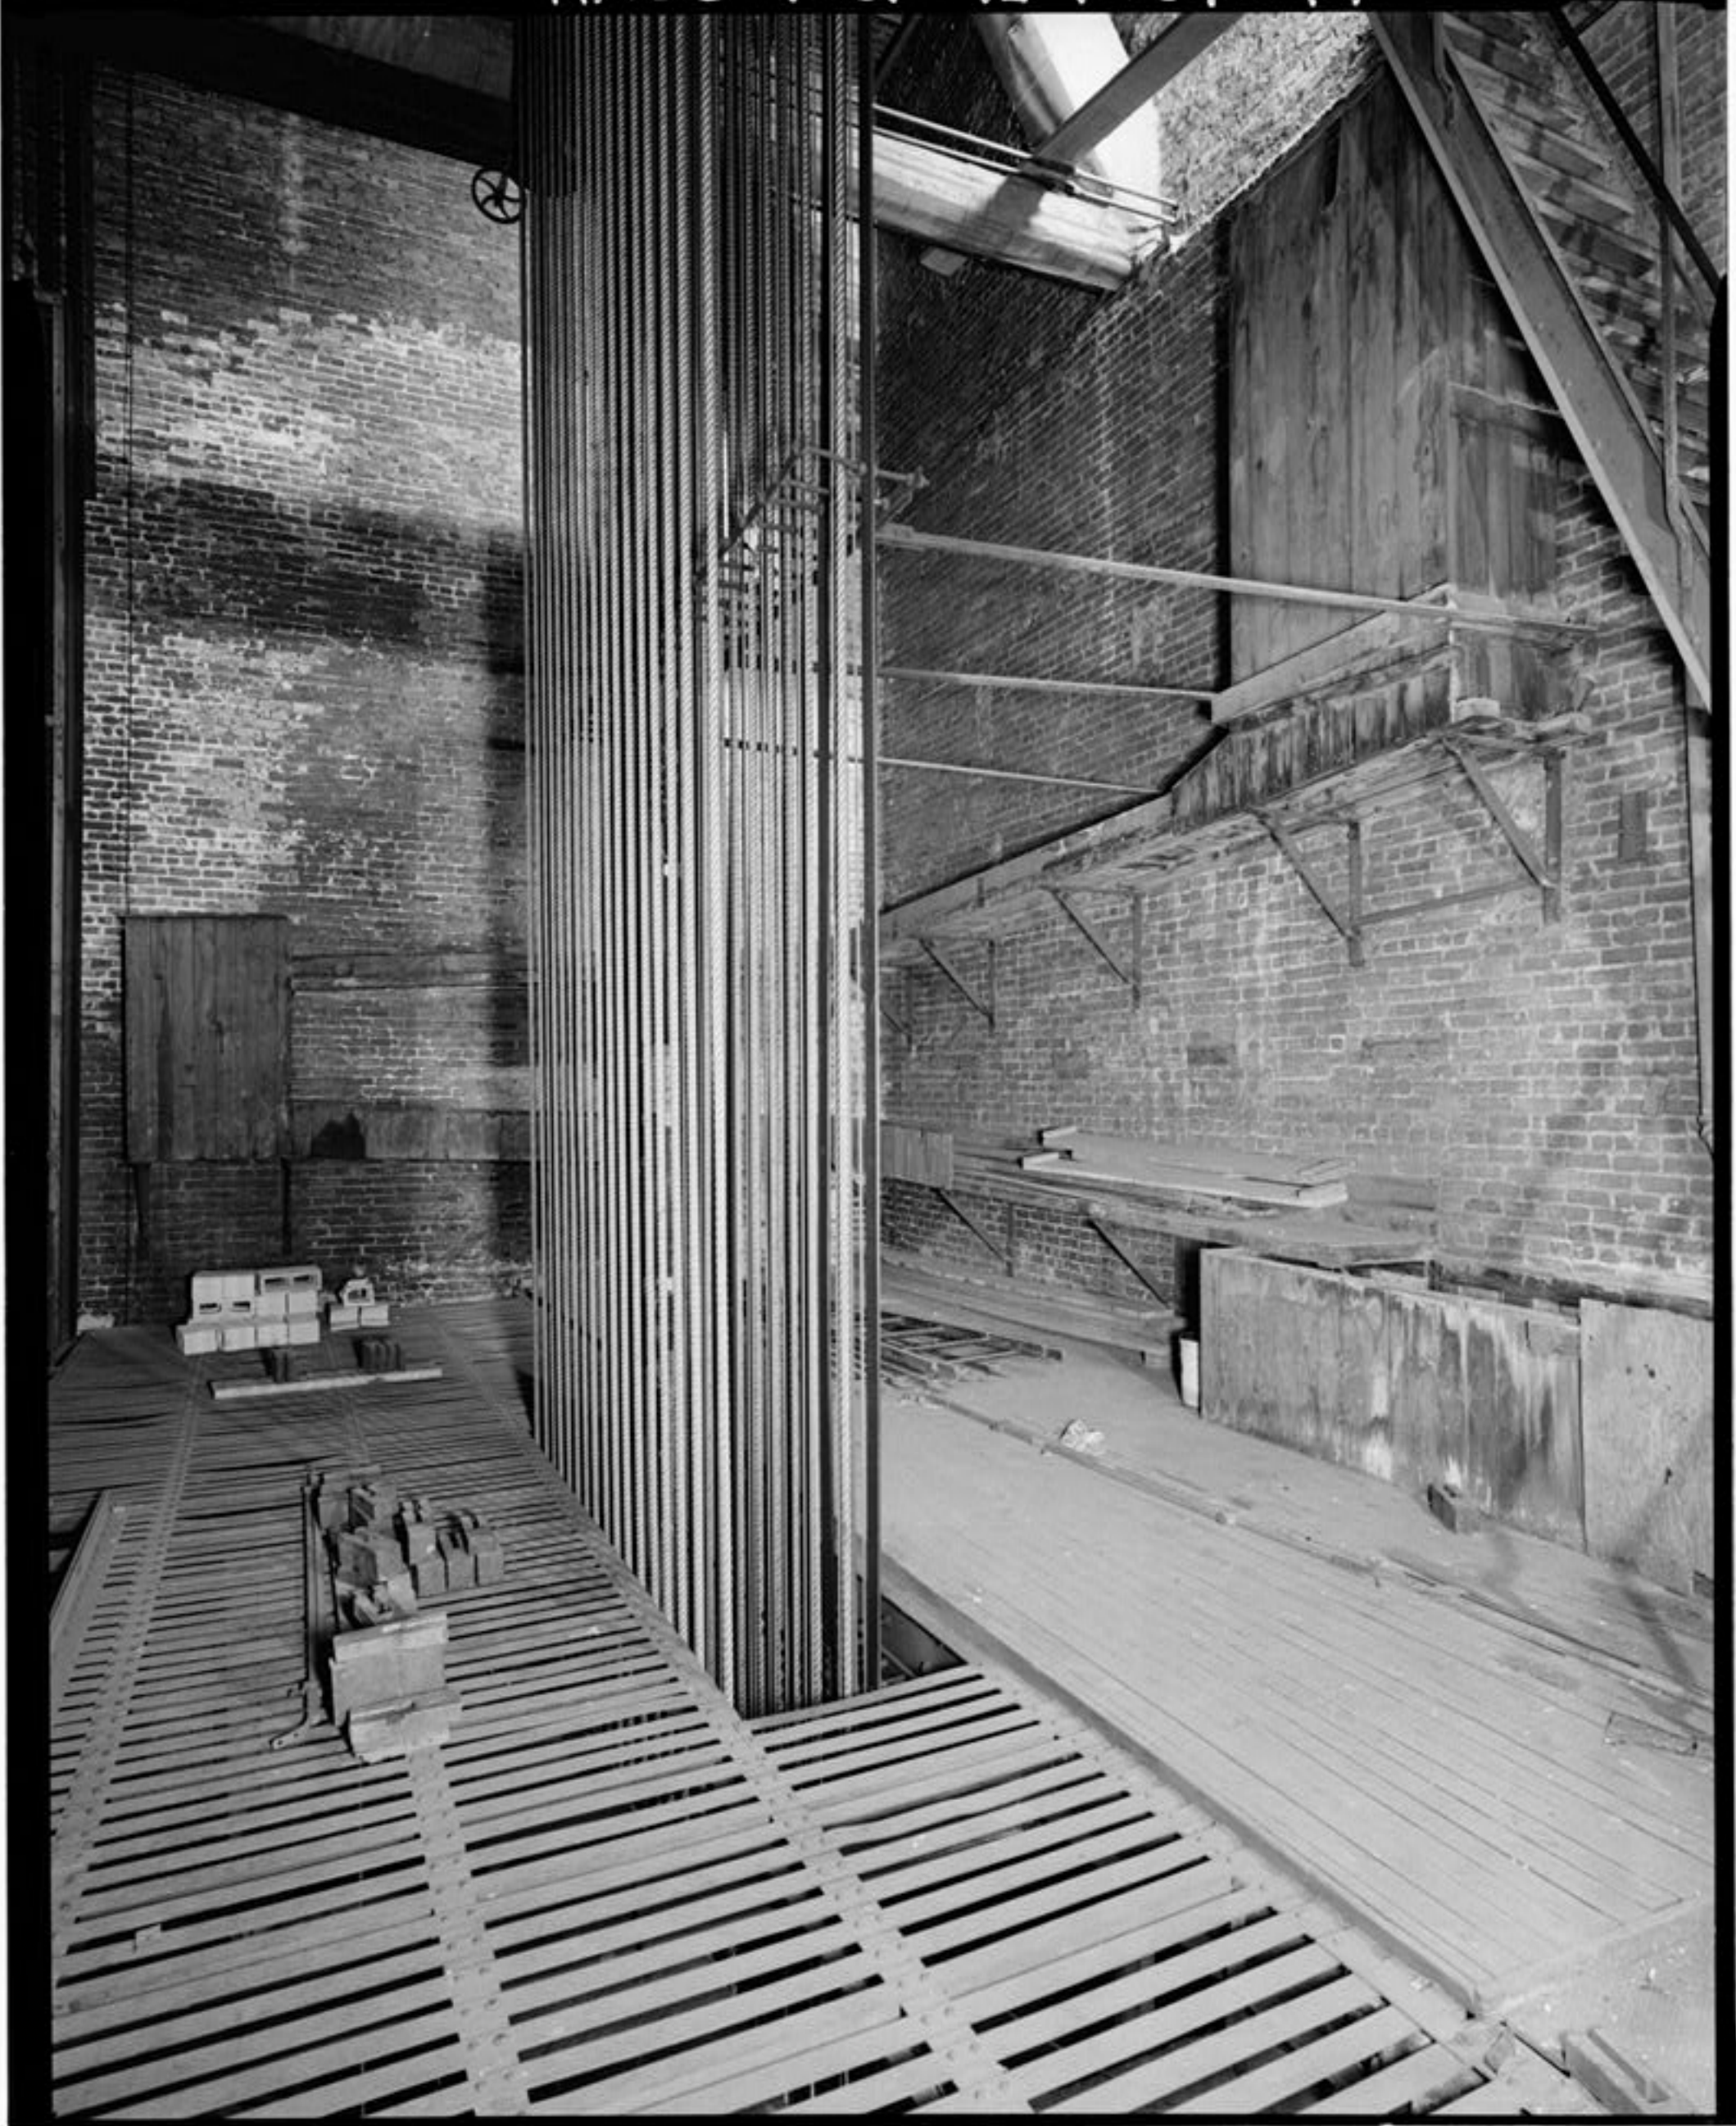
HABS NO. IL-1007-44

- IL-1007-44 THUNDER MACHINE ON SOUTH WALL OF STAGE HOUSE, SECOND CATWALK.
- IL-1007-45 RIGGING FOR SETS AND UNDERSIDE OF STAGE HOUSE TRUSSES FROM
 SECOND CATWALK, LOOKING SOUTH.

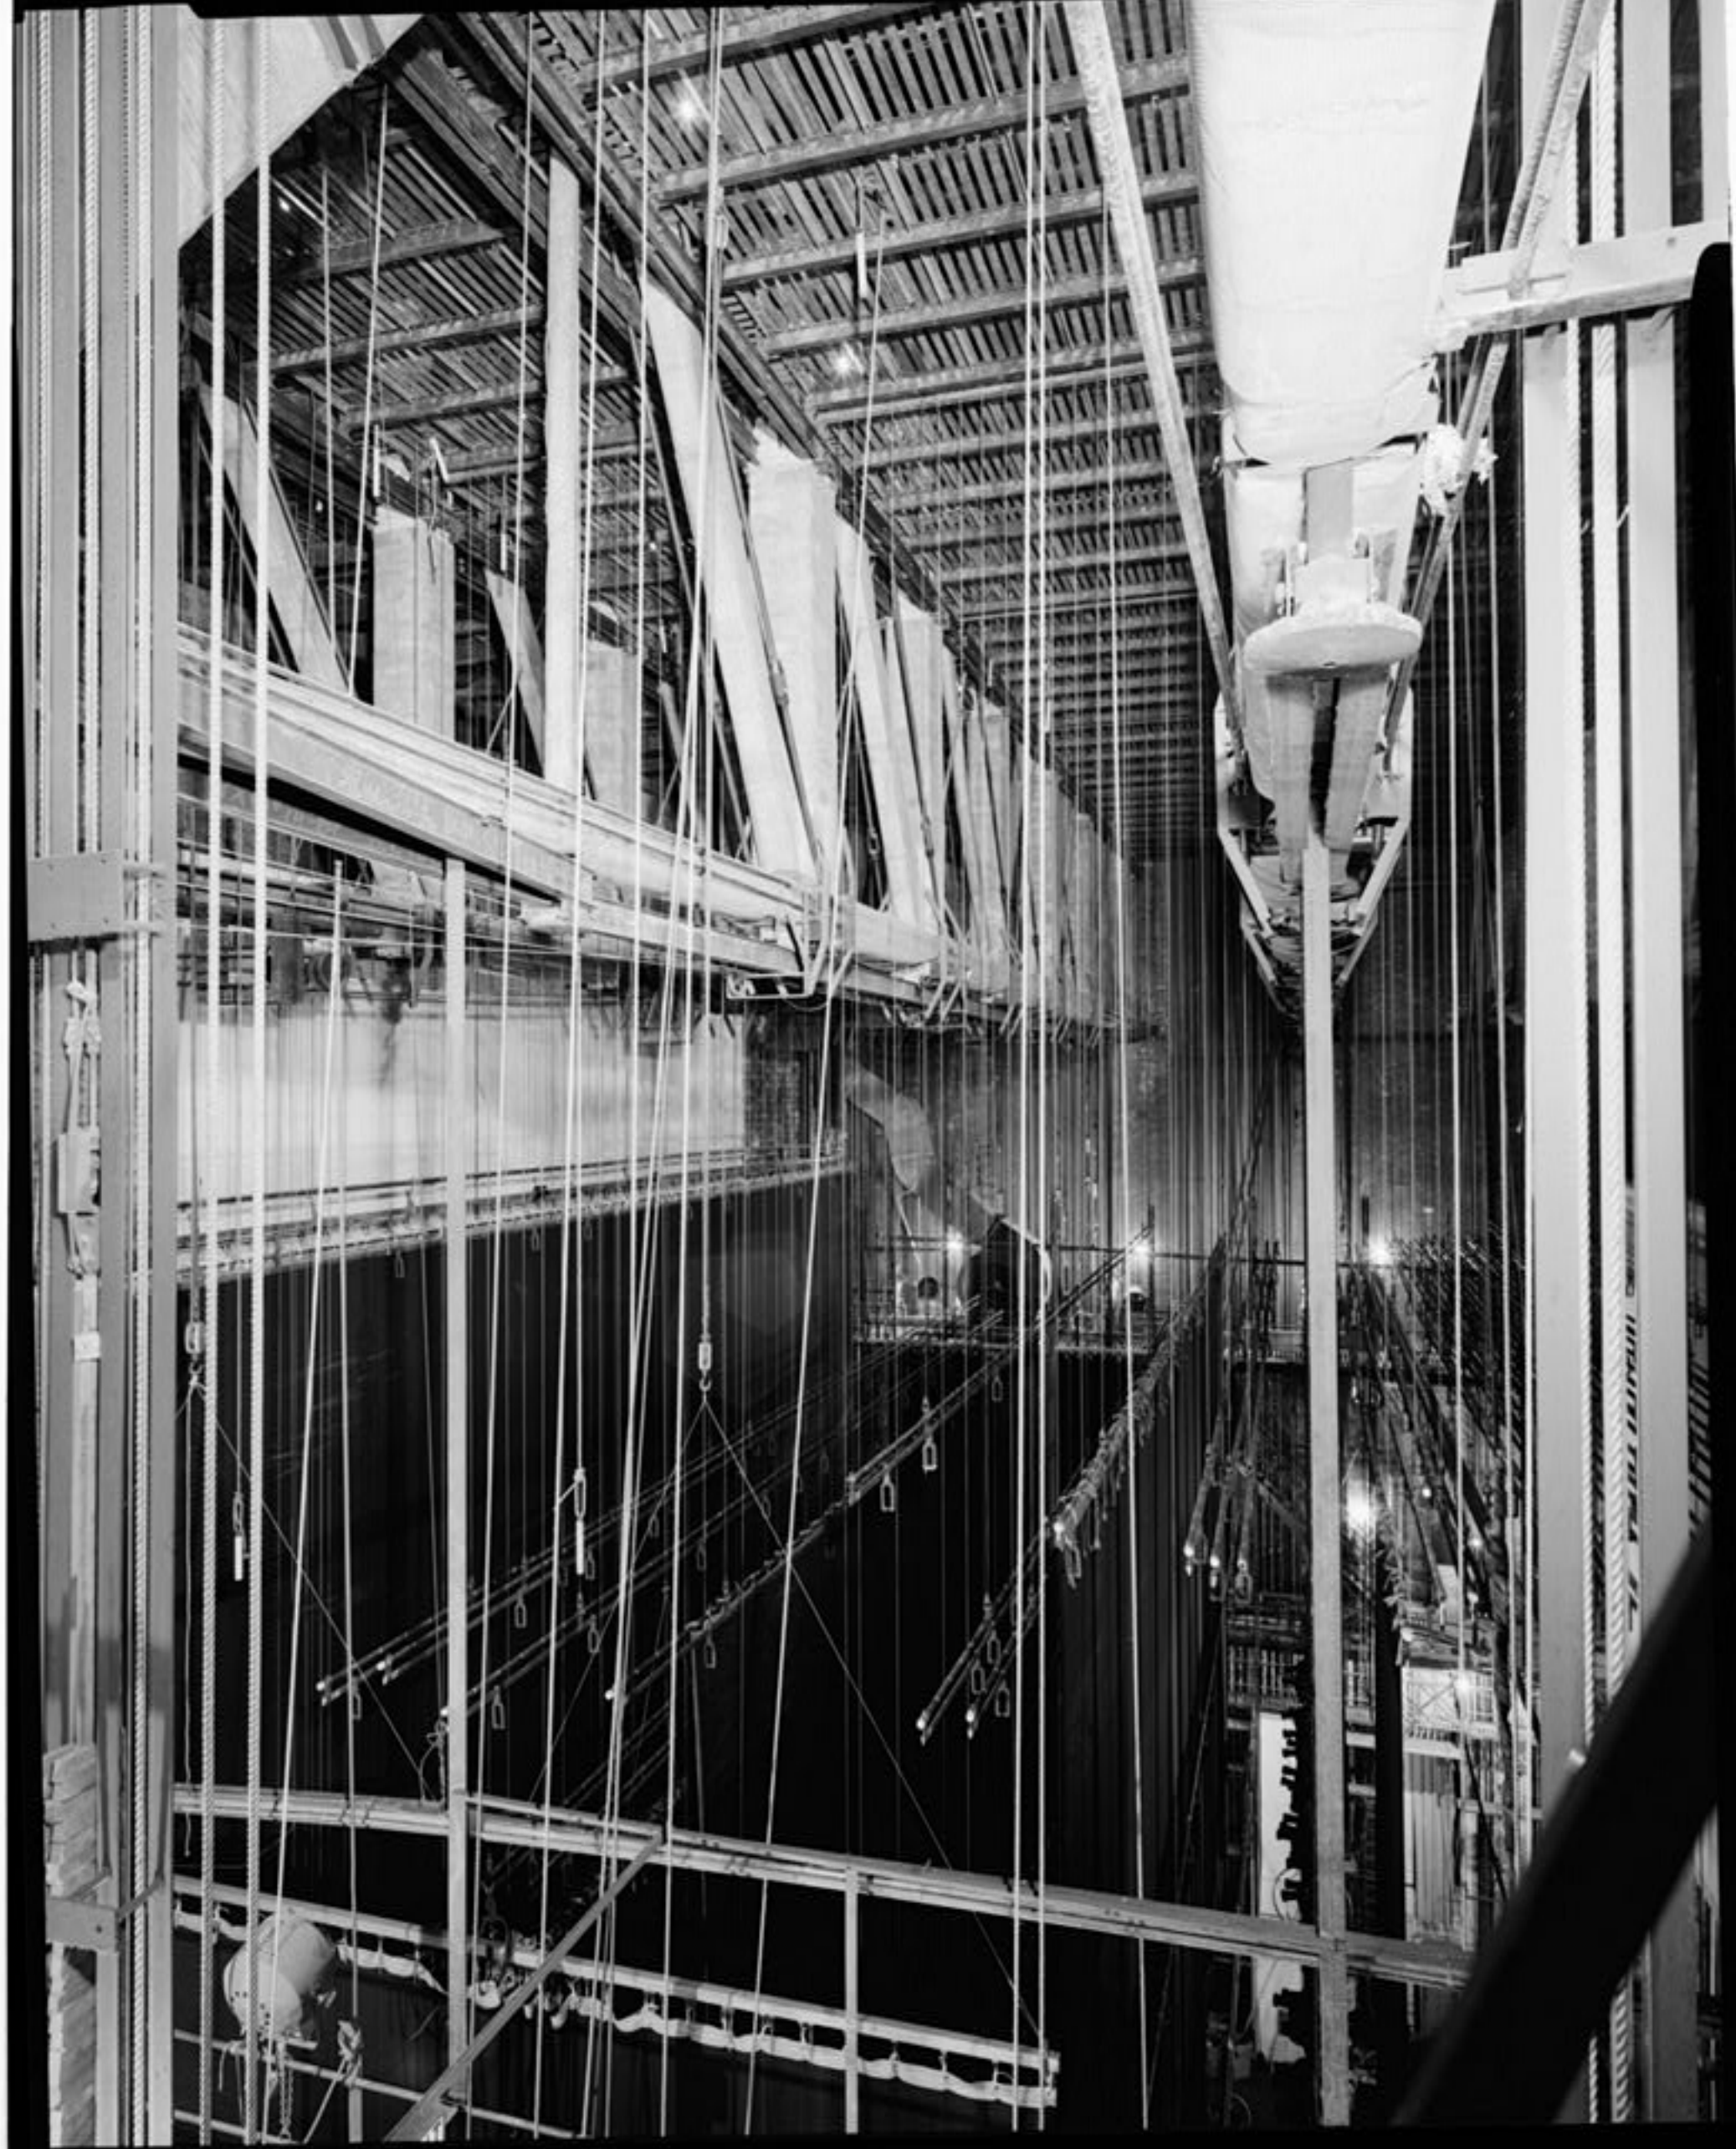
S HS HABS NO. IL-1007-46

- IL-1007-46 LOWER CHORDS OF STAGE HOUSE TRUSSES TAKEN FROM LADDER TO
 FLYLOFT, LOOKING NORTH.
- IL-1007-47 DETAIL OF INCLINED END POST AT NORTH END OF TRUSS R, FLYLOFT,
 LOOKING WEST. NOTE TERRA COTTA FIREPROOFING AND LATER
 REINFORCEMENT.

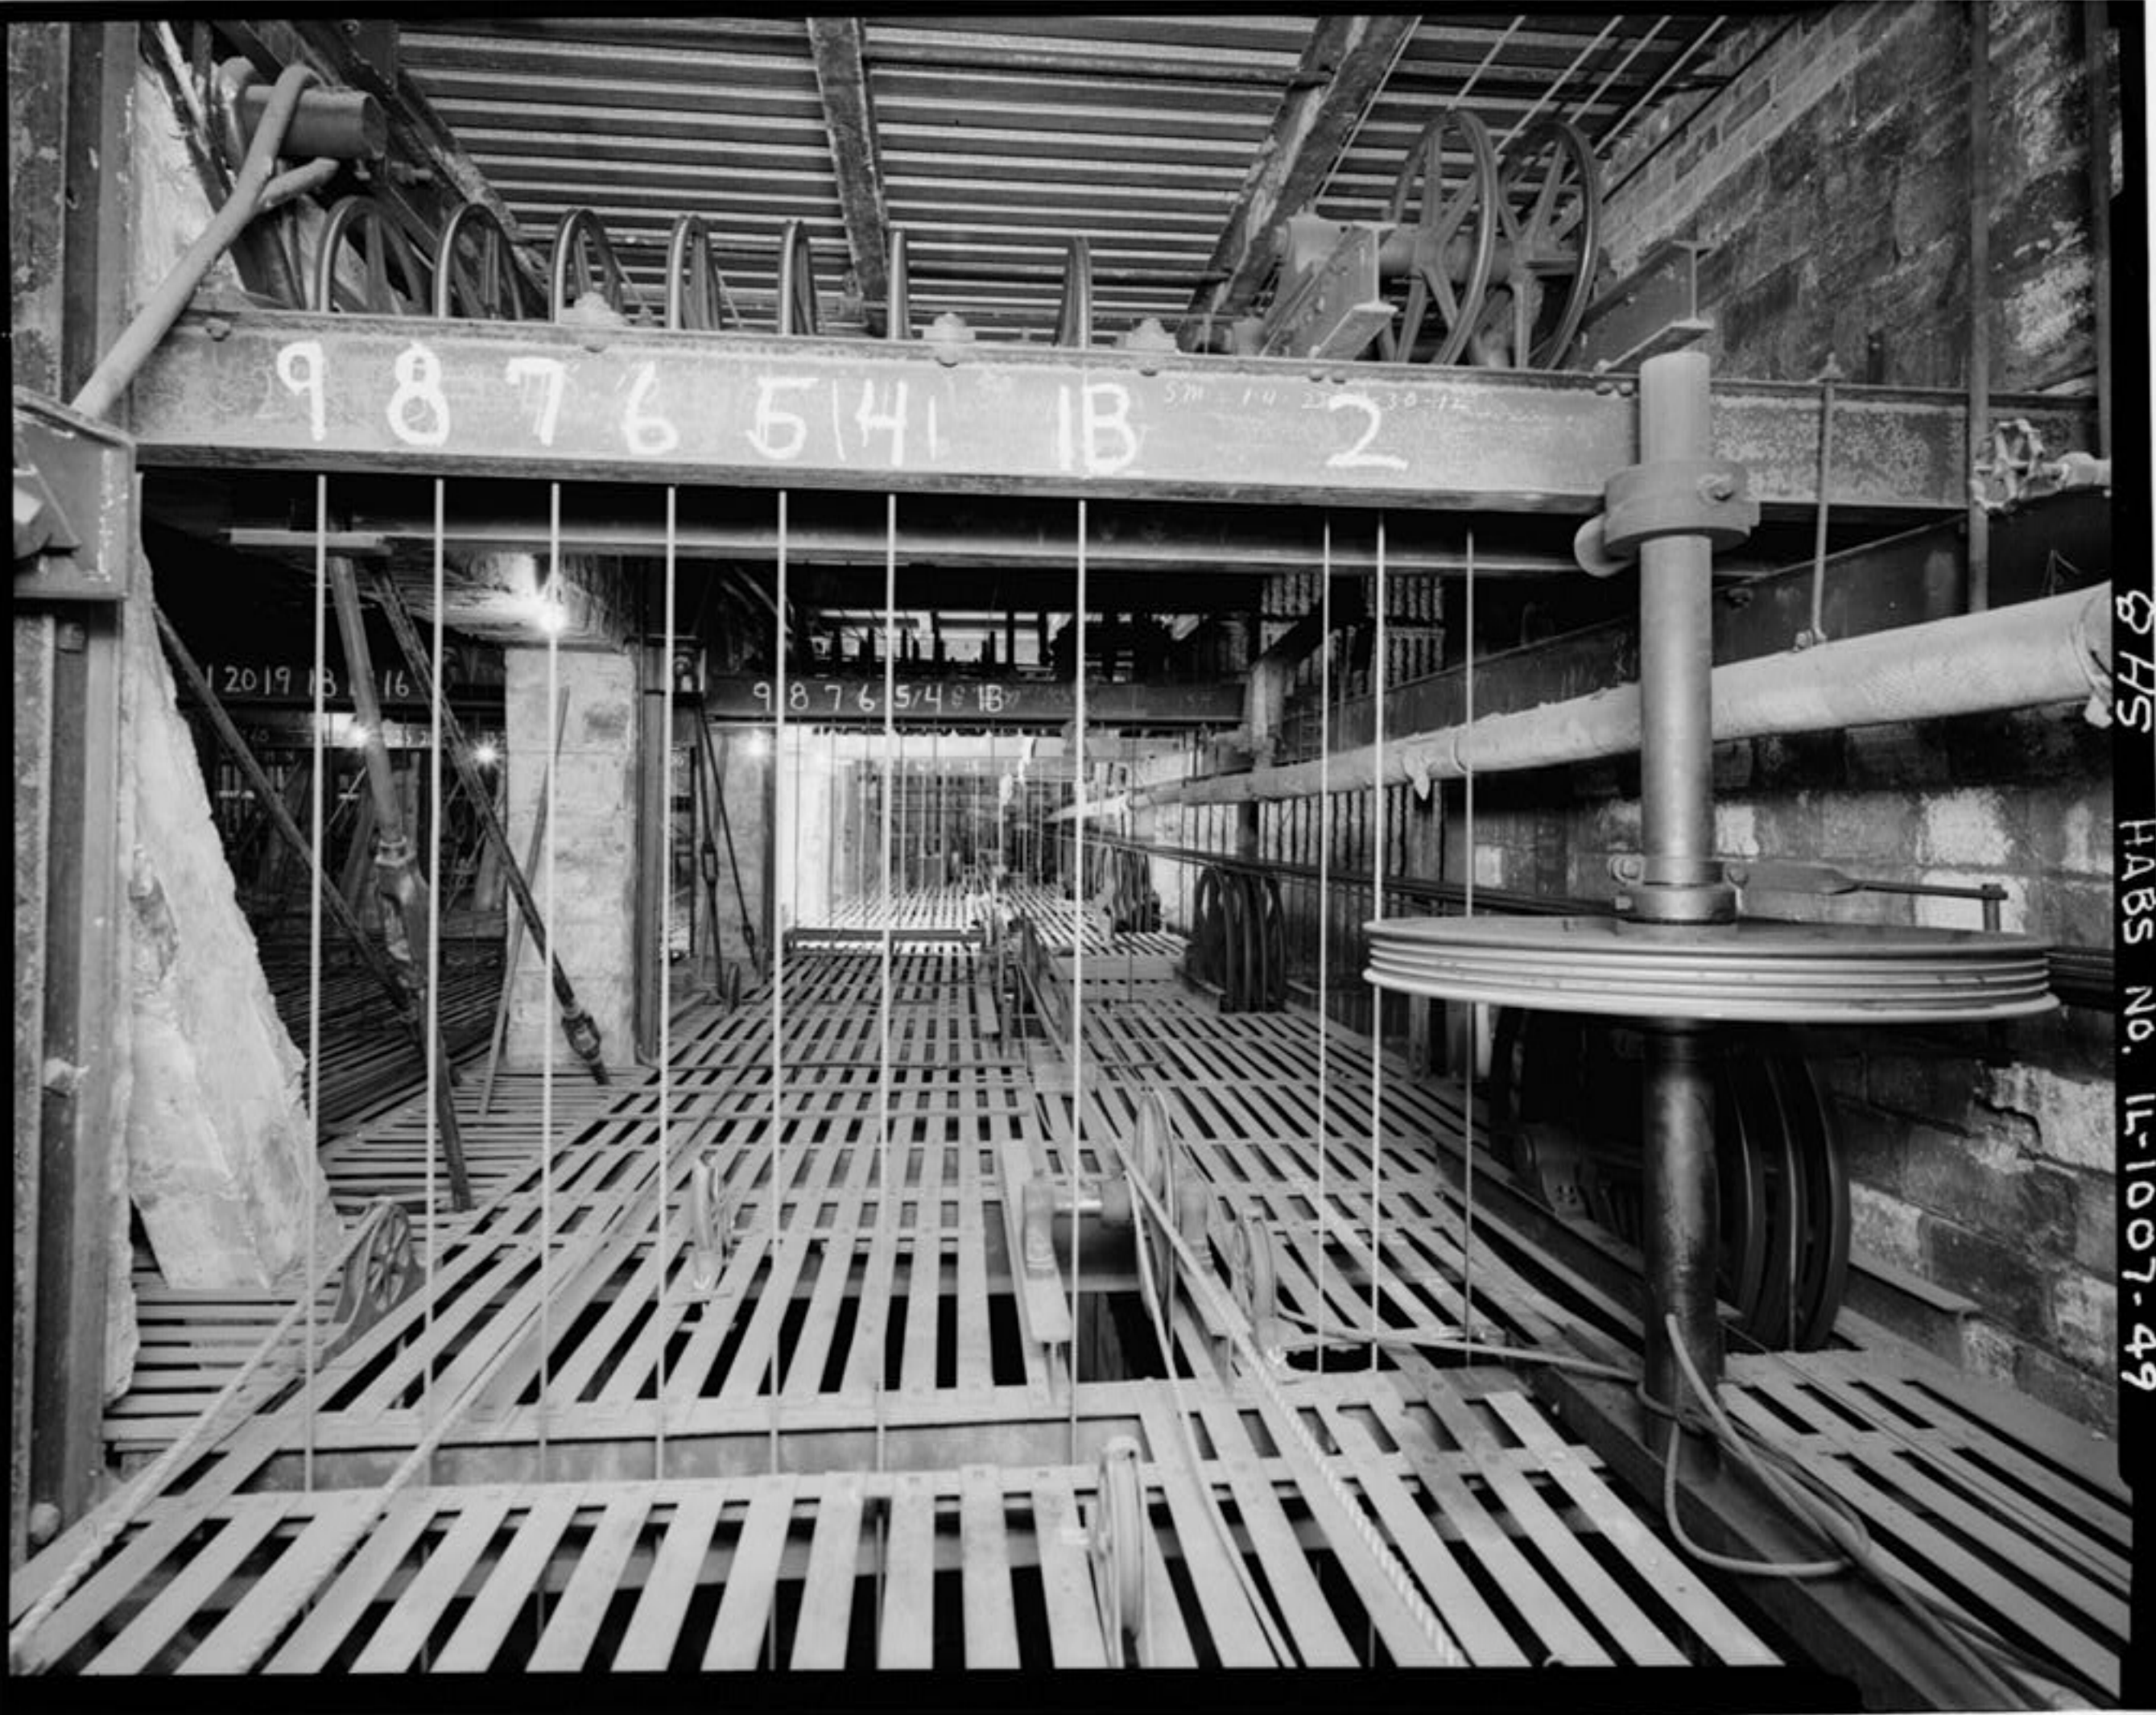
HABBS No. 1L-1007-48

- IL-1007-48 NORTH END OF TRUSS Q, RIGGING FOR SETS, AND IRON STRAP FLOOR OF
 FLYLOFT.
- IL-1007-49 FLYLOFT, SHOWING RIGGING FOR SETS, IRON STRAP FLOOR, AND CURTAIN
 WALL OVER PROSCENIUM, LOOKING SOUTH.

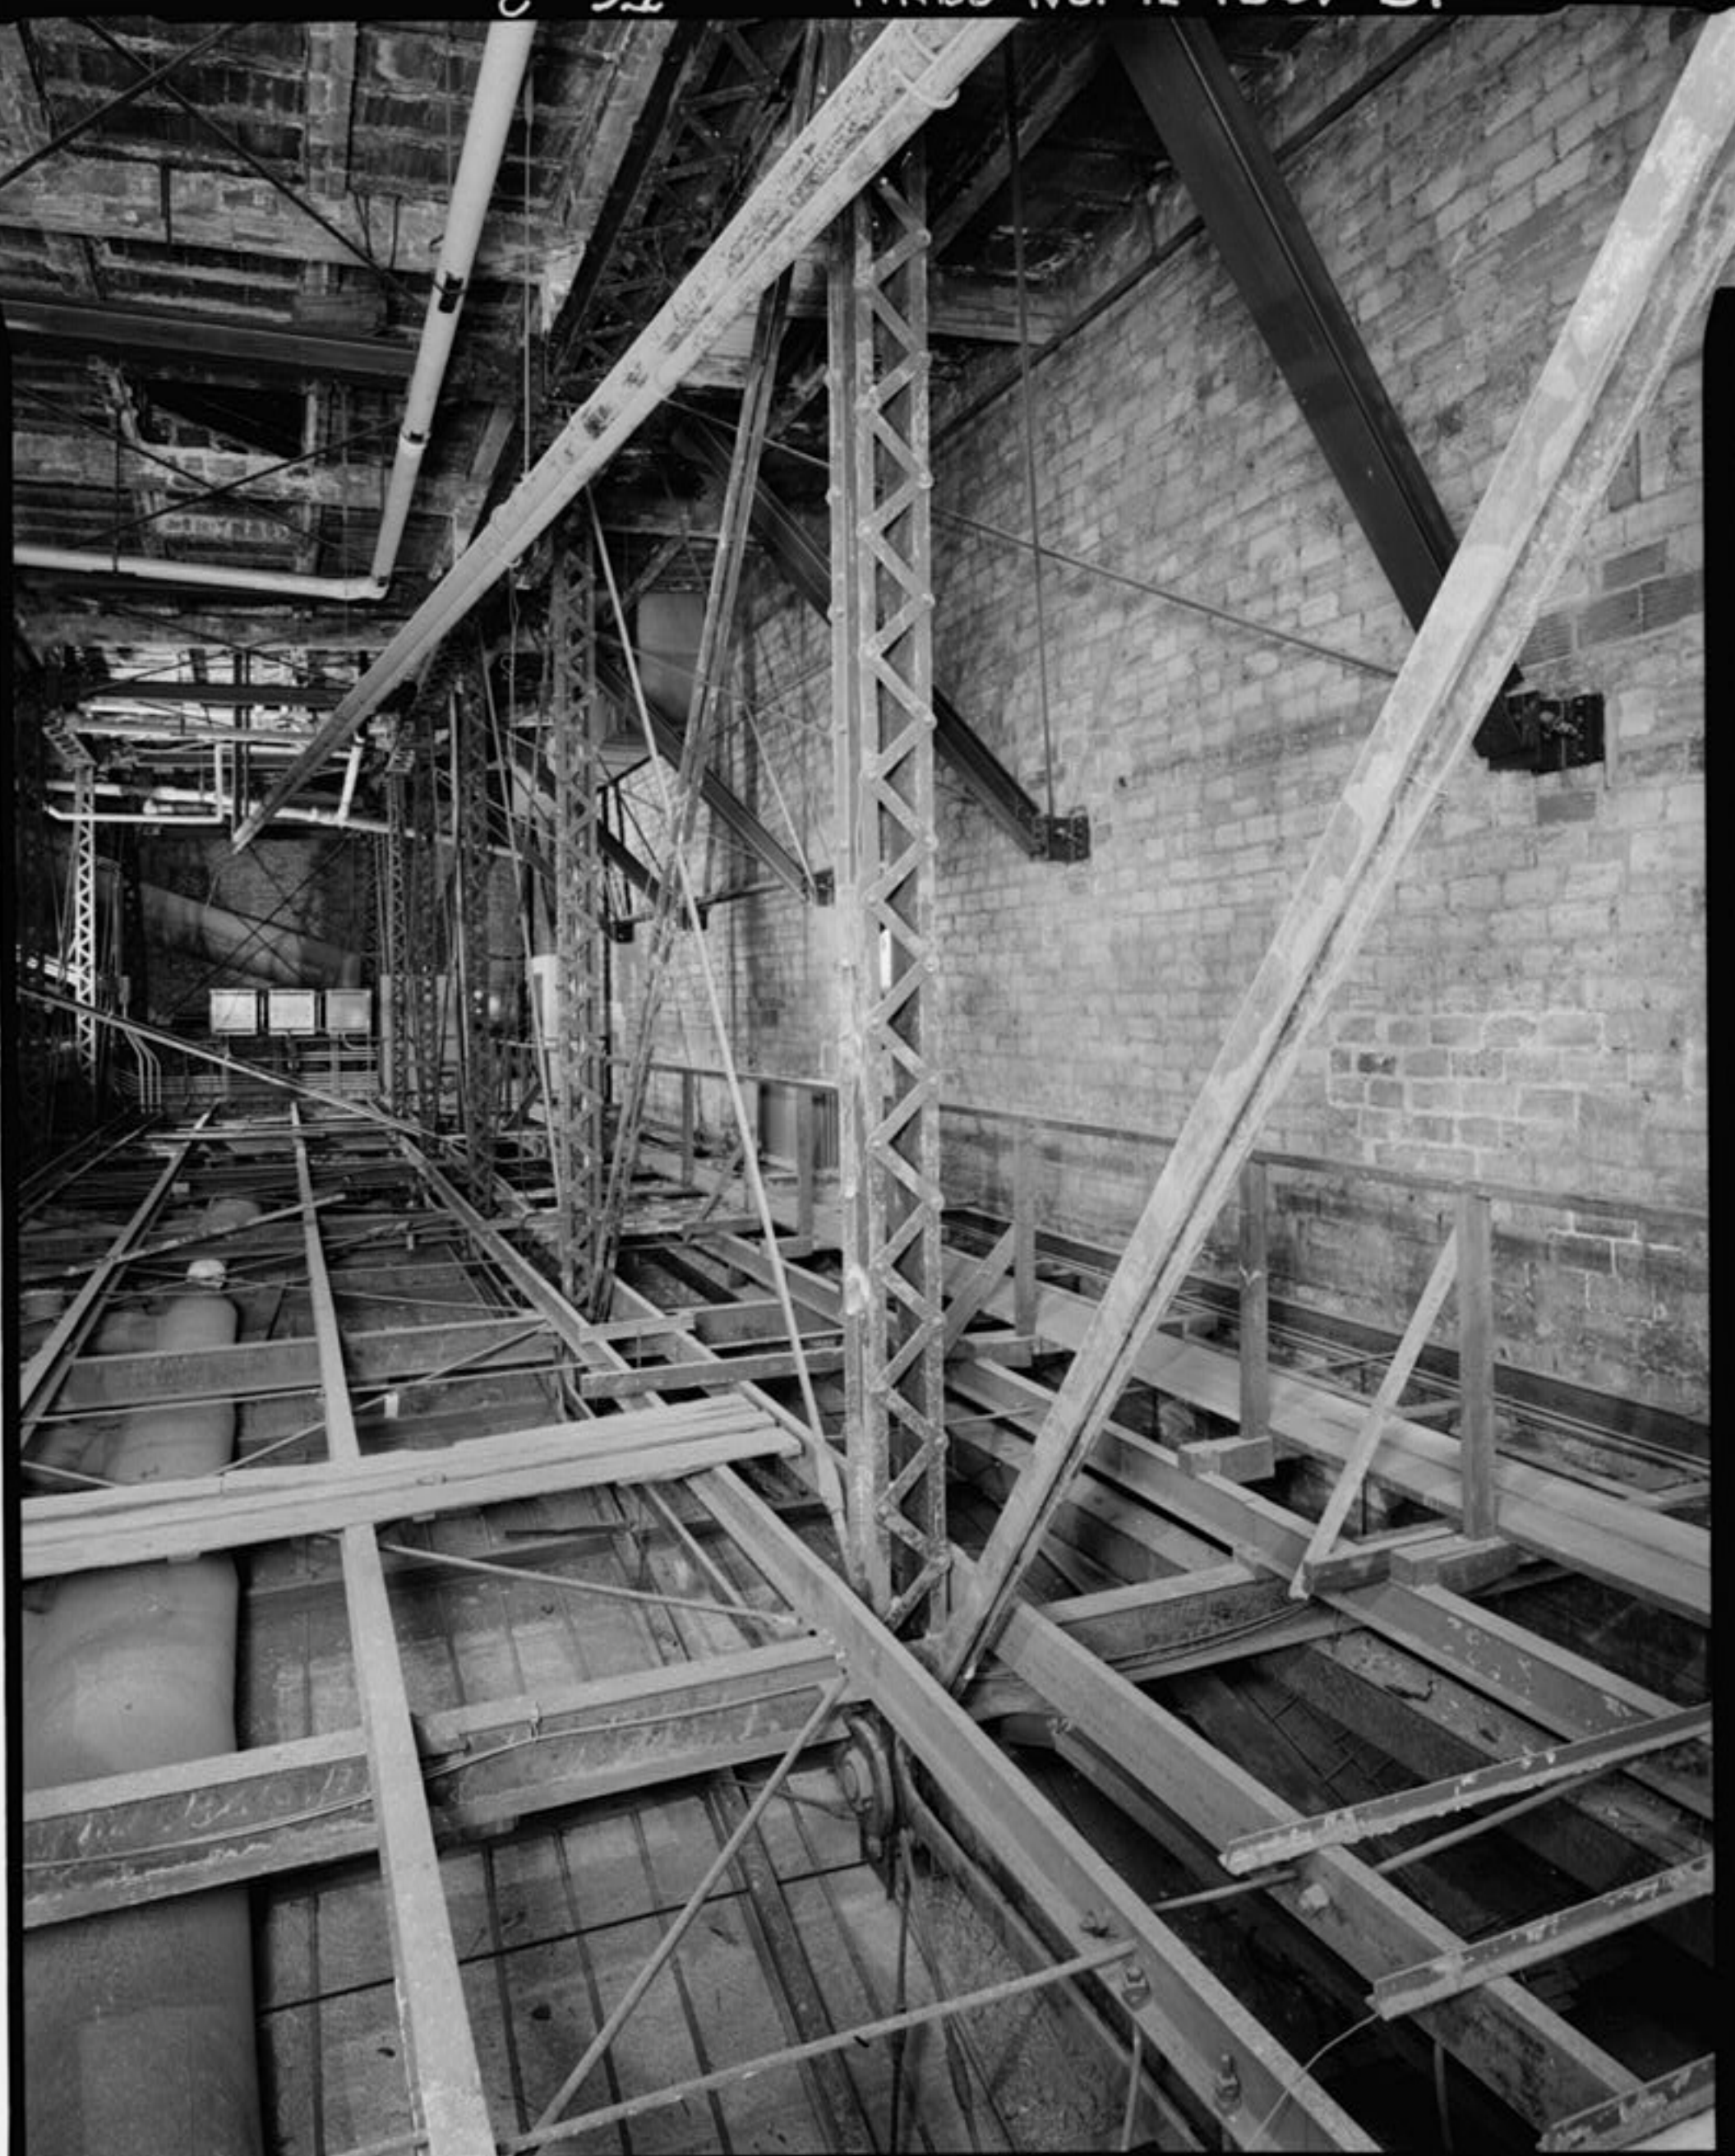
HABS NO. IL-1007-51

- IL-1007-50 SOUTHWEST CORNER OF FLYLOFT SHOWING PULLEYS FOR RIGGING SETS AND STAGE CURTAIN.
- IL-1007-51 TRUSS A AND PROSCENIUM WALL IN THEATER ATTIC, LOOKING NORTHEAST. NOTE TERRA COTTA FIREPROOFING OF ROOF DECK; HEAVY PLASTER CEILING PROVIDED FIRE SEPARATION FROM THEATER BELOW.
