HISTORIC AMERICAN BUILDINGS SURVEY

INDEX TO PHOTOGRAPHS

Auditorium Building (Roosevelt University)
430 South Michigan Avenue
Chicago
Cook County
Illinois

HABS No. IL-1007

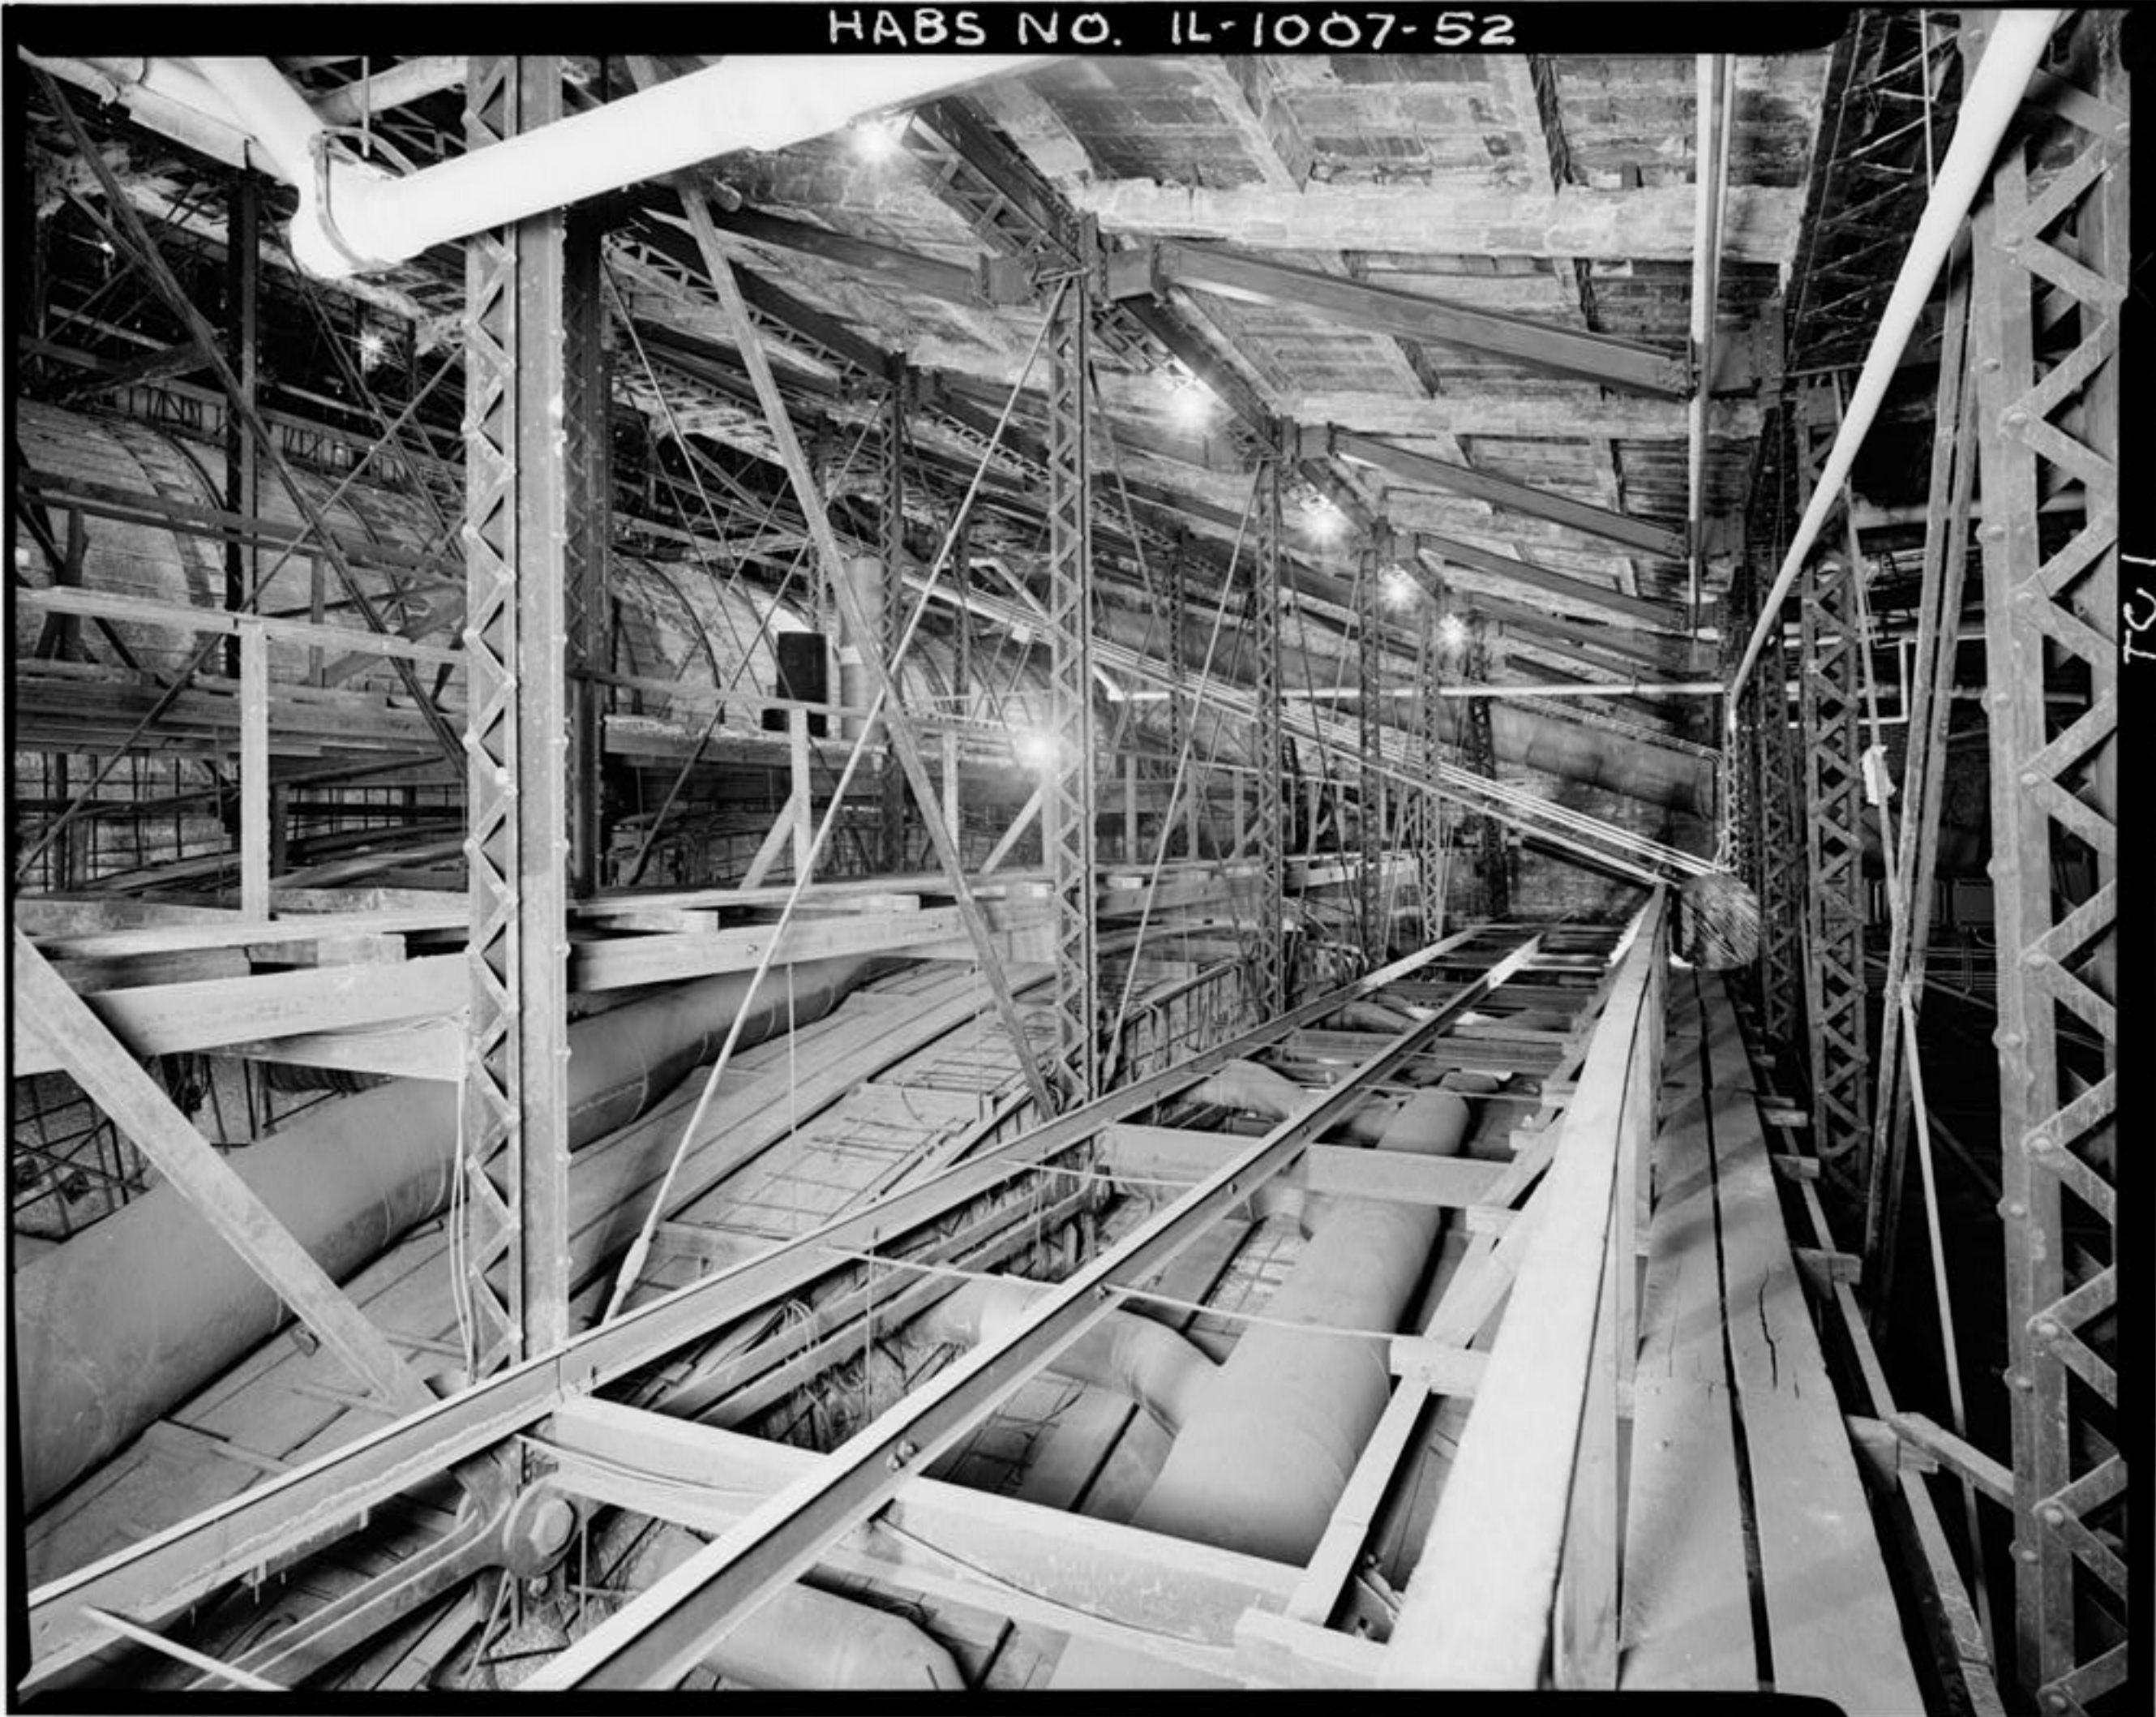
HABS NO. IL-1007-52

- IL-1007-52 LOOKING NORTHWEST FROM BETWEEN TRUSSES B AND C OF THEATER ATTIC. NOTE CURVE OF ELLIPTICAL CEILING BELOW, AIR SUPPLY DUCTS, AND LATERAL BRACING ADDED BETWEEN TRUSSES.

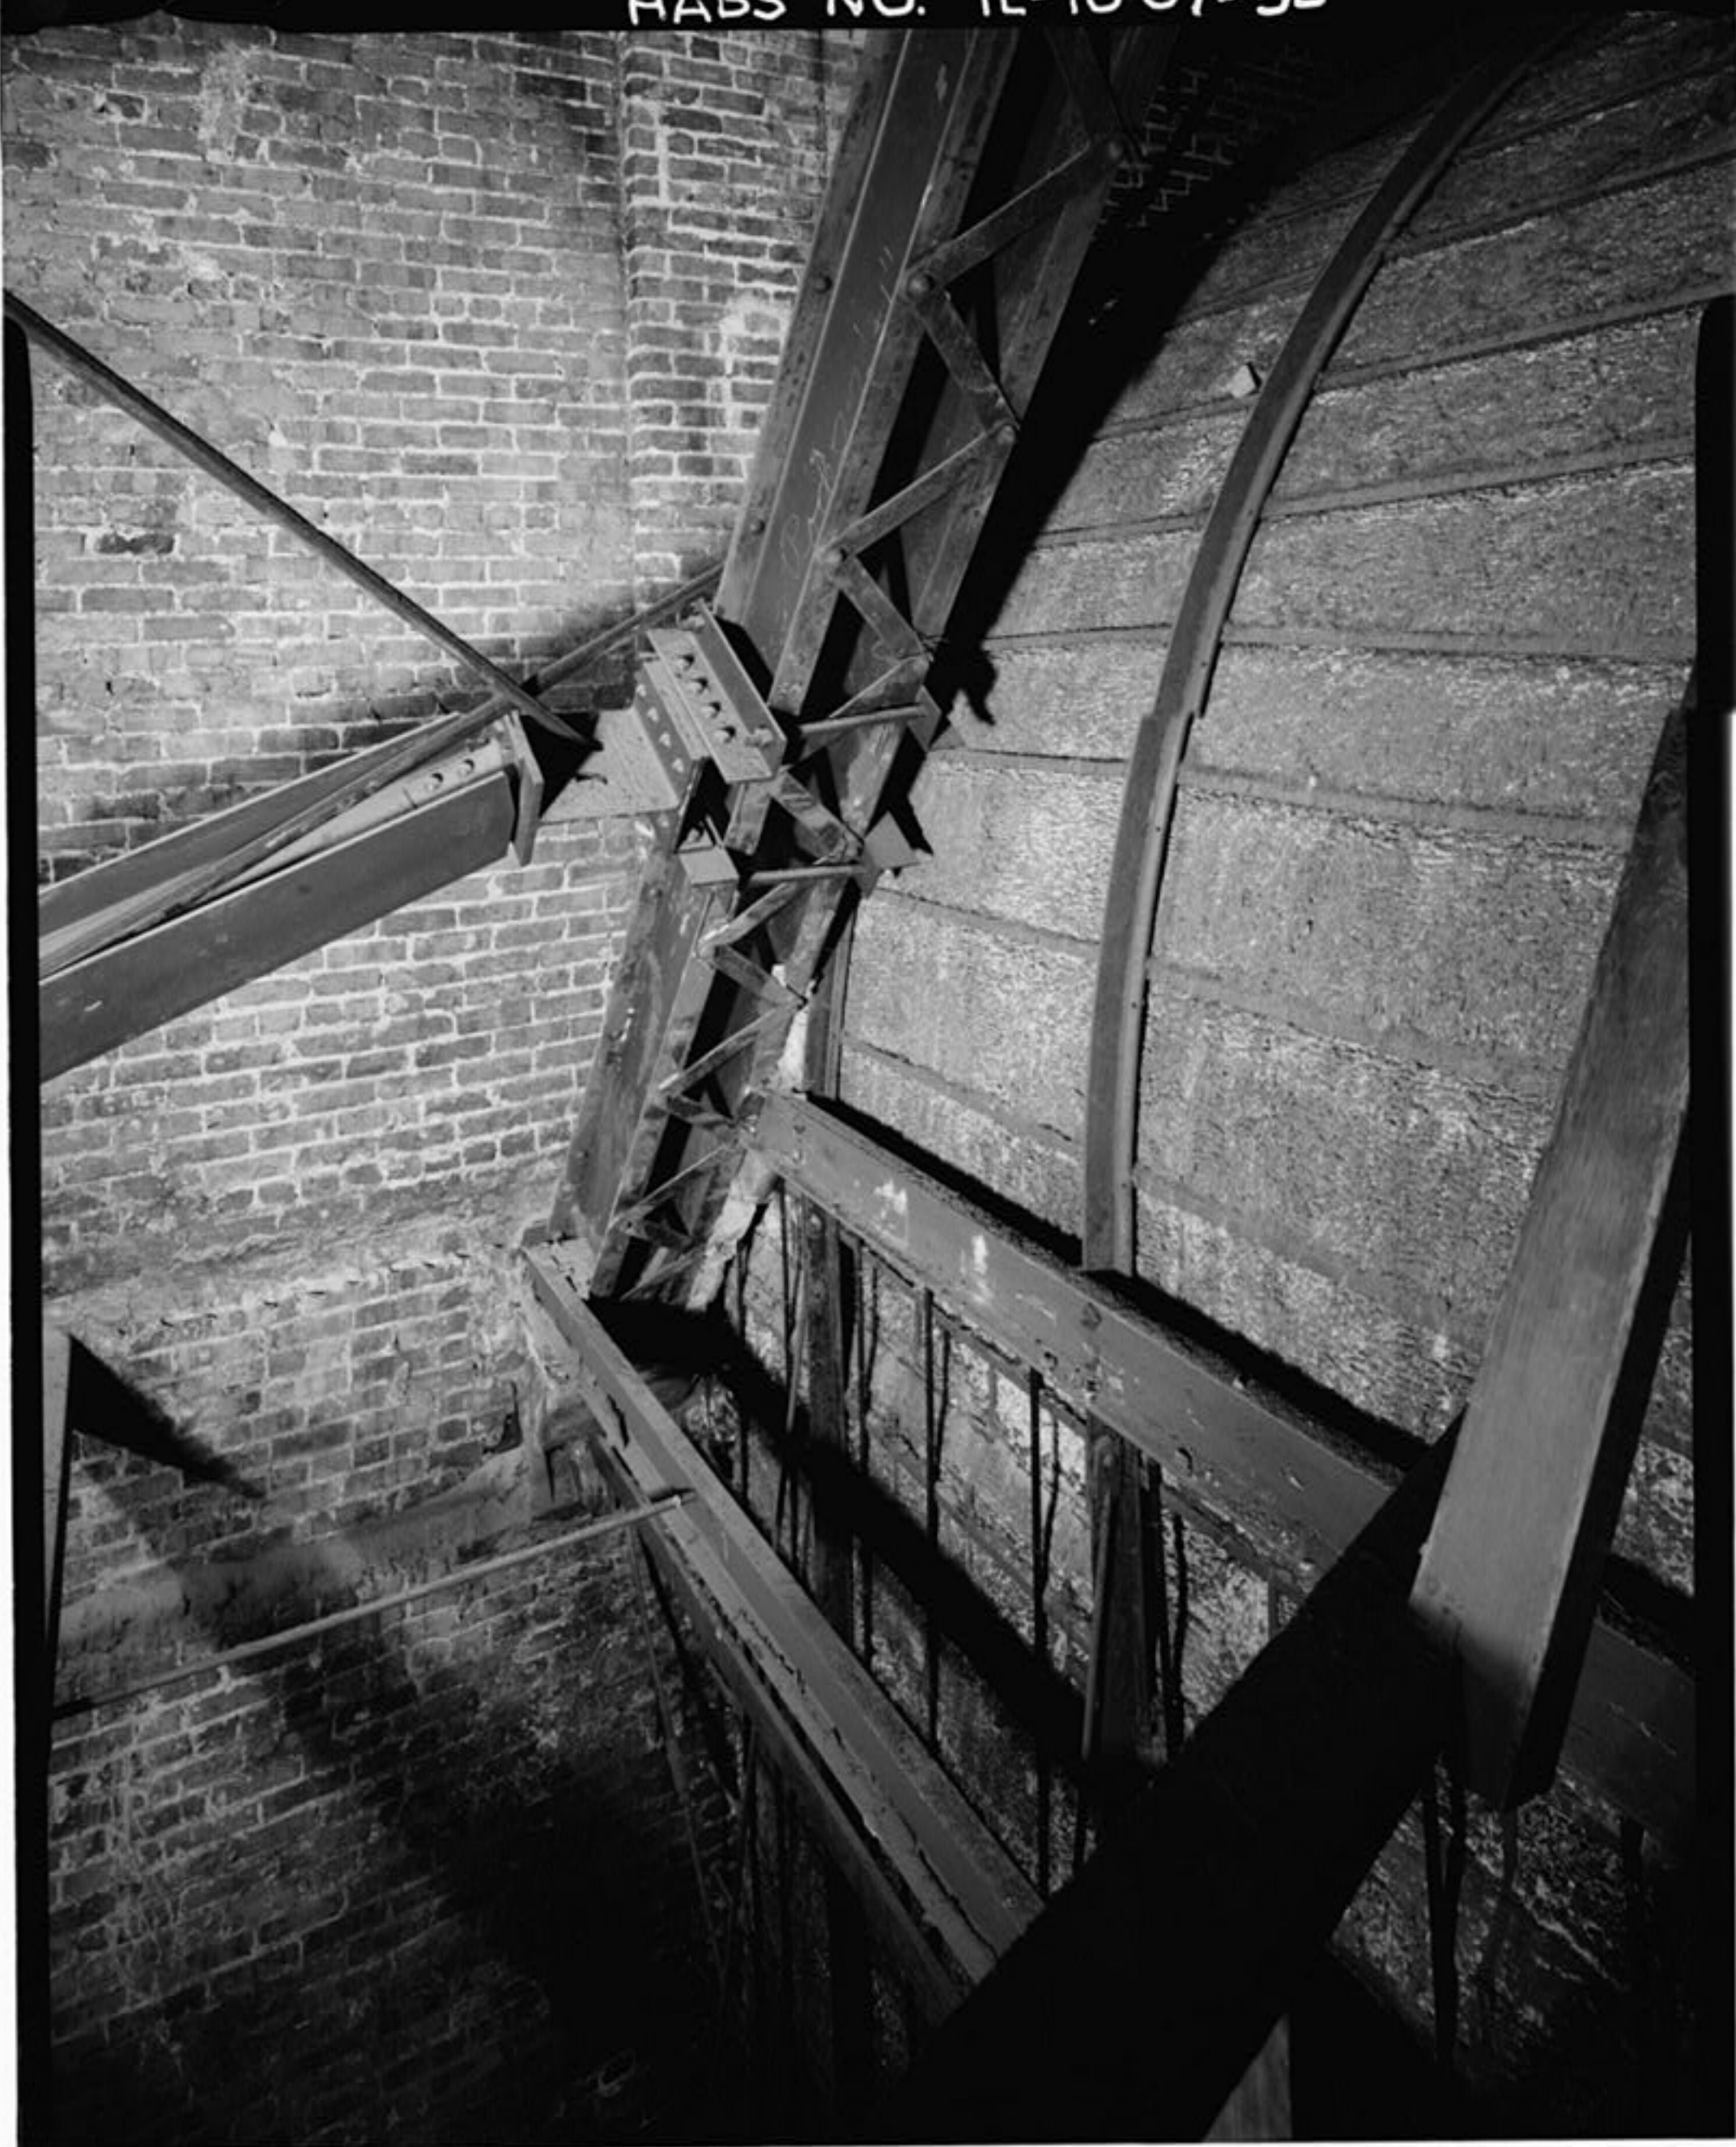
HABS NO. IL-10 07-53

- IL-1007-53 DETAIL OF SOUTH END OF TRUSS E, SOUTH BEARING WALL OF THEATER, AND COVE CEILING OF THEATER SKYLIGHT, THEATER ATTIC.
- IL-1007-54 LOOKING WEST FROM BETWEEN TRUSSES C AND D TOWARD SPANDREL WALL SUSPENDED FROM TRUSS E, THEATER ATTIC. NORTH BEARING WALL OF THEATER ON RIGHT.

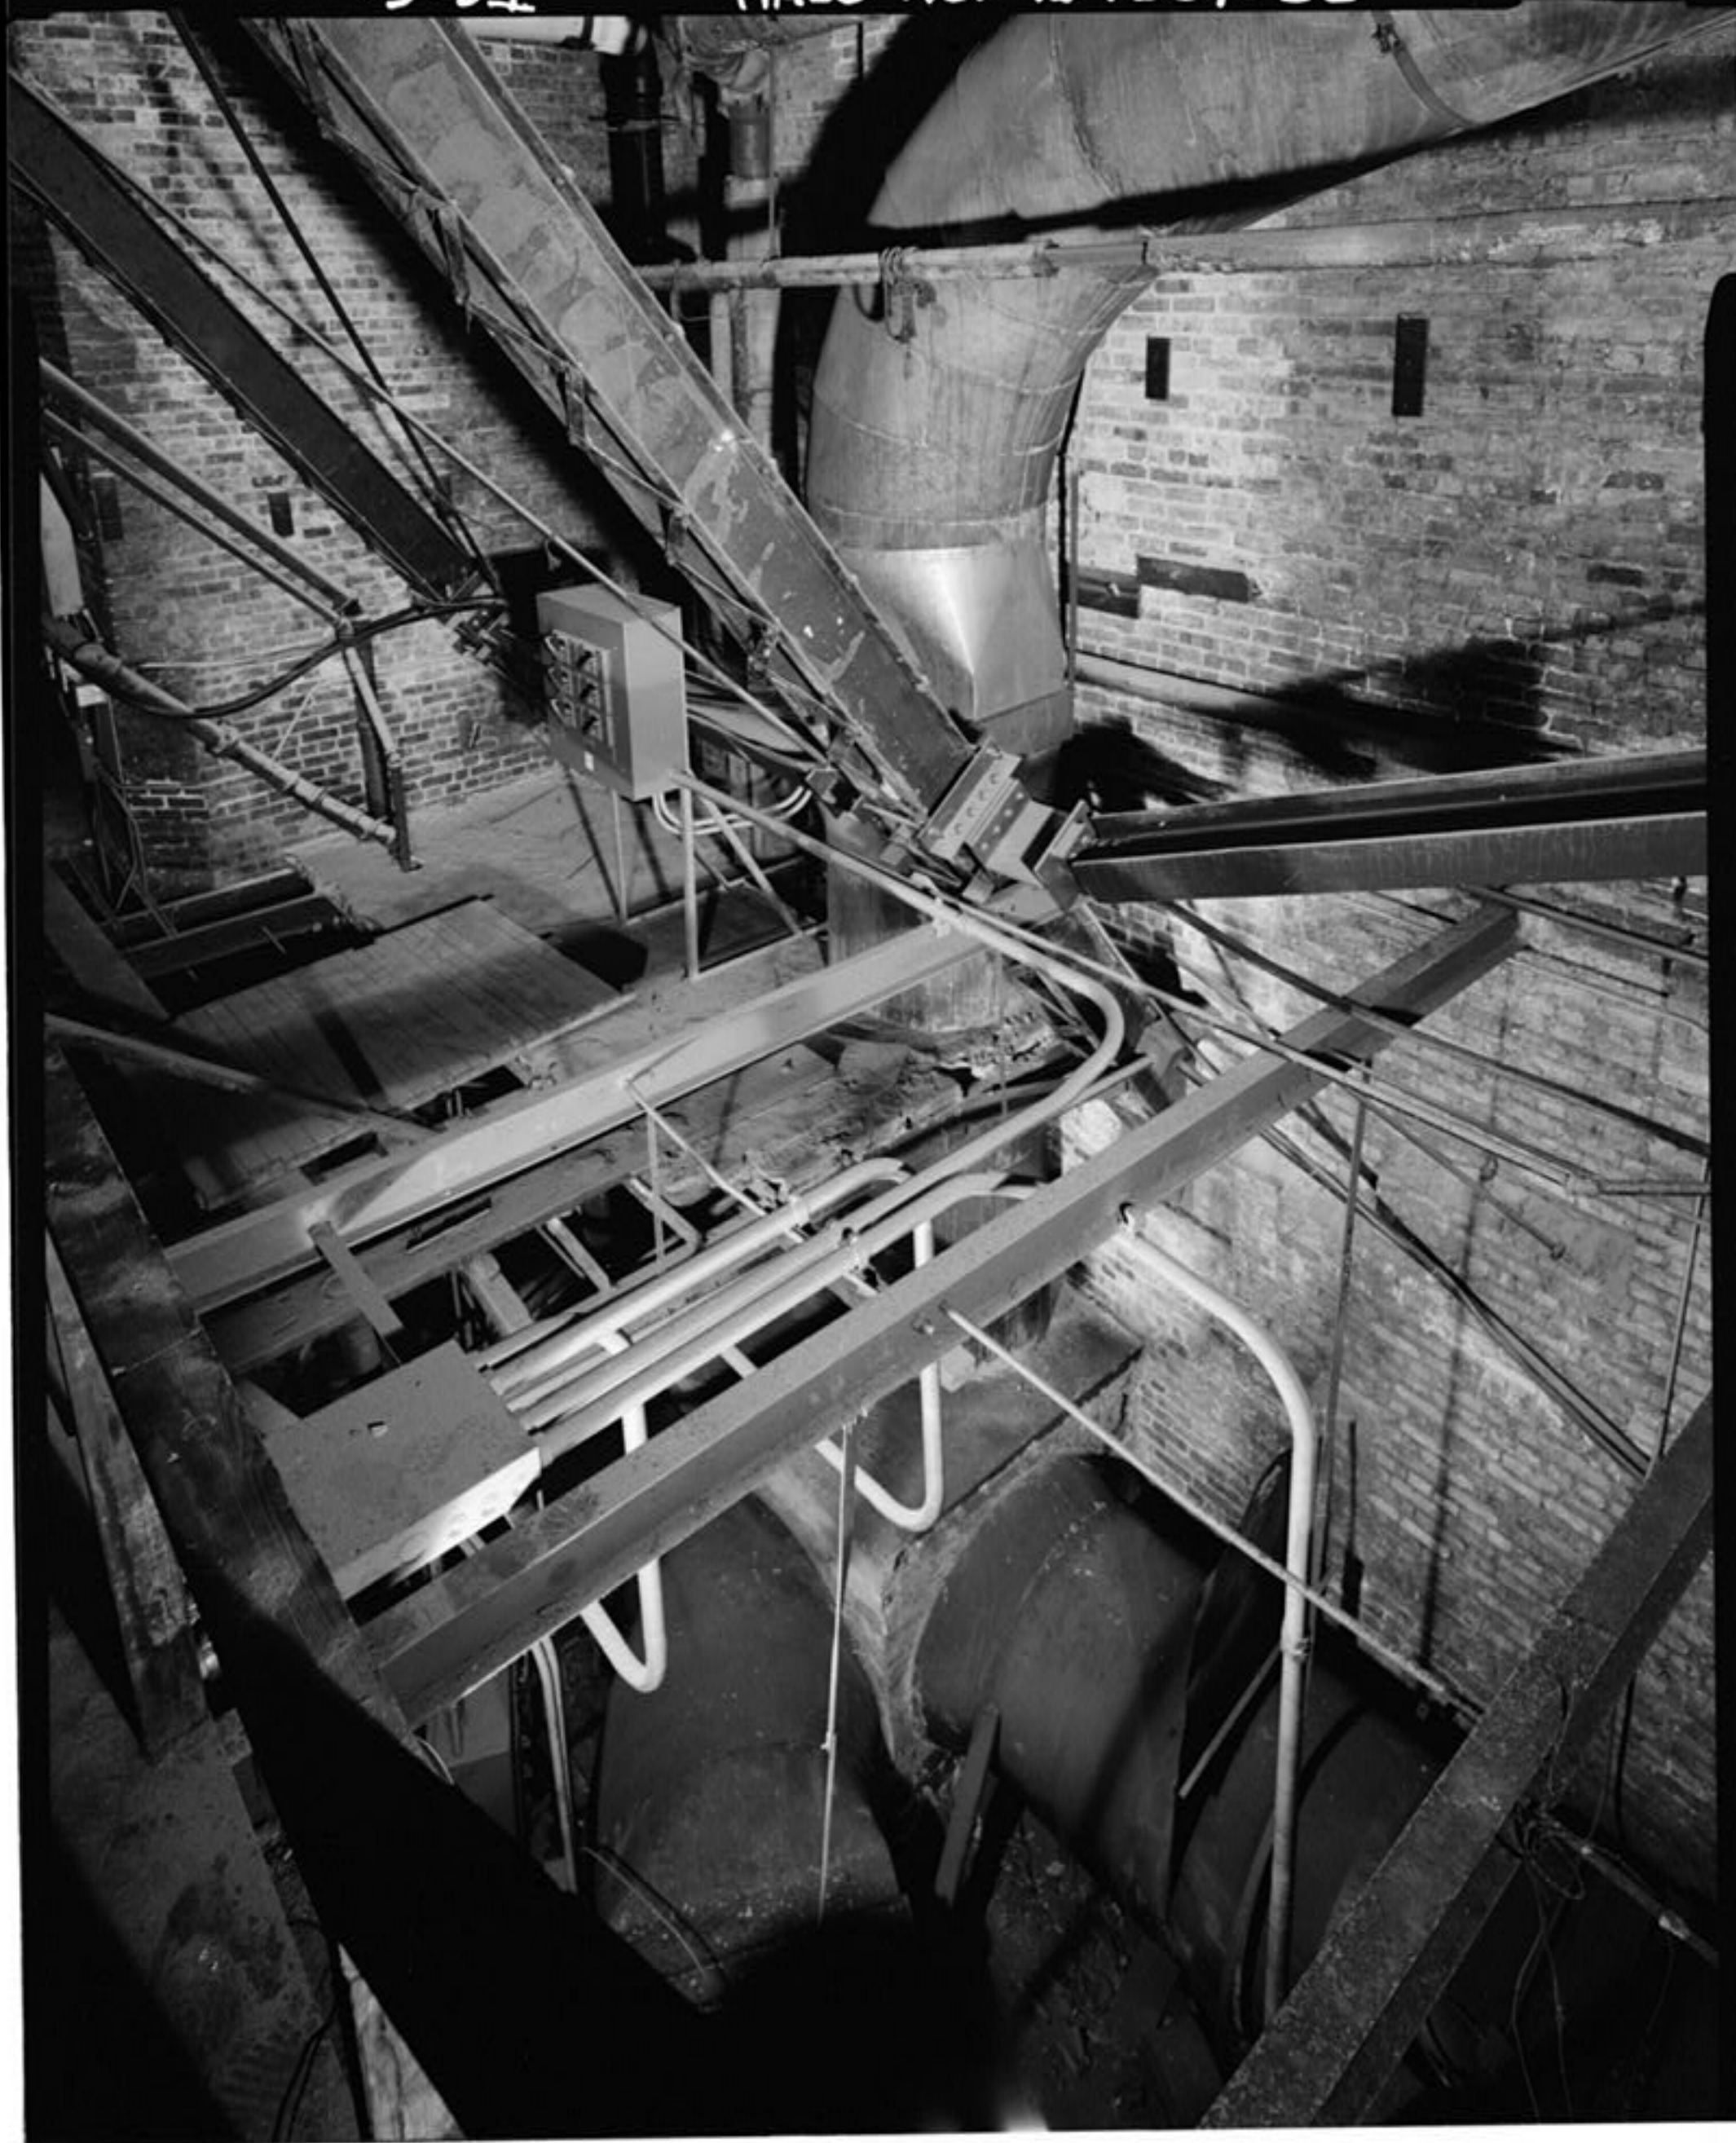
HABS NO. IL-1007-55

- IL-1007-55 AIR SUPPLY DUCT FOR SOUTH HALF OF THEATER, THEATER ATTIC.
- IL-1007-56 AIR SUPPLY DUCT FOR NORTH HALF OF THEATER, THEATER ATTIC.
- IL-1007-57 AIR SUPPLY DUCT FEEDING DIFFUSERS IN EXTRADOS OF ELLIPTICAL CEILING ARCH OF THEATER, THEATER ATTIC, LOOKING NORTH.

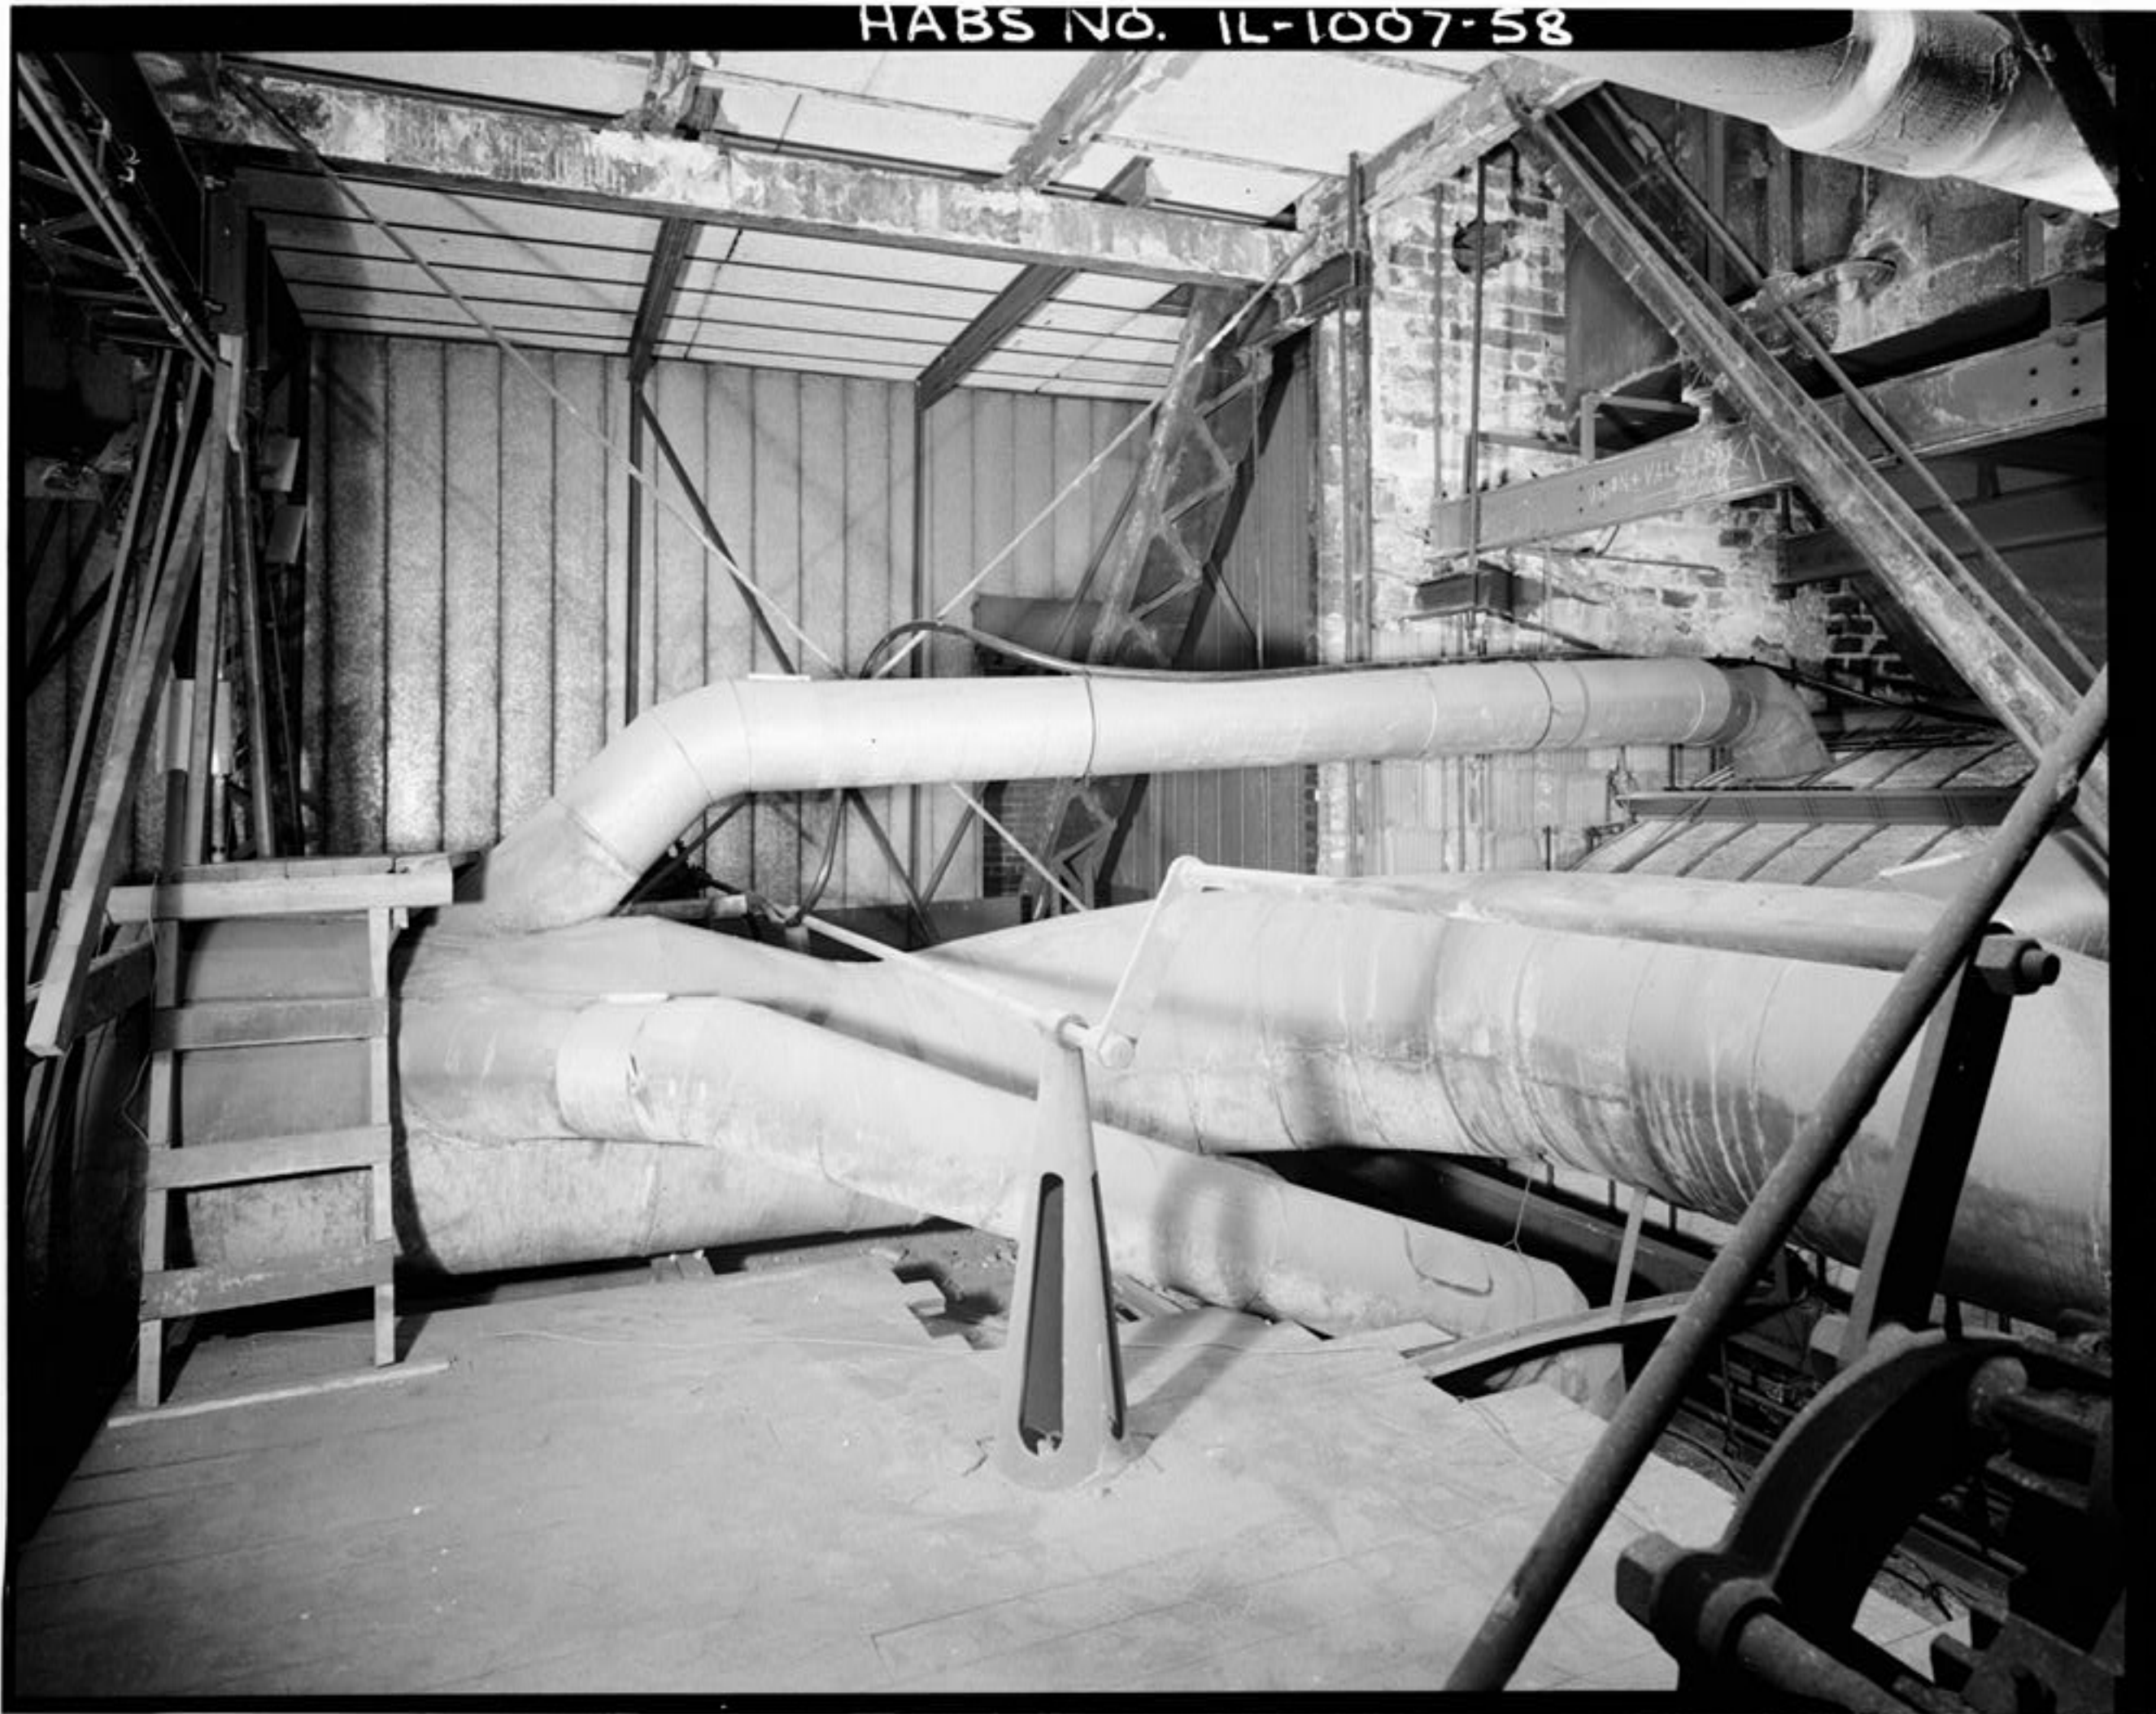
HABS NO. 1L-1007-58

- IL-1007-58 AIR SUPPLY DUCTS FOR SOUTH HALF OF UPPER GALLERY, THEATER ATTIC BETWEEN TRUSSES H AND J, LOOKING SOUTH.
- IL-1007-59 WINCHES FOR OPERATING CLOSABLE COVE CEILING OF UPPER GALLERY, THEATER ATTIC BETWEEN TRUSSES H AND J, LOOKING NORTH.

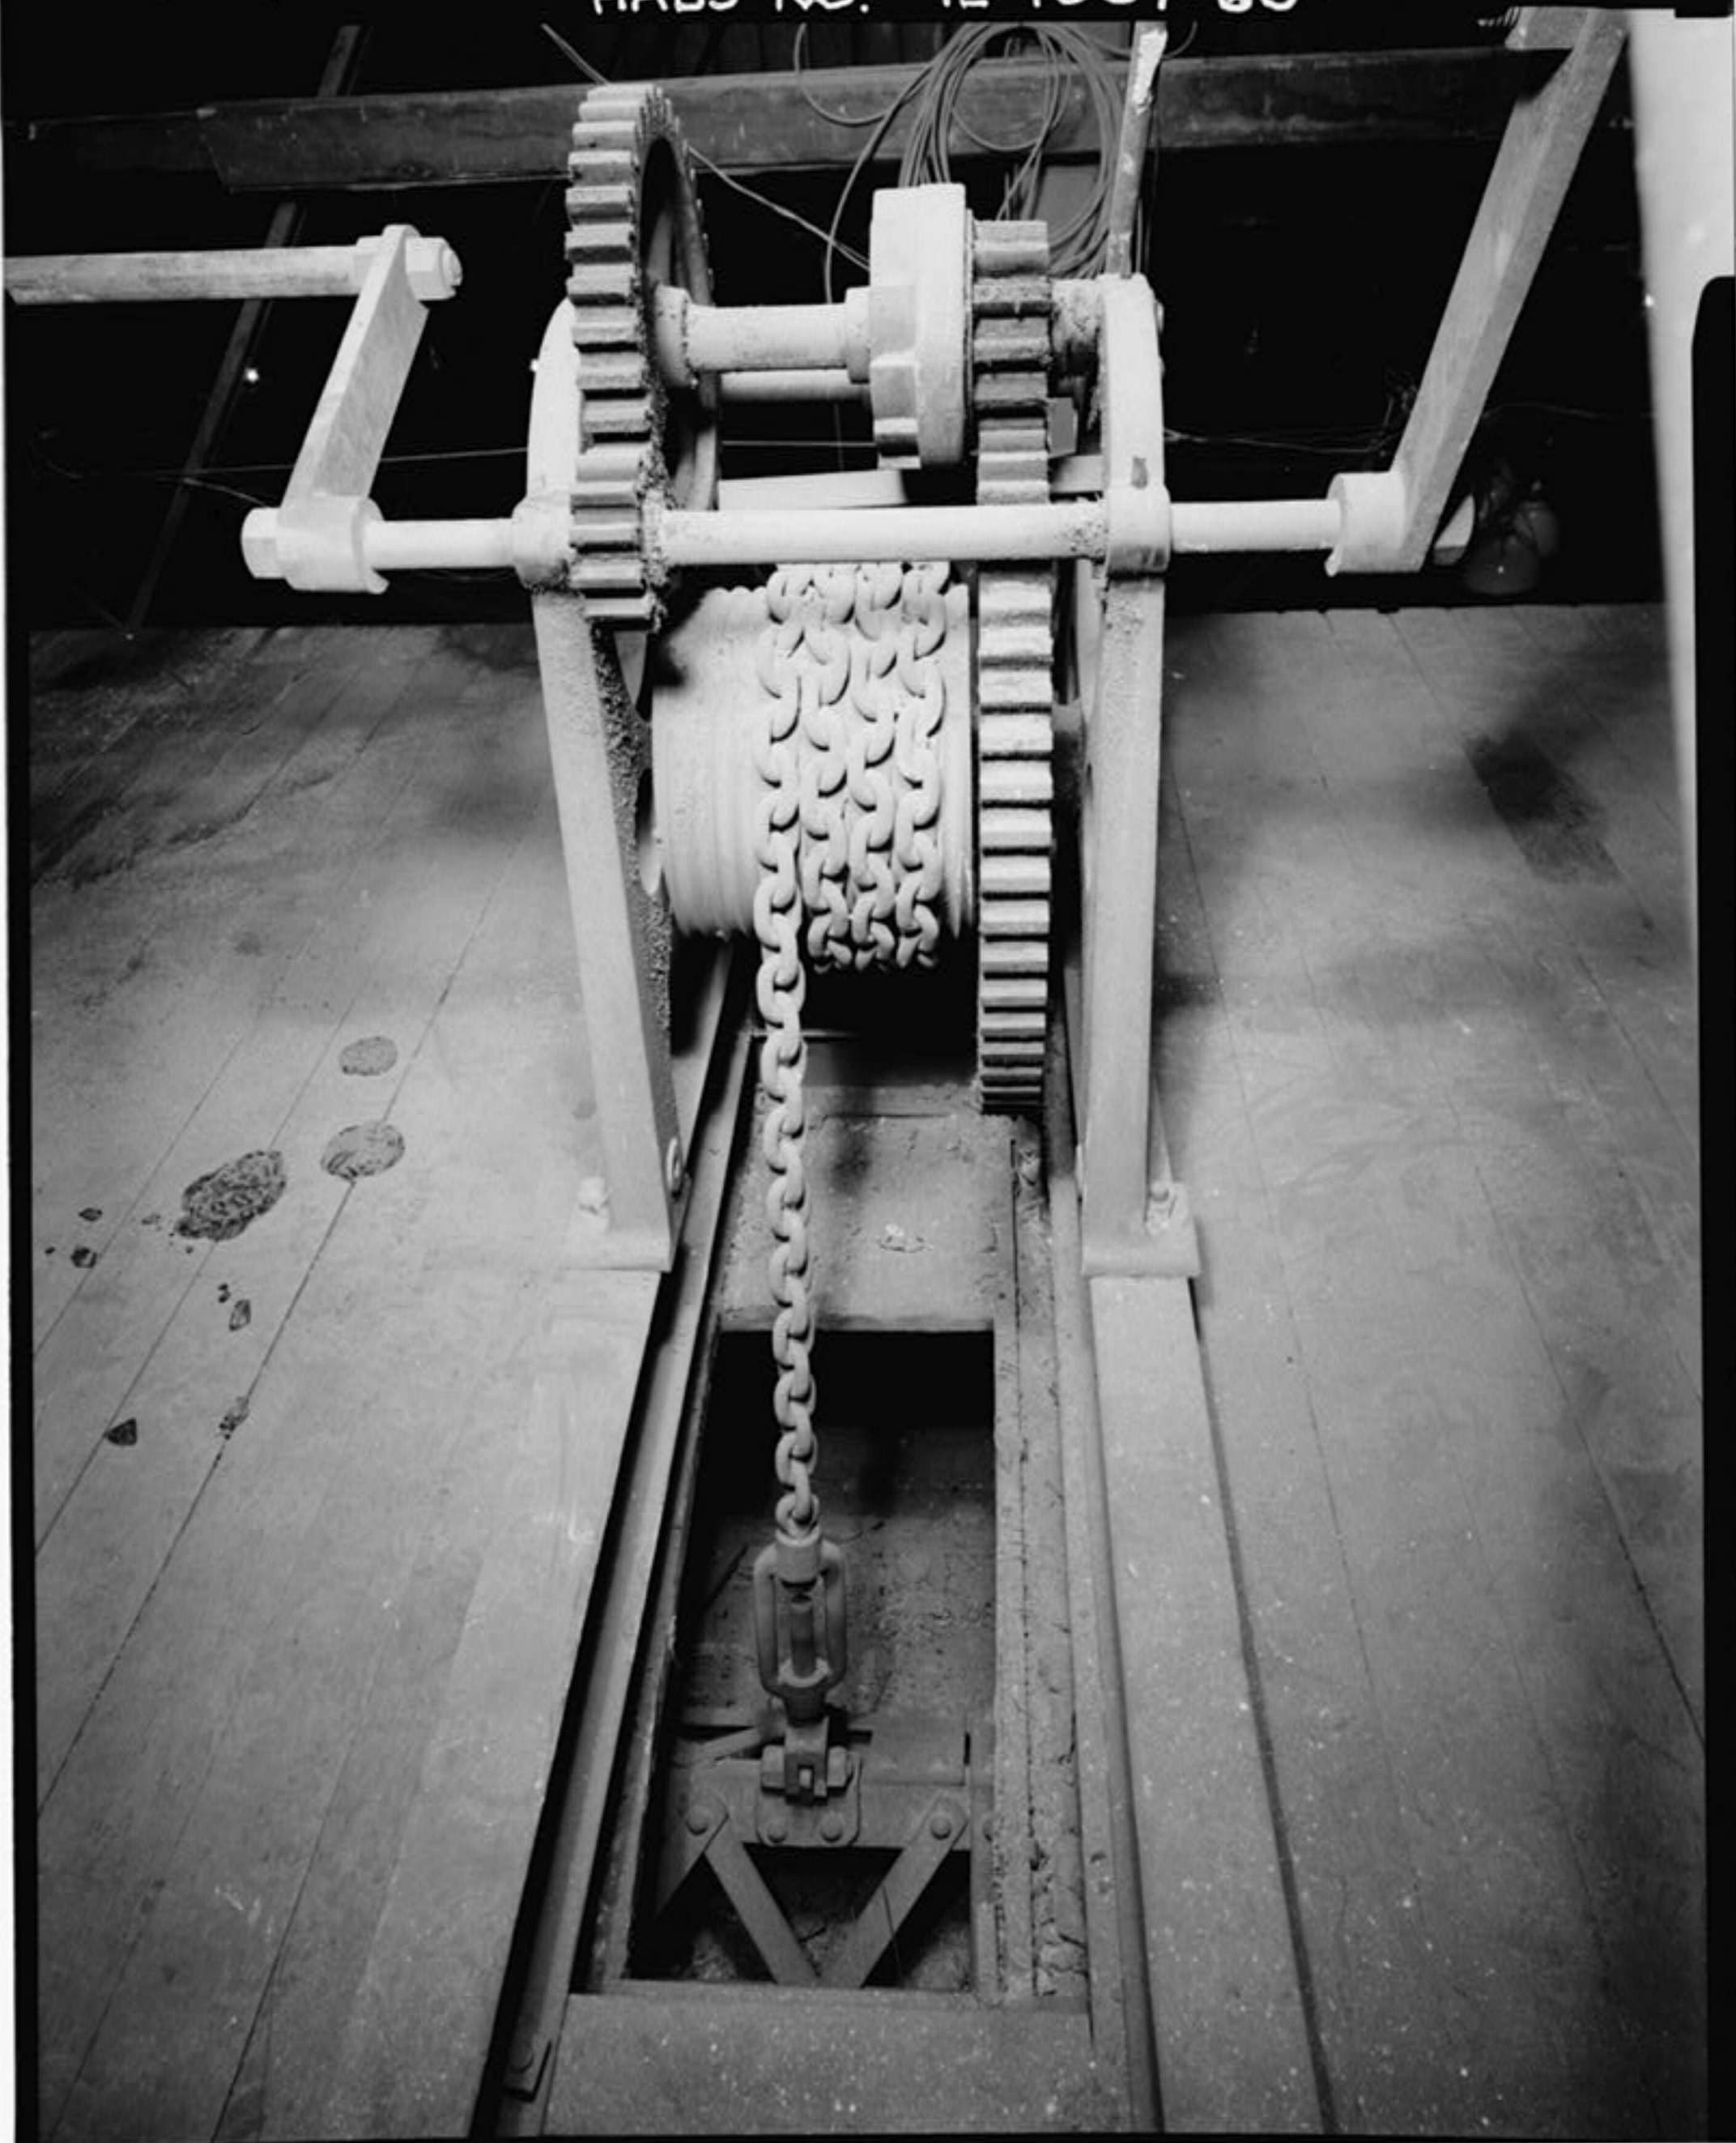
HABS NO. 1L-1007-60

- IL-1007-60 WINCH FOR OPERATING CLOSABLE COVE CEILING OF UPPER GALLERY, THEATER ATTIC.
- IL-1007-61 WEST WALL OF BANQUET HALL FROM SOUTHWEST.
- IL-1007-62 WEST WALL OF BANQUET HALL FROM NORTHWEST.

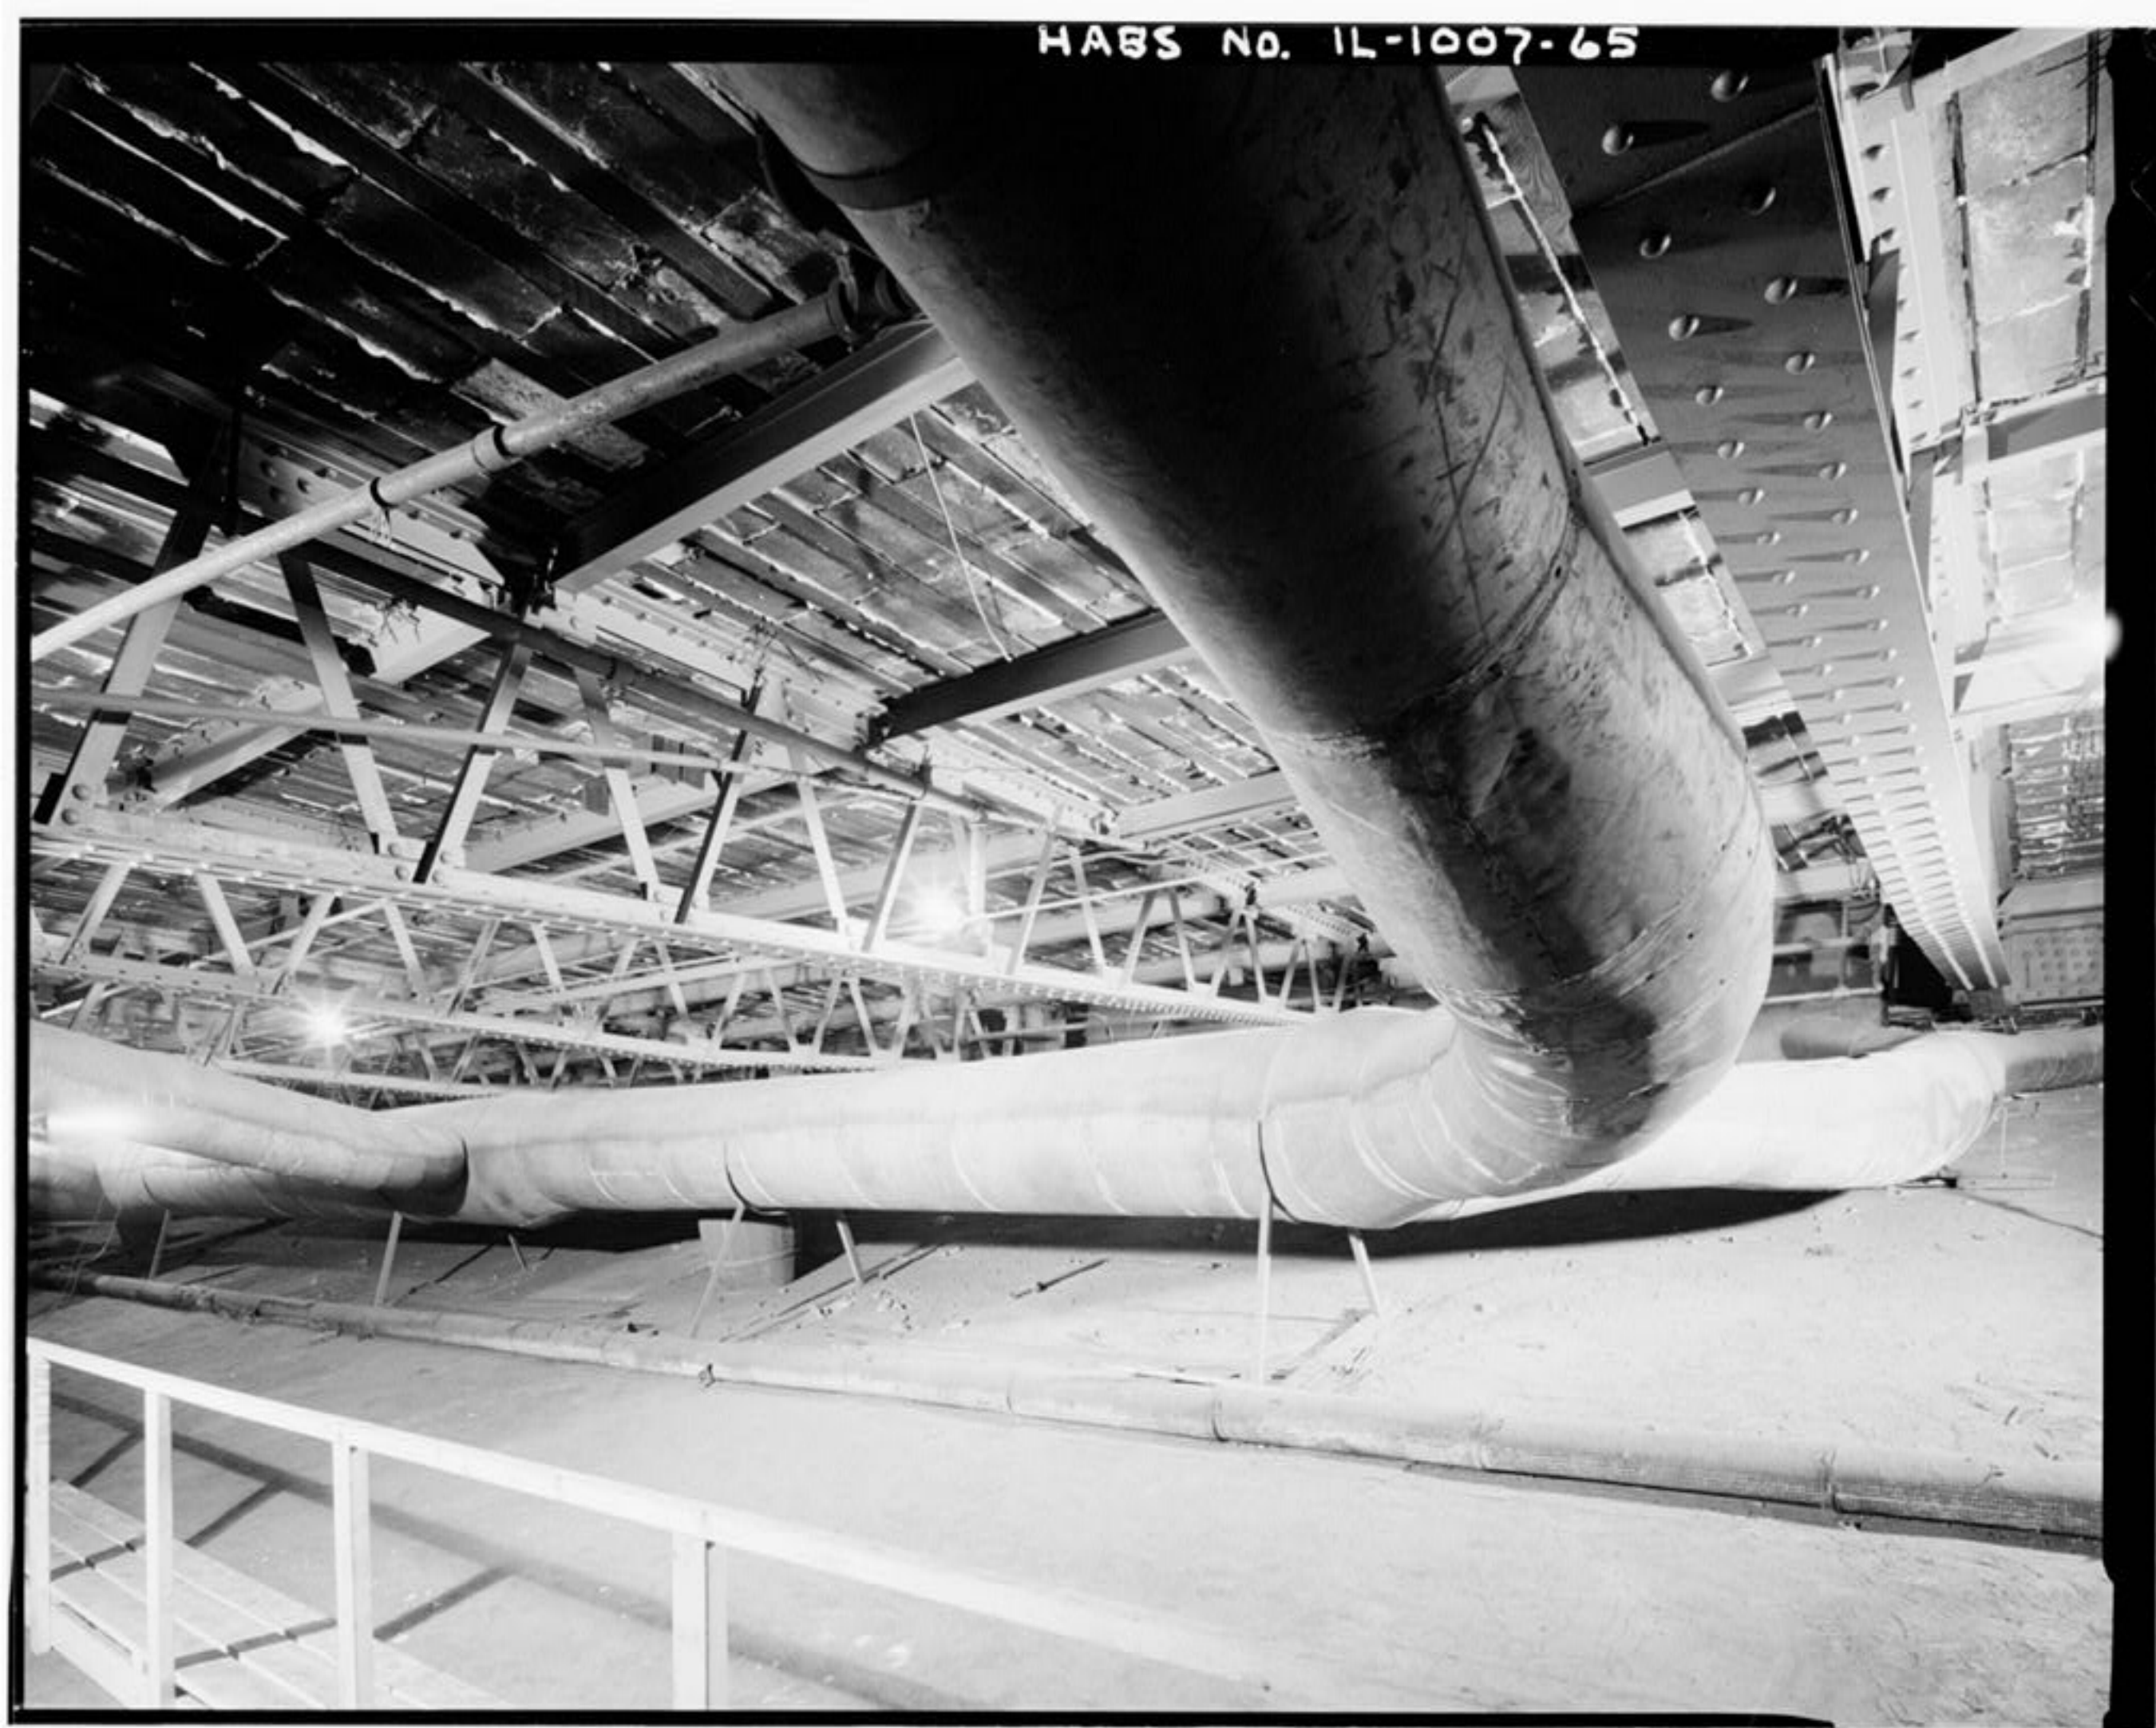
HABS No. IL-1007-65

- IL-1007-65 TRANSVERSE TRUSSES AND AIR SUPPLY DUCTS UNDER FLOOR OF BANQUET HALL, LOOKING SOUTHWEST. NOTE SLOPE OF THEATER ROOF BELOW.
