HISTORIC AMERICAN BUILDINGS SURVEY

INDEX TO PHOTOGRAPHS

Auditorium Building (Roosevelt University)
430 South Michigan Avenue
Chicago
Cook County
Illinois

HABS No. IL-1007

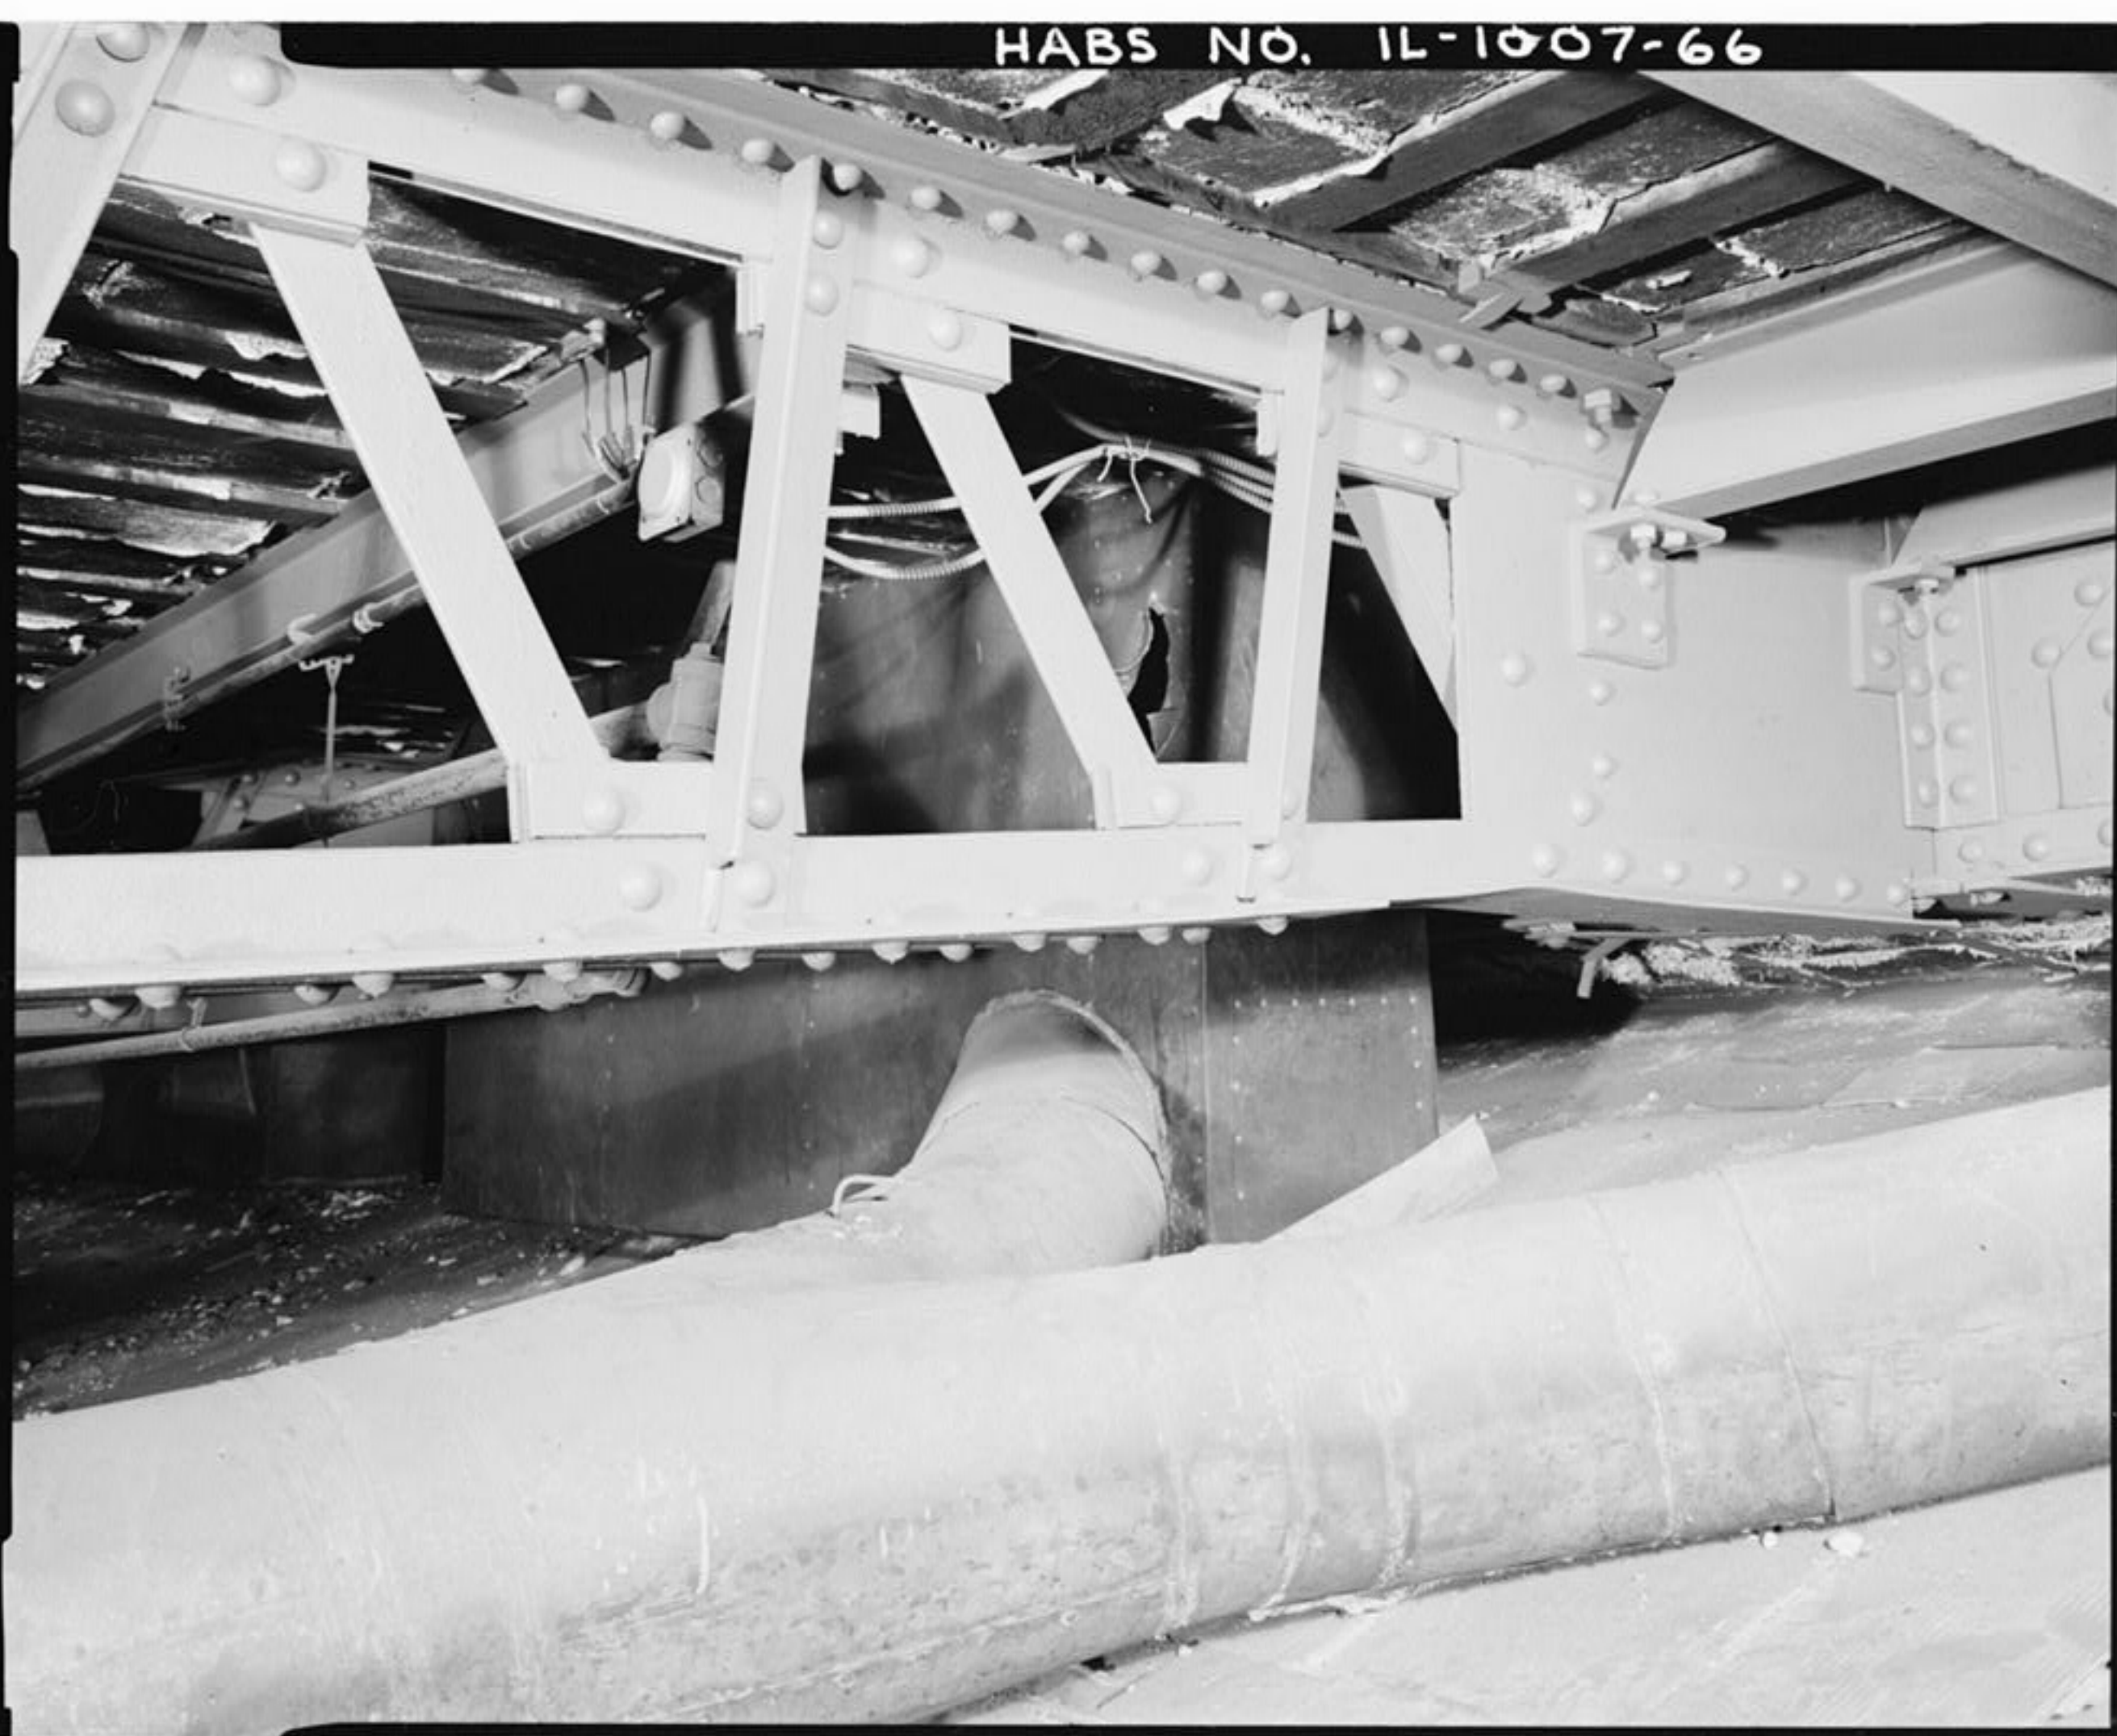
HABS NO. IL-1007-66

- IL-1007-66 DETAIL OF TYPICAL TRANSVERSE TRUSS CONNECTION TO TRUSS U, UNDER BANQUET HALL FLOOR, LOOKING SOUTHWEST.
- IL-1007-67 DETAIL OF TYPICAL TRANSVERSE TRUSS CONNECTION TO TRUSS T, UNDER BANQUET HALL FLOOR, LOOKING NORTH.

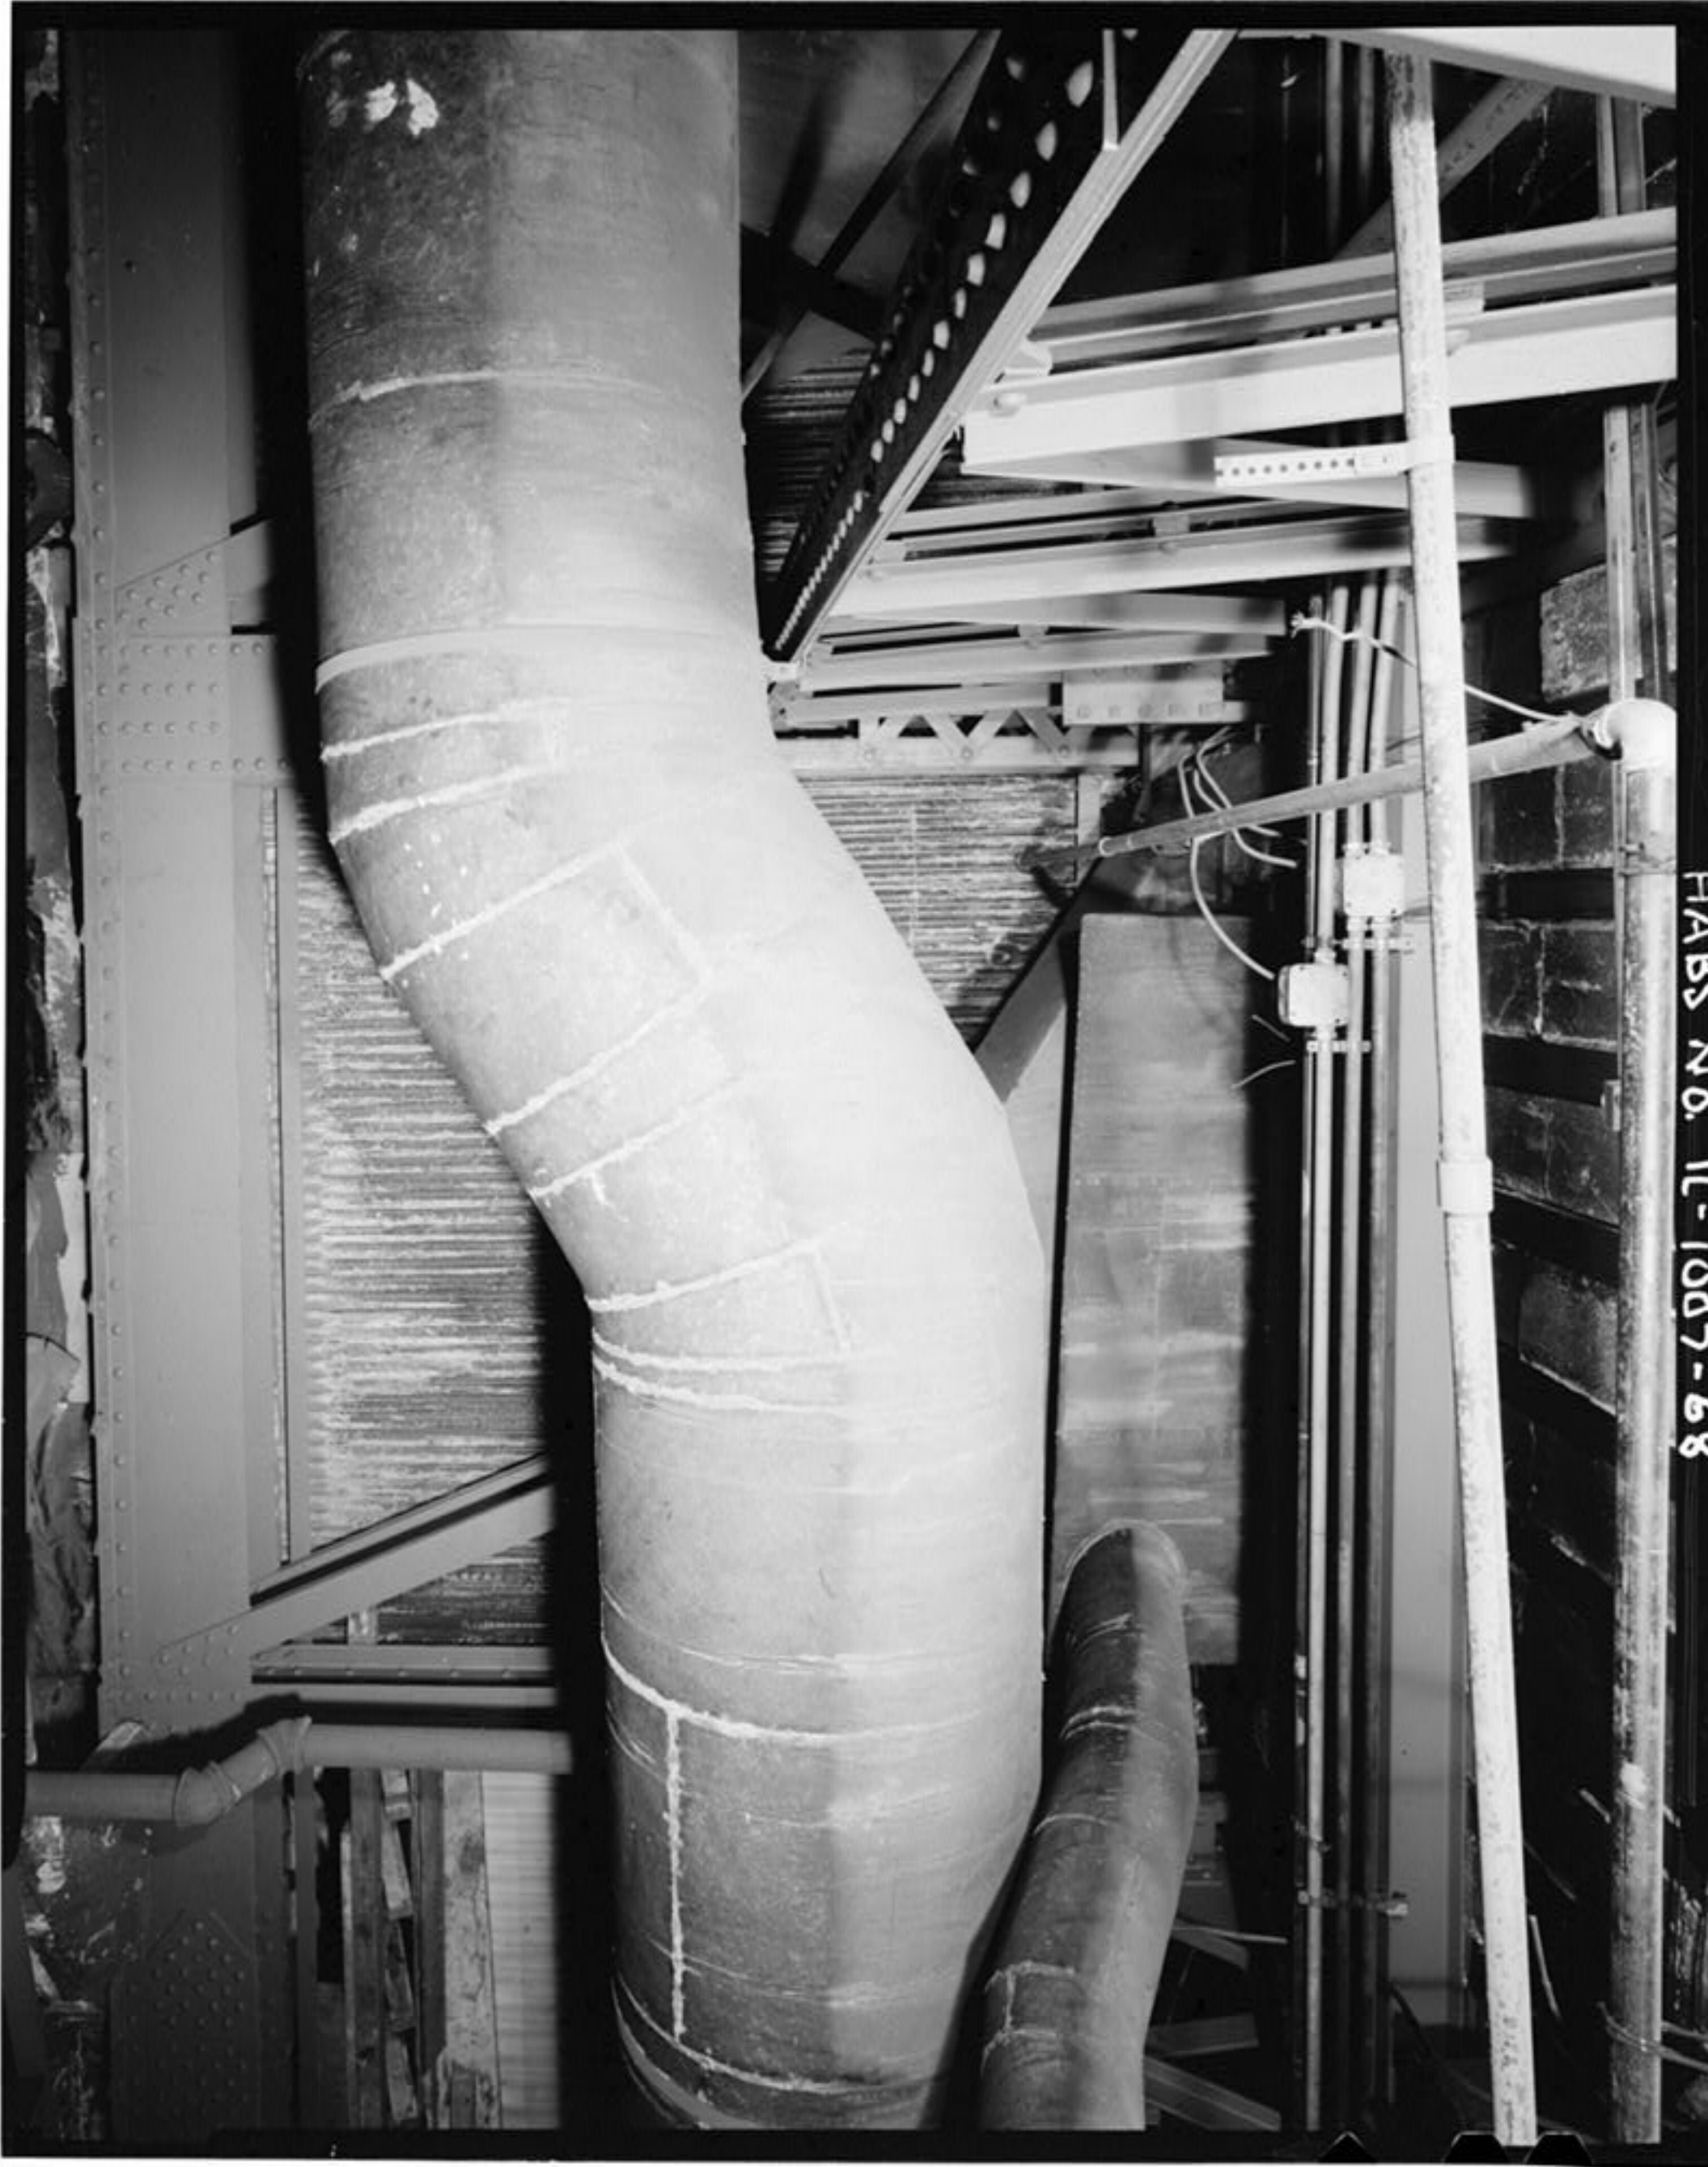
HABS NO. IL-1007-68

- IL-1007-68 DETAIL OF RETURN AIR DUCT, TRANSVERSE TRUSS 9 CONNECTION TO TRUSS T, AND ORIGINAL CORRUGATED METAL SHEATHING, UNDER BANQUET HALL FLOOR, LOOKING EAST.

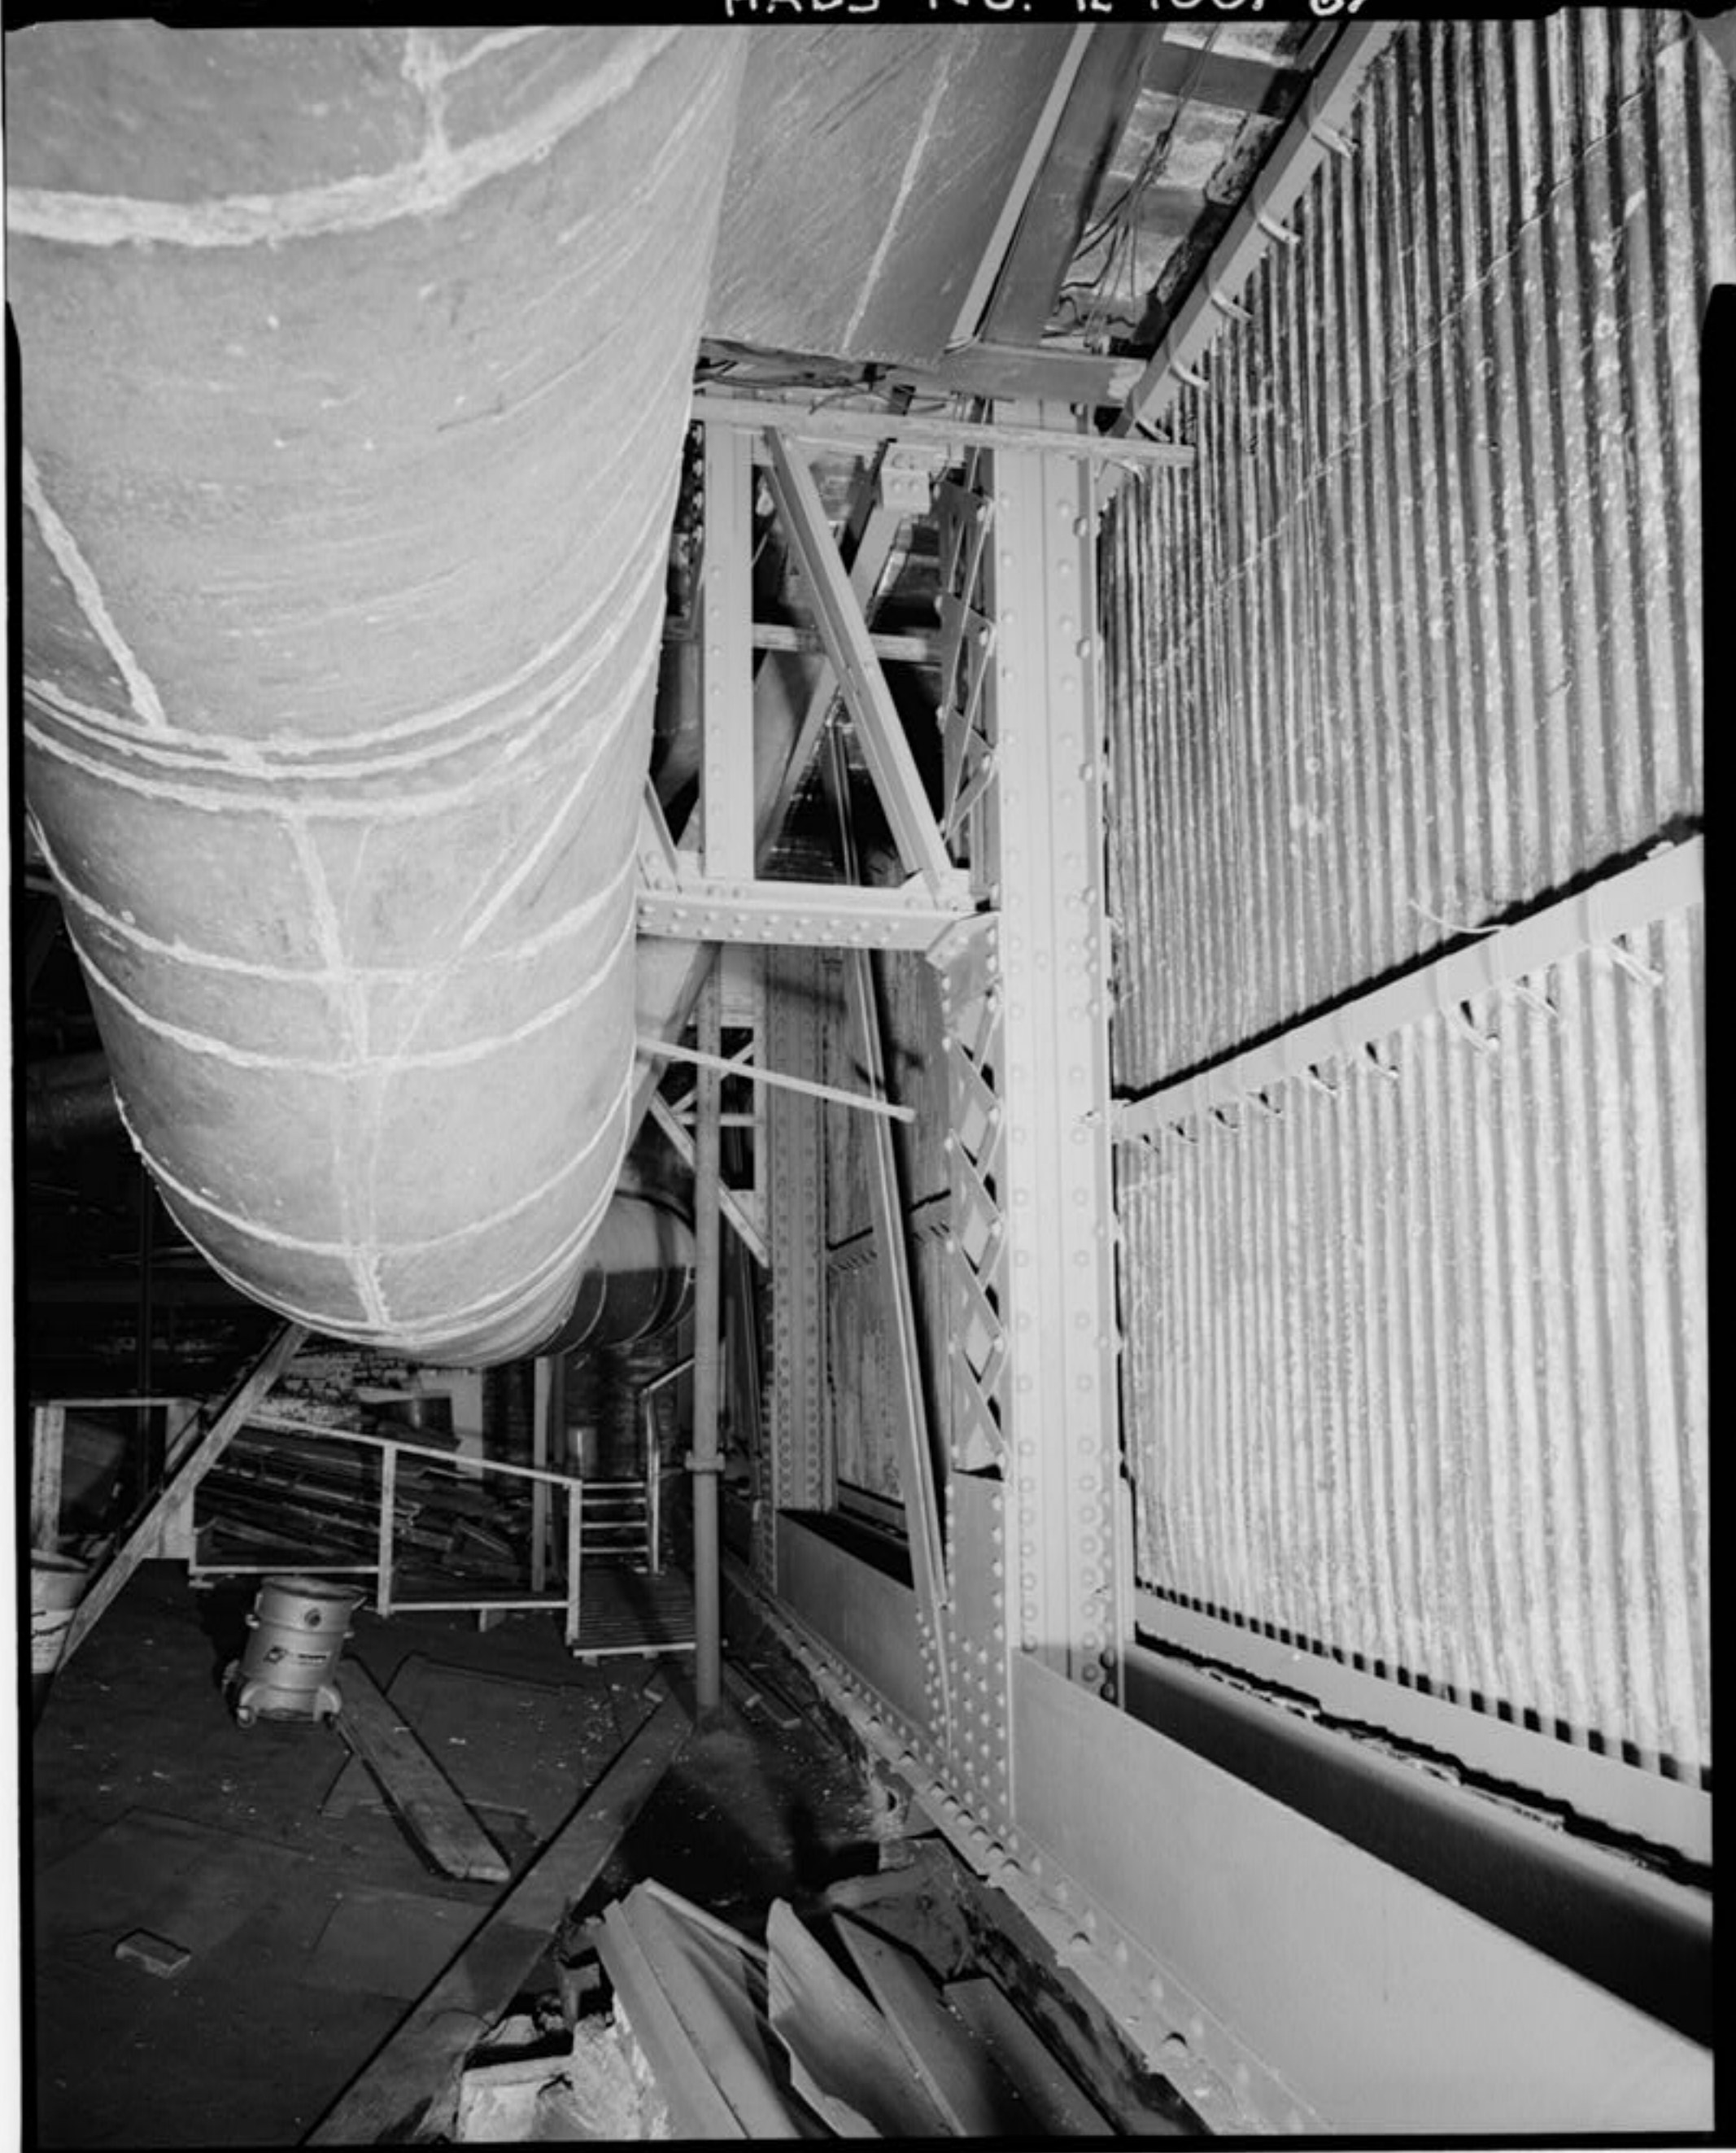
HABS NO. IL-1007-69

- IL-1007-69 DETAIL OF TRANSVERSE TRUSS 9 CONNECTION TO TRUSS T AND ORIGINAL CORRUGATED METAL SHEATHING, UNDER BANQUET HALL FLOOR, LOOKING NORTH.
- IL-1007-70 DETAIL OF RETURN AIR DUCTS AND RETURN PLENUM, UNDER BANQUET HALL FLOOR, LOOKING EAST.

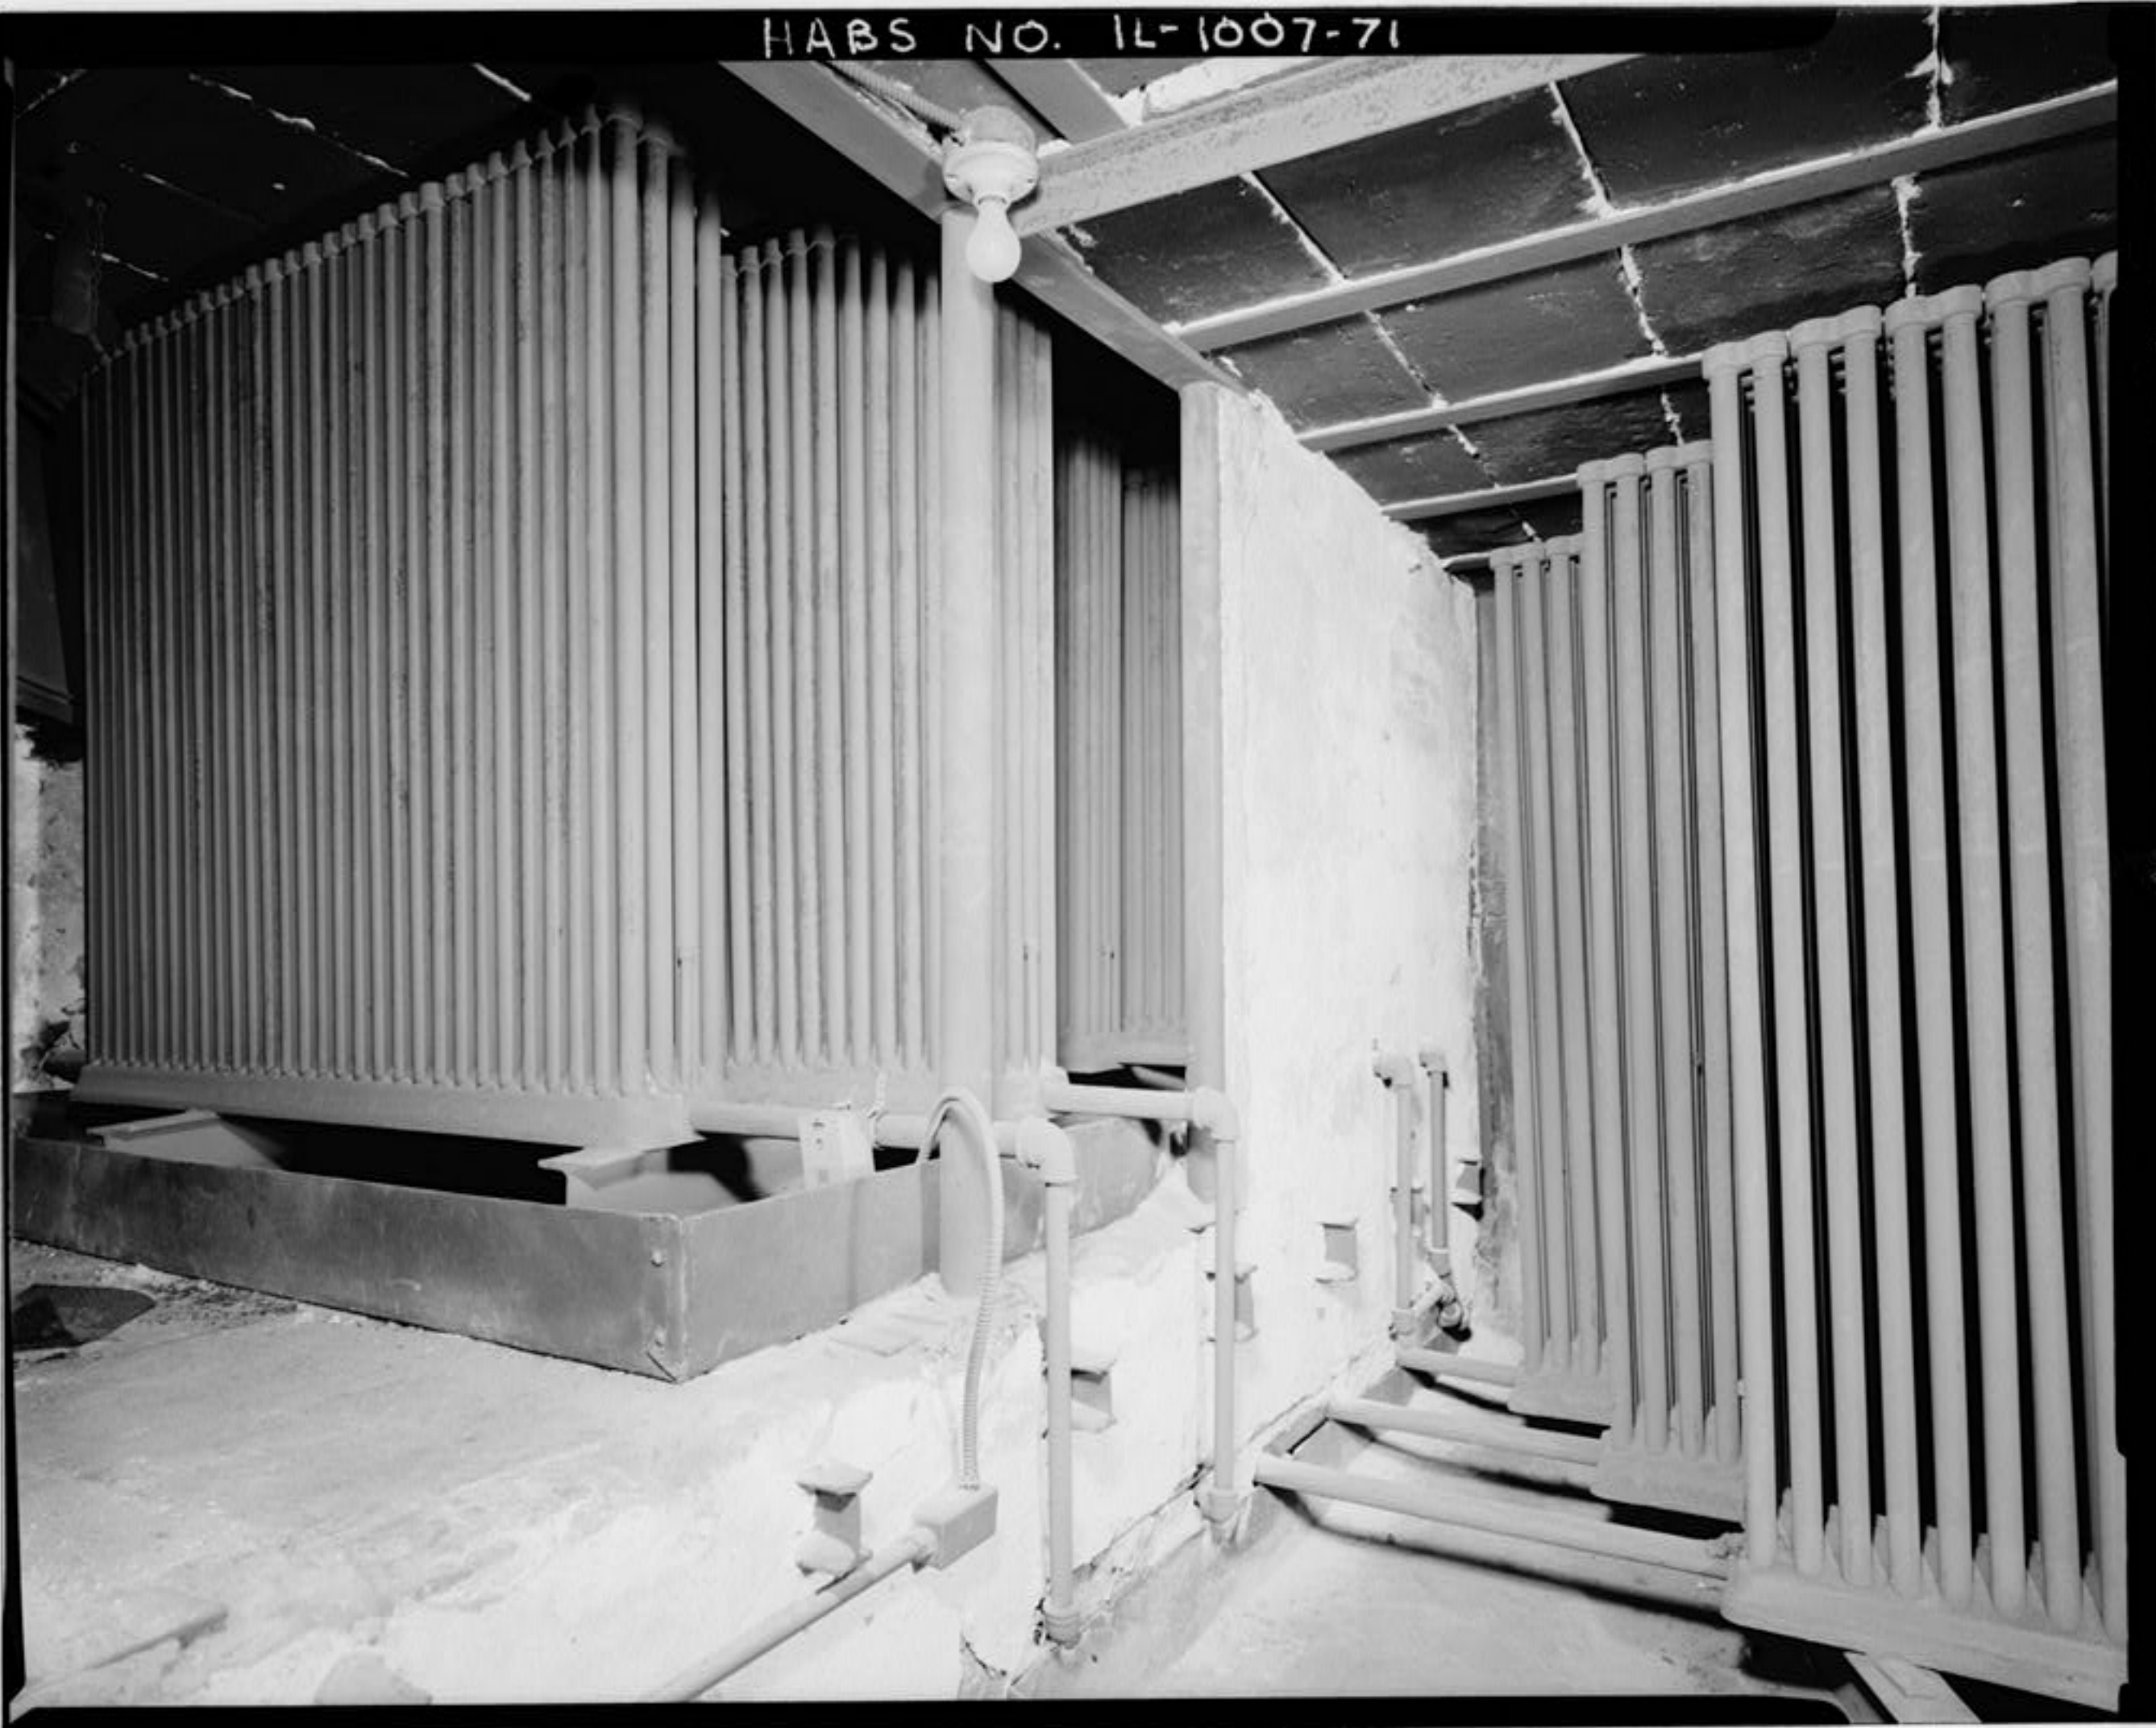
HABS NO. 1L-1007-71

- IL-1007-71 DETAIL OF ORIGINAL HEATING COILS, UNDER BANQUET HALL FLOOR, LOOKING NORTHWEST.
- IL-1007-72 ORIGINAL BUFFALO FORGE COMPANY NO. 50 BLOWER FAN, UNDER BANQUET HALL FLOOR, LOOKING EAST.

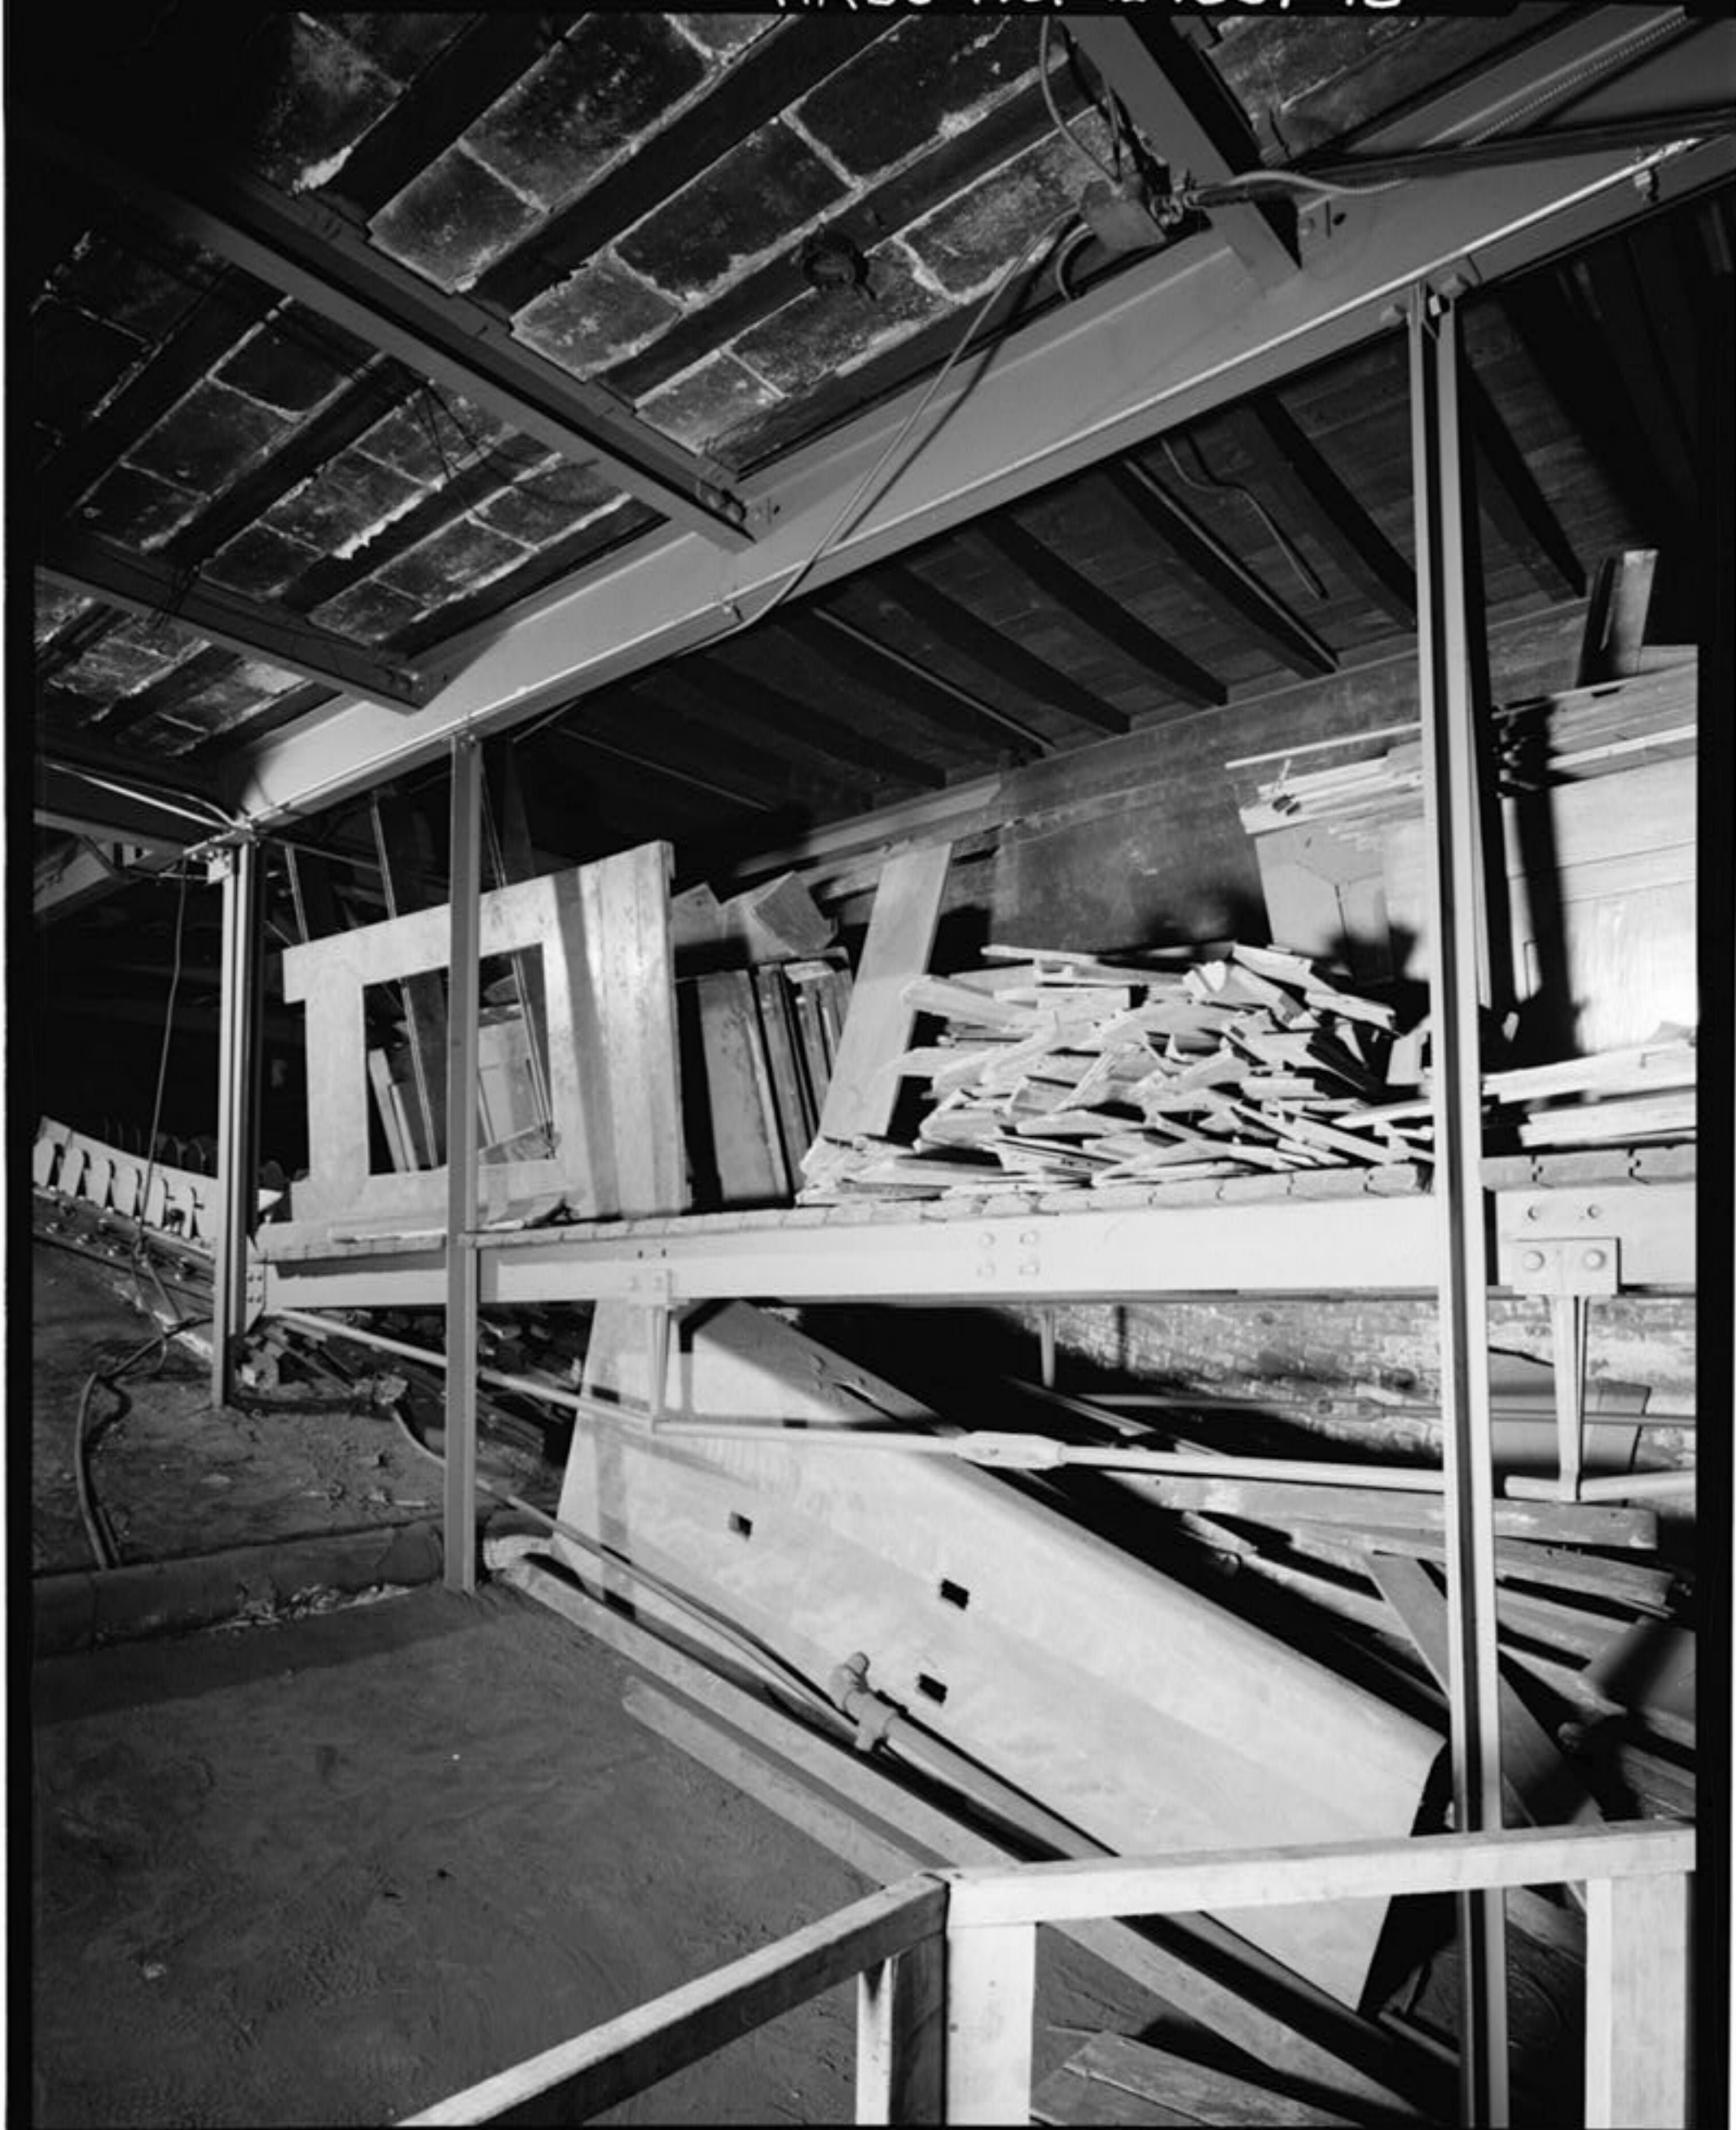
HABS NO. IL-1007-73

- IL-1007-73 CARPET HOIST, UNDER BANQUET HALL FLOOR, LOOKING NORTHWEST.
- IL-1007-74 DETAIL OF FURNITURE TRAP, UNDER BANQUET HALL FLOOR, LOOKING NORTHWEST.

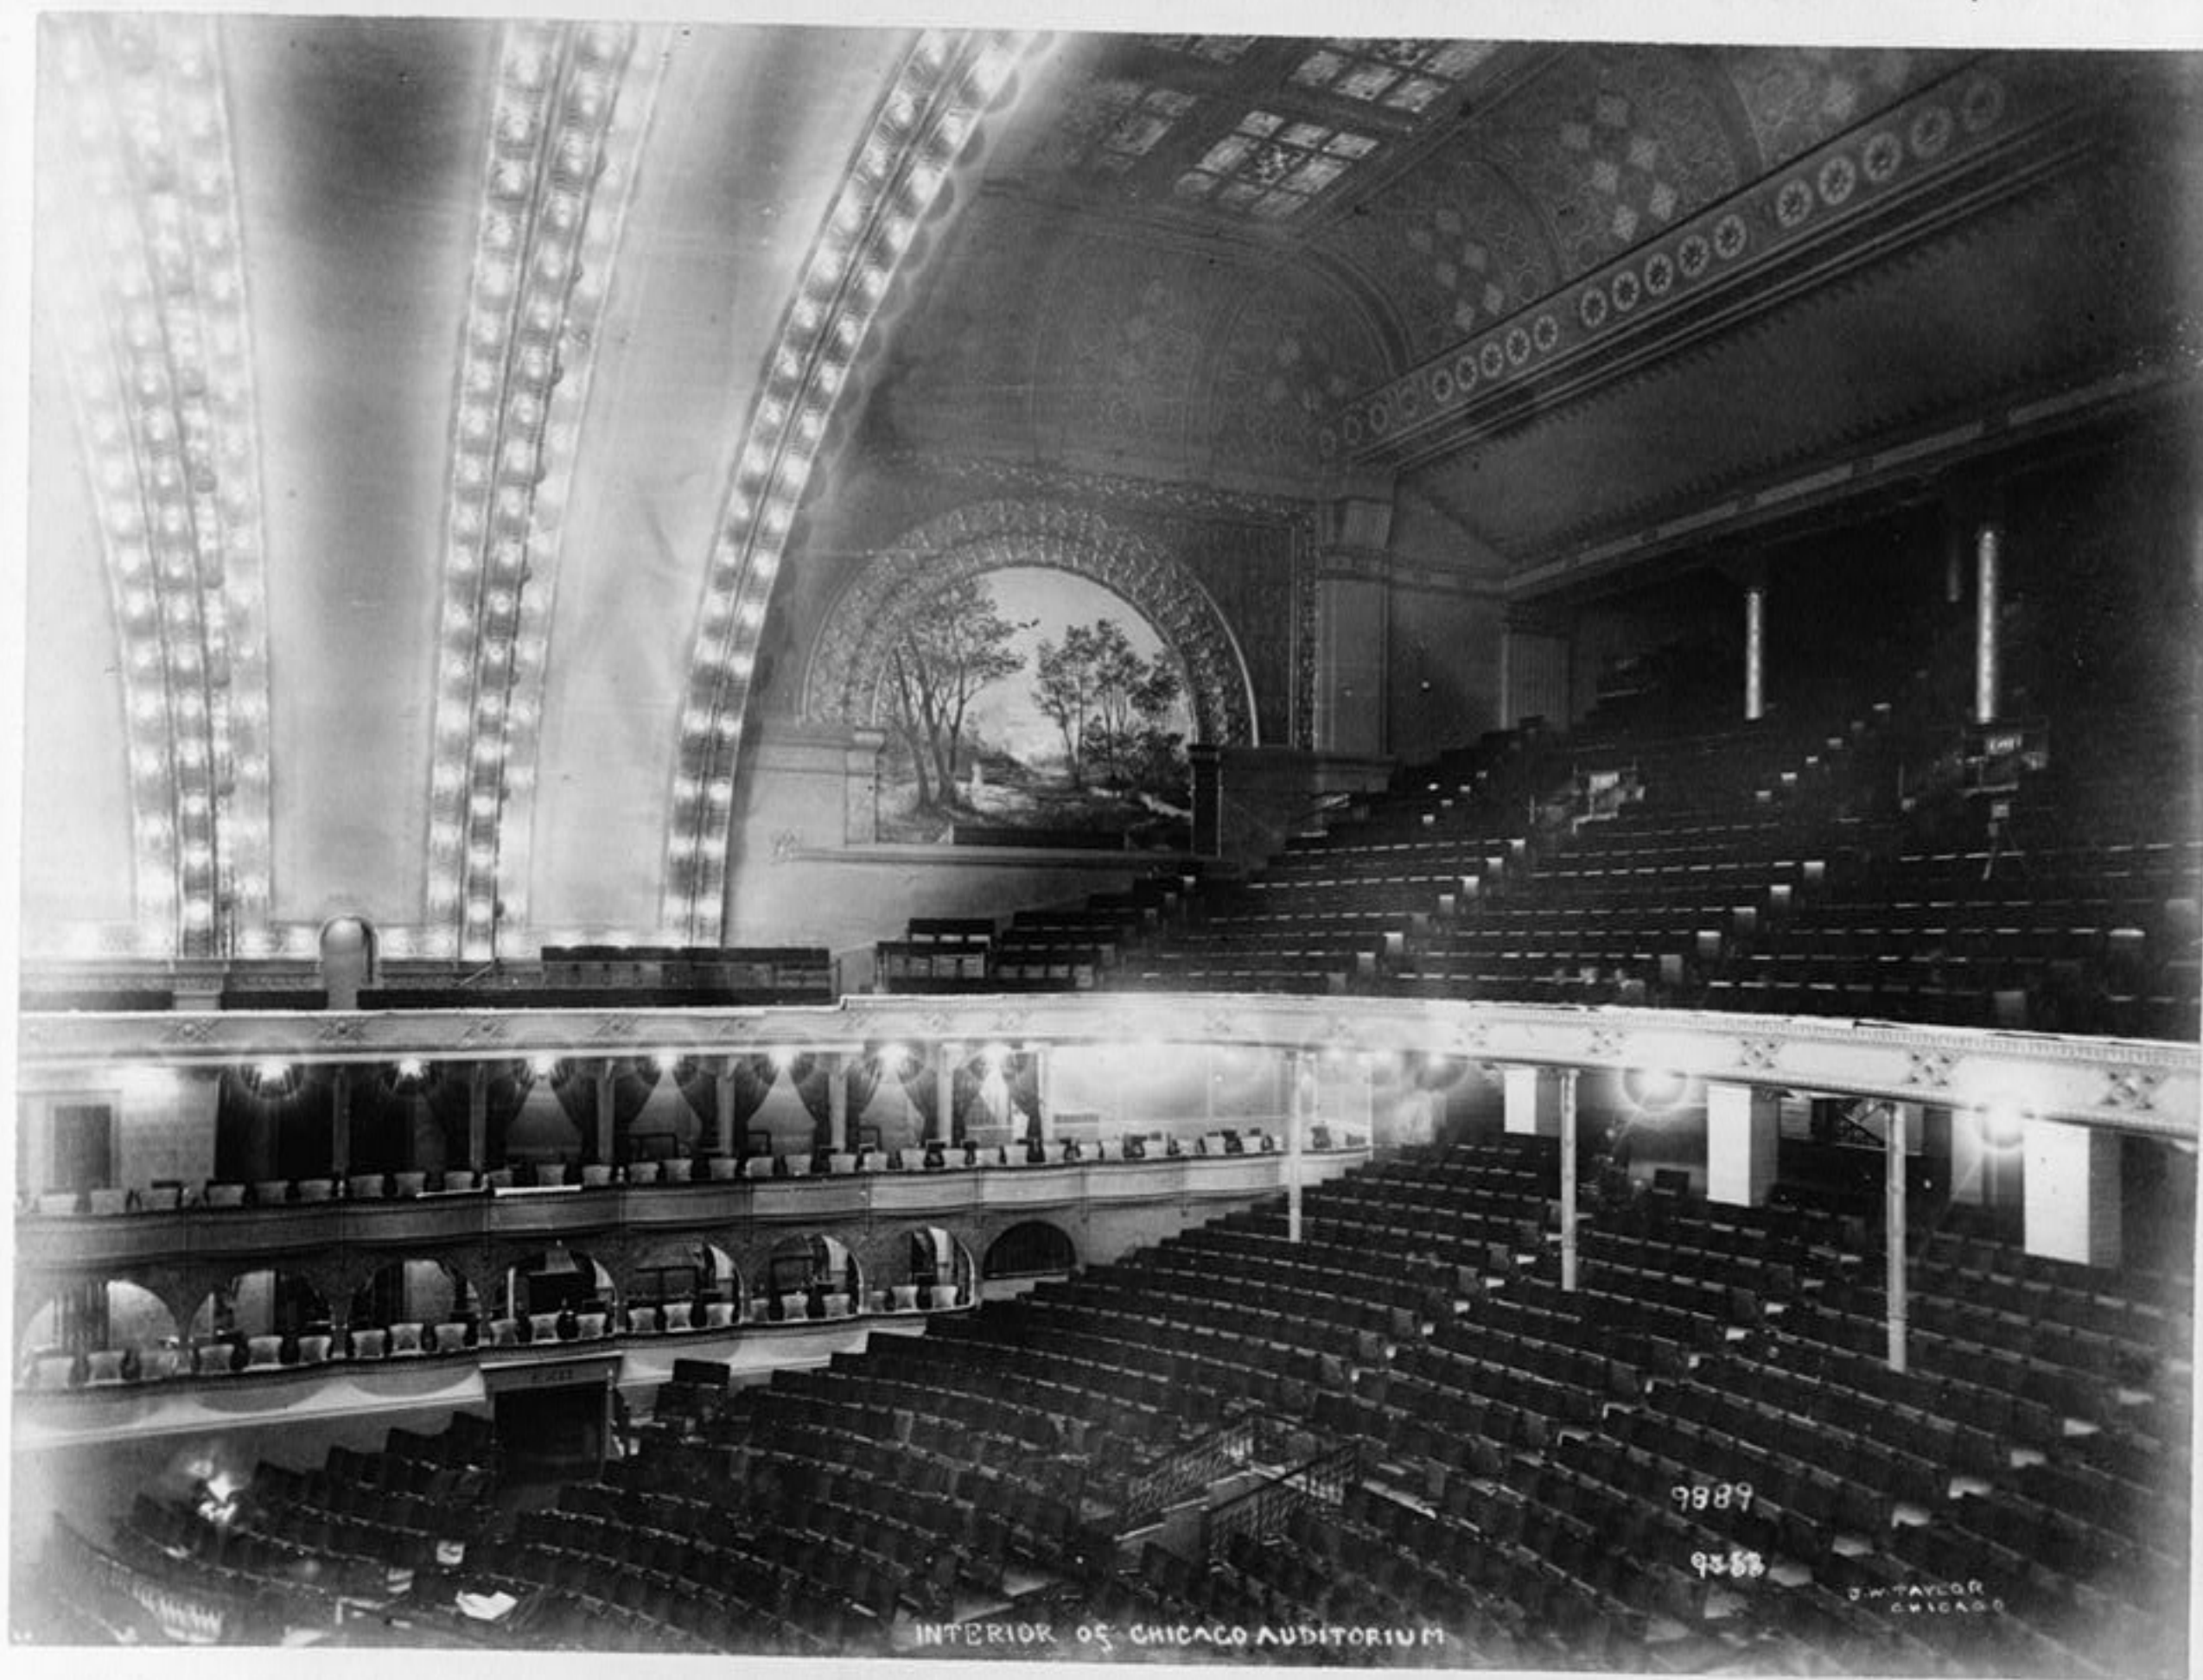
INTERIOR OF CHICAGO AUDITORIUM
